Geocomposite Edge Drain Evaluation on Ontario Highway 402 at Strathroy

ABSTRACT: Presented are results from excavations made to evaluate the performance of Geocomposite Edge Drains (GED). The highway of the areas investigated was built in 1981 over a stiff ($c_u = 50$ to 100 kPa) clay subgrade (LL=40; PL=20; PI=20) as part of Ontario's freeway system (i.e. limited access divided highway). The GED was placed in 1990 and consisted of a plastic core 300 mm wide with 25 mm high cusps all wrapped in a nonwoven geotextile. The excavations clearly showed differences between the installation concept and actual construction. First, the GED was unable to prevent the underlying clay from pumping. Second, the GED installed was not square ended. Third, permeability tests on the backfill showed that the granular backfill was nearly 1000 times less permeable than the geotextile of the GED. These and other factors resulted in several valuable and practical conclusions.

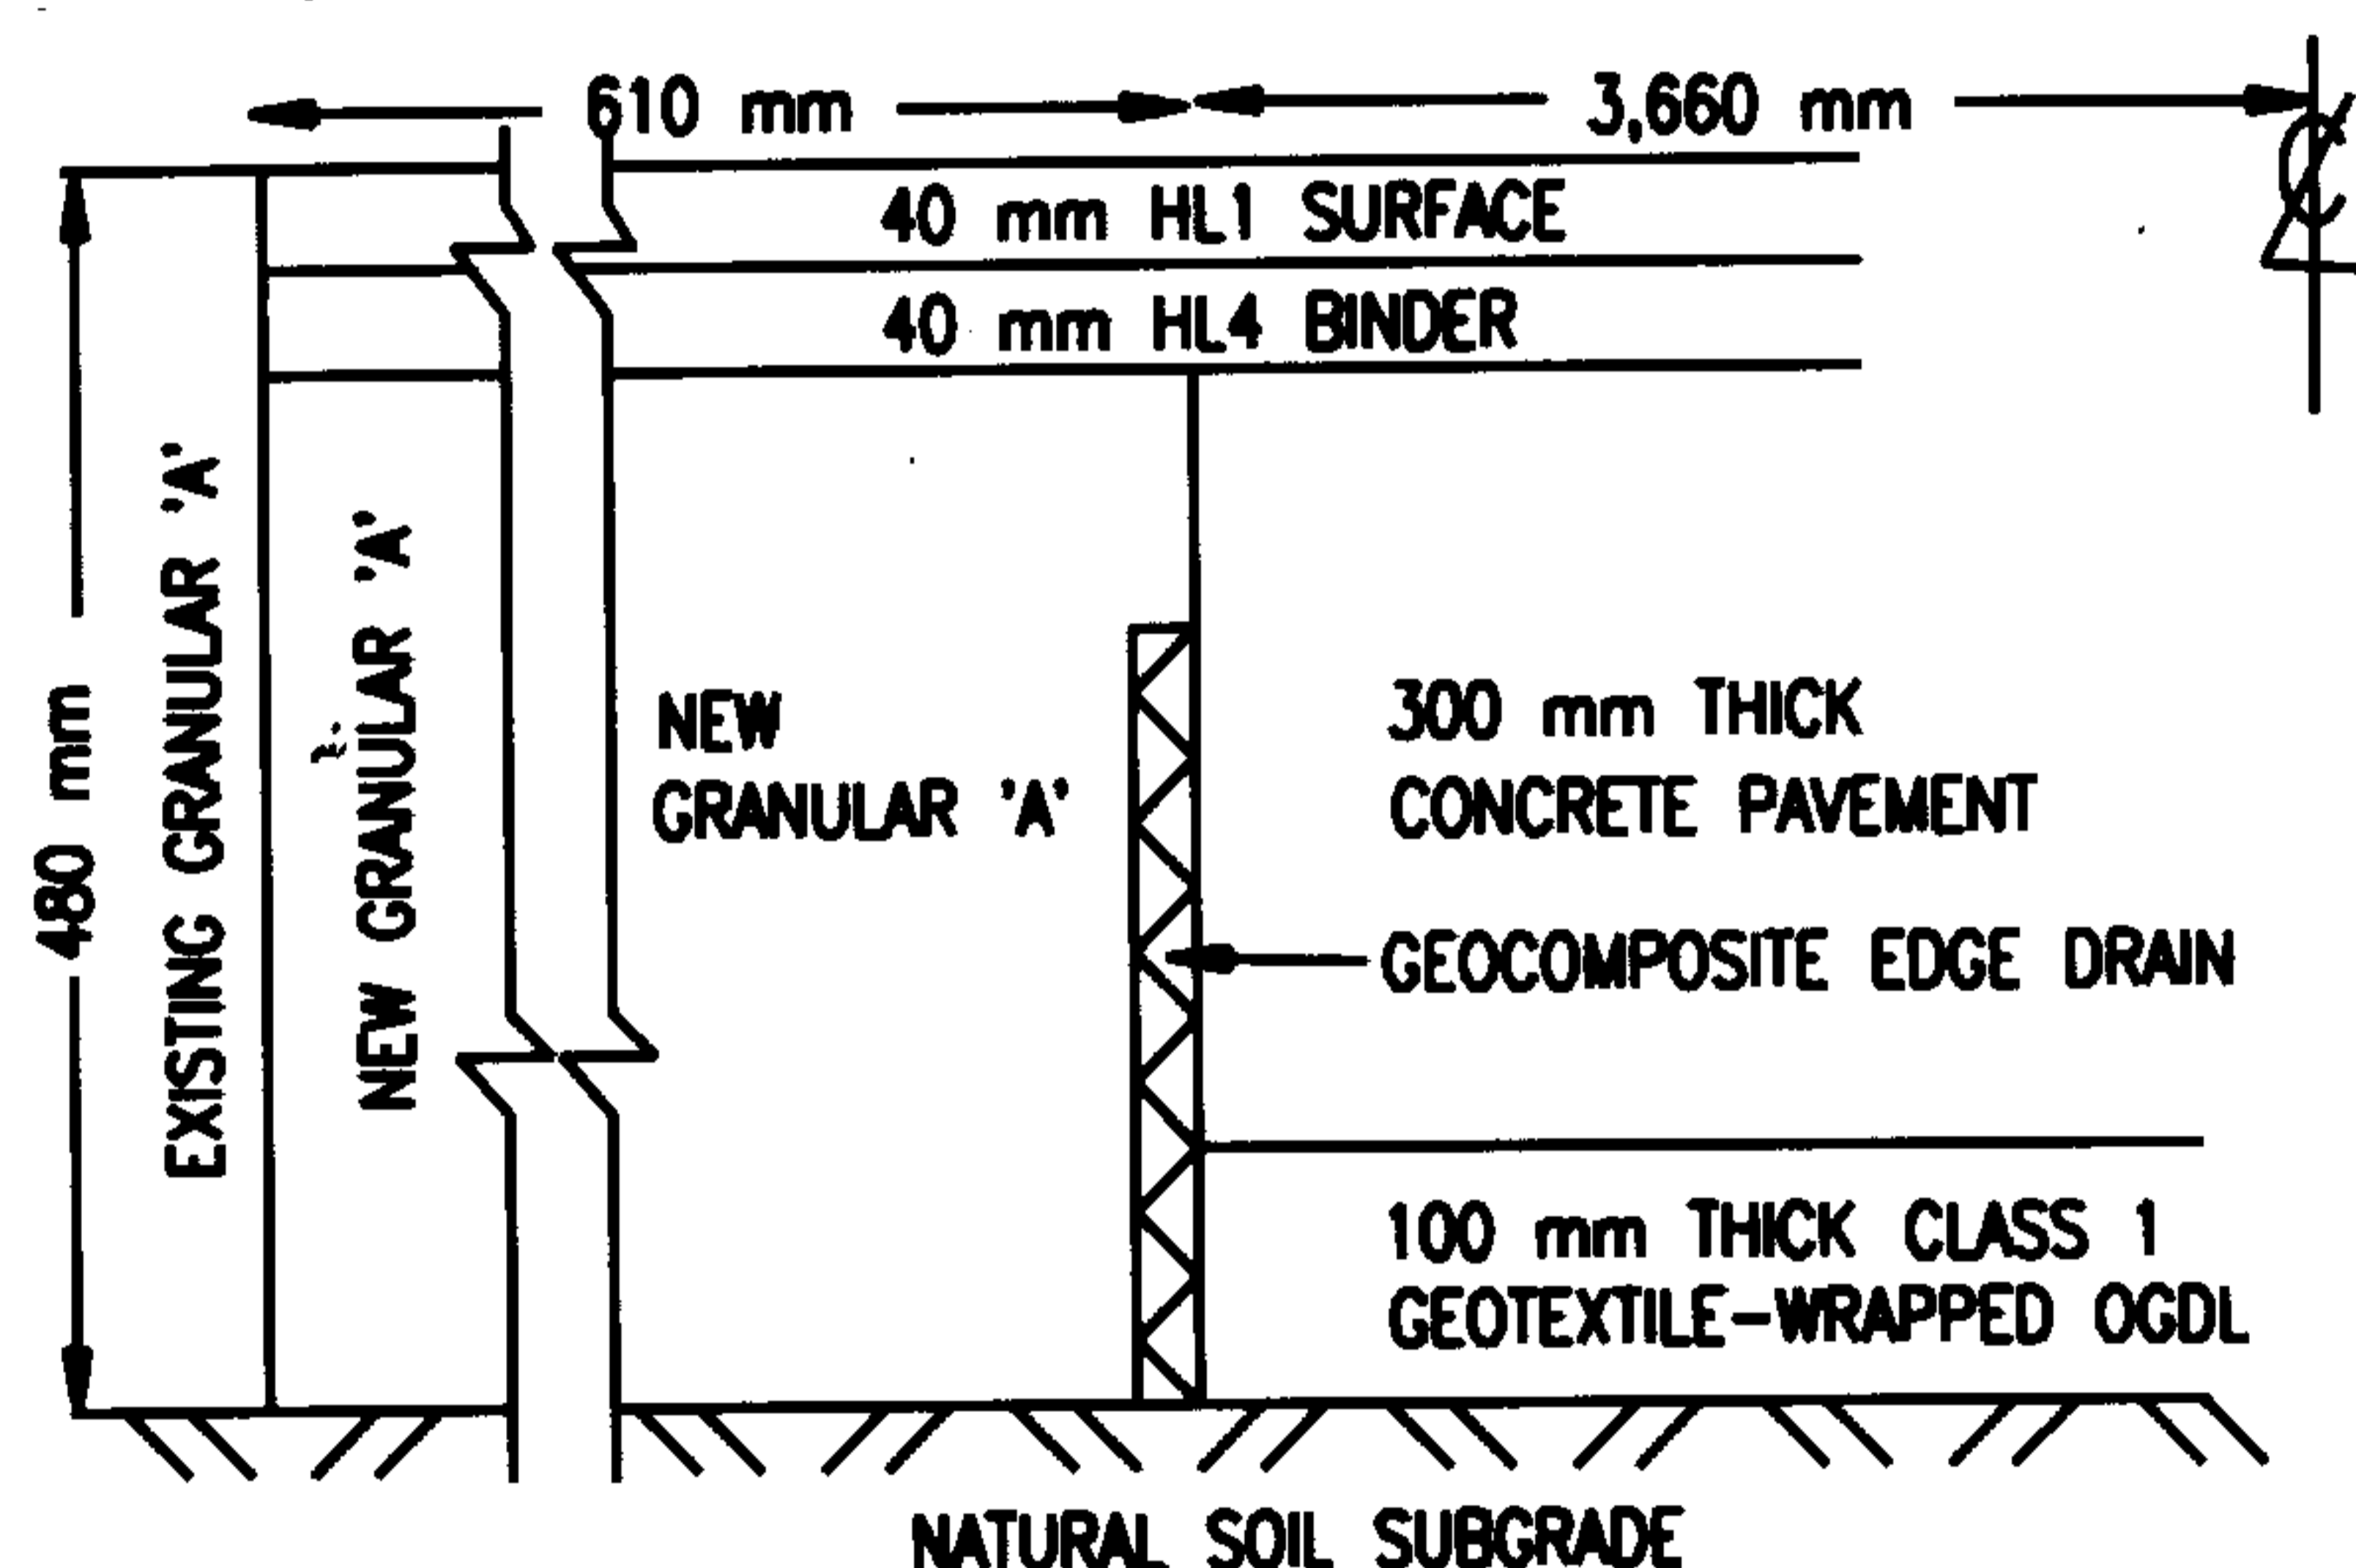
Figure 1. Cross section of Geocomposite Edge Drain installation as required from construction drawing.

The second point worth noting is that the GED installed was not square ended as shown on the construction drawing (see Figure 1). The outer face was longer than the inner face, thus there were bevels at both ends leaving a probable gap of 15 mm at the bottom of the inner face. To ensure contact with the base elevation of the OGDL the base of

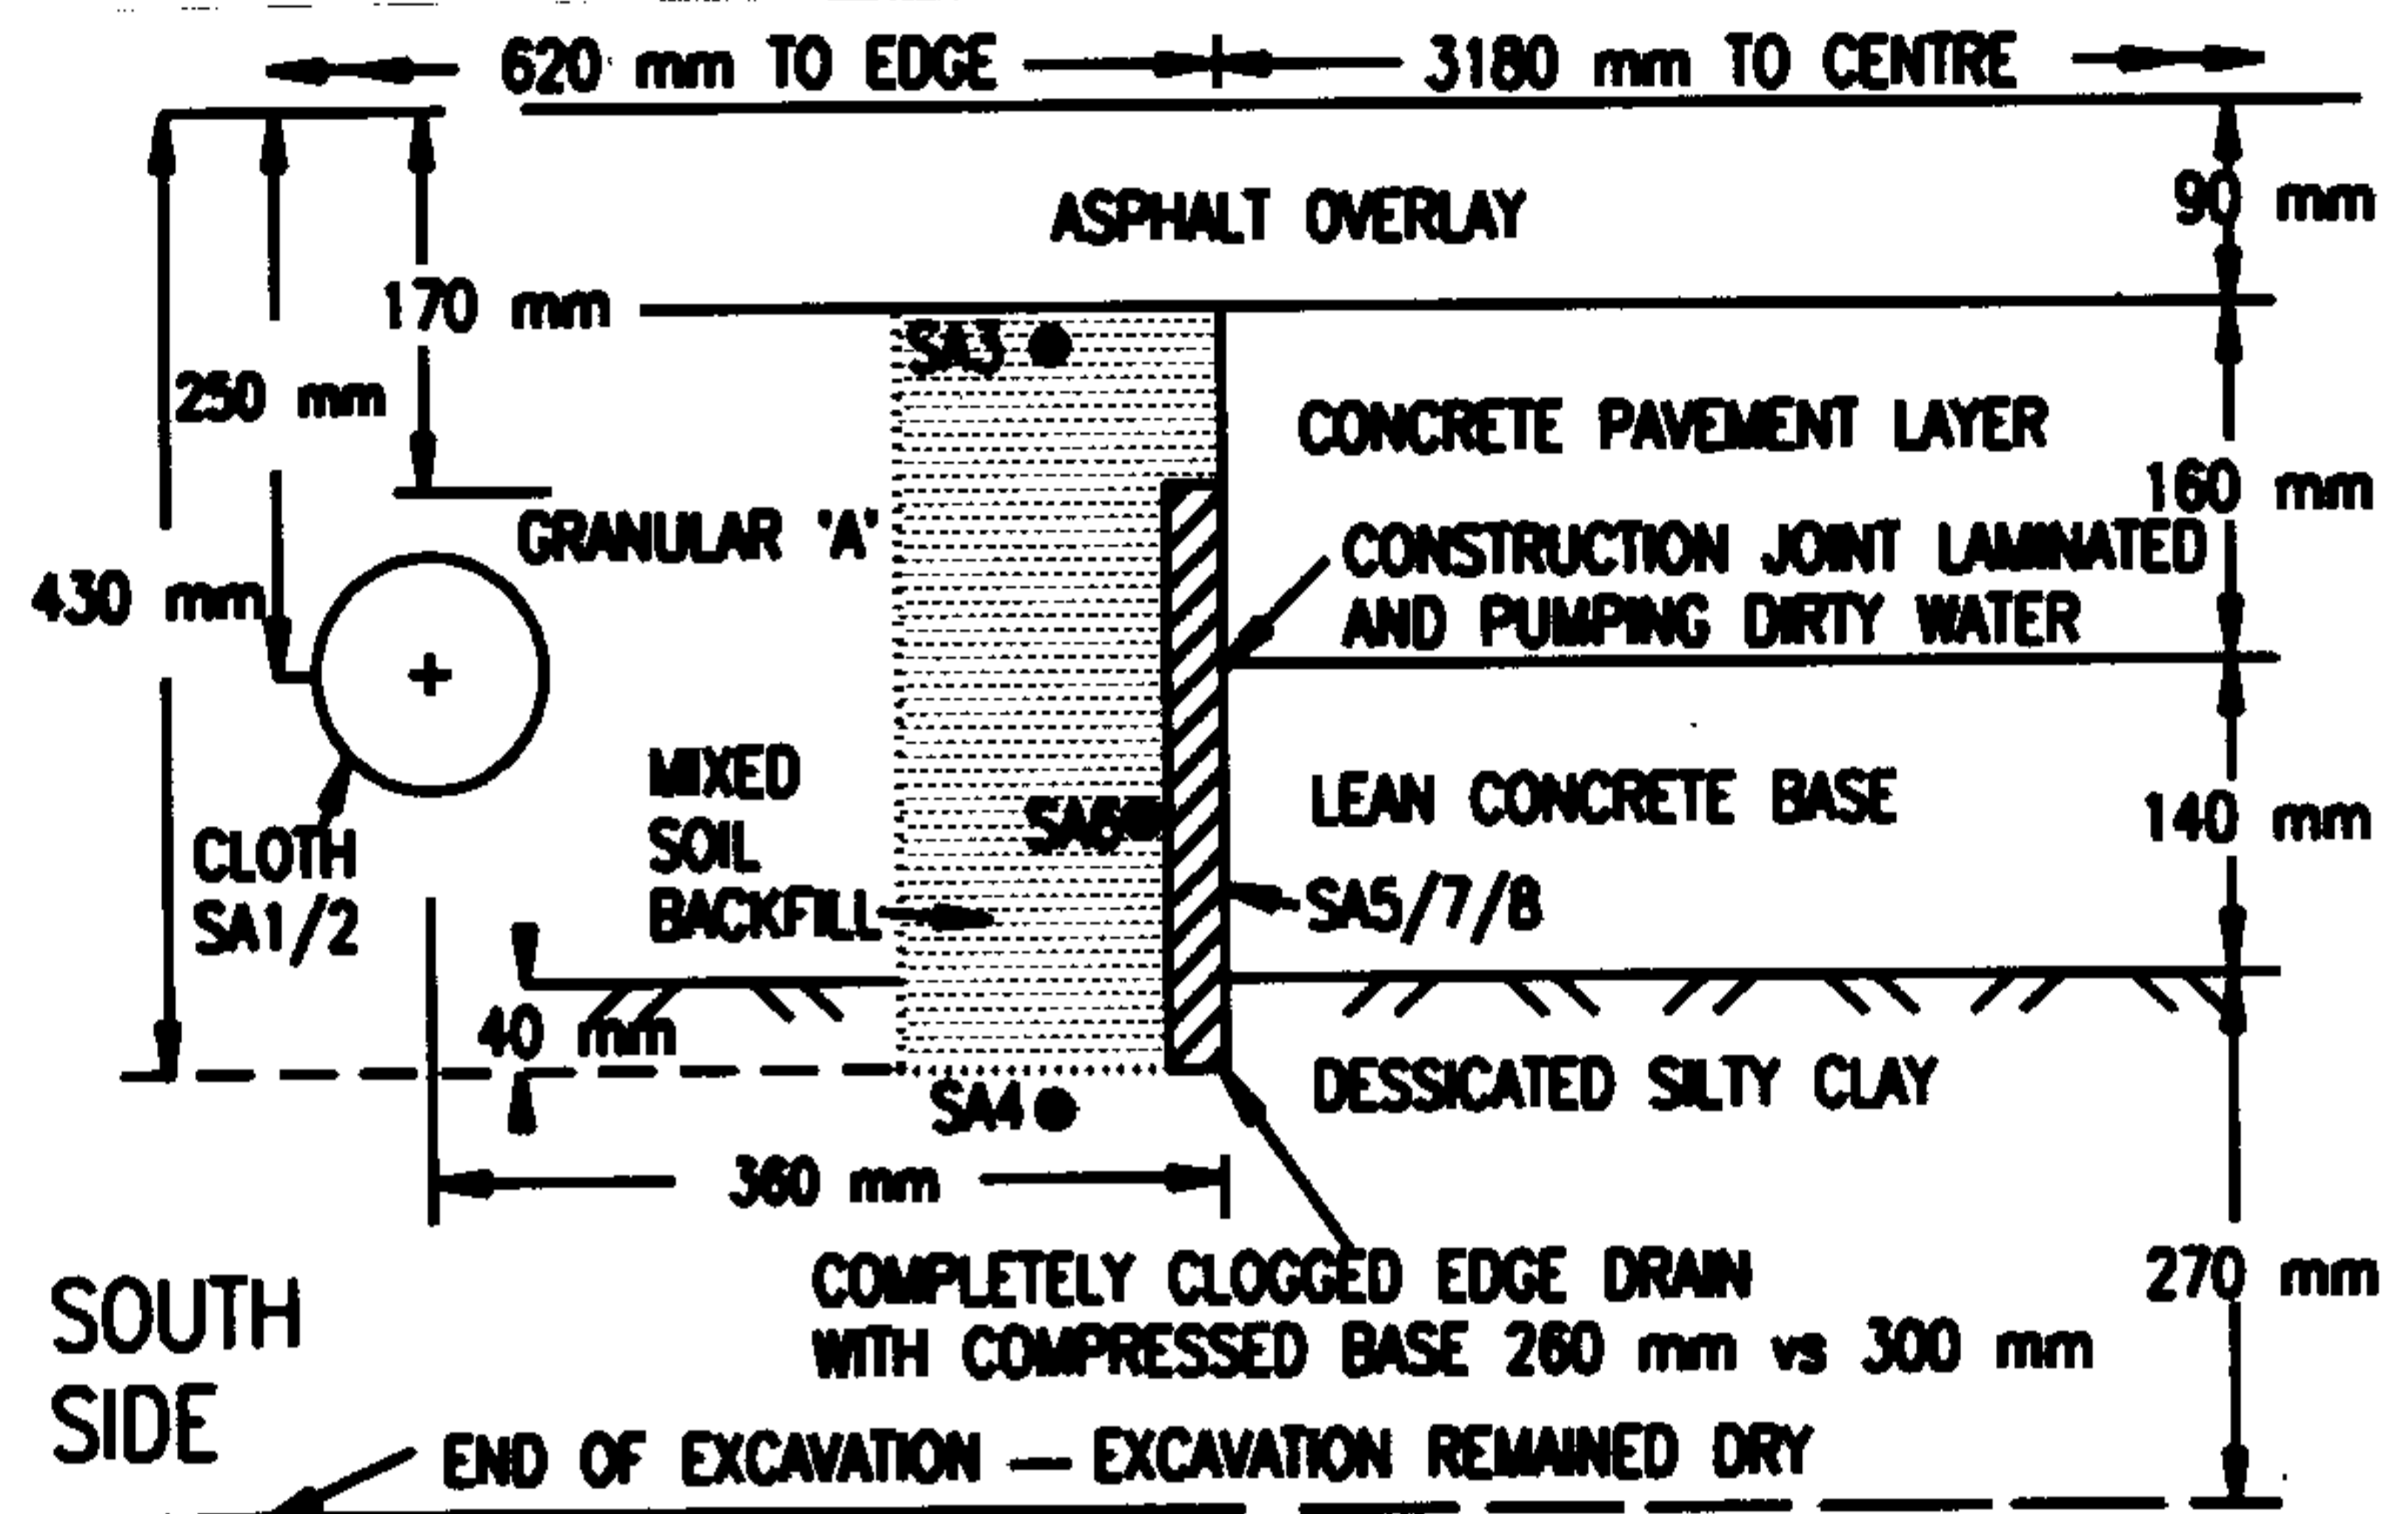
Figure 2. Cross section at Excavation TP1.

This first excavation was made in a Phase 2 only area (i.e. GED only installed with no rebuild). The pavement edge dimension, GED dimensions and locations of samples taken are given in Figure 2. The GED was completely plugged with clay. A grain size analysis on the subgrade gave 100% passing the 75 μm sieve which is the minimum FOS limit specified by MTO for GED geotextiles. Examination of the concrete slab edge wall indicated that clay was pumping between the structural concrete and lean concrete layers and there was infiltration of water through the pavement surface crack. The GED, was installed into the subgrade as seen in Figure 2. The subgrade soil appeared to be part of the GED trench backfill soil. A grain size analysis of the backfill (sample SA6 on Figure 2) is presented in Figure 3 and shows some 14% of the sample passing the 75 μm sieve. Such a high percentage of fines would not be conducive to good drainage. This was confirmed by doing a permeability test on the material passing the 4 mm sieve, washing the fines from the tested sample and repeating the test. The resulting values gave a

permeability of $0.532 \mu\text{m/s}$ for the dirty sample, $99 \mu\text{m/s}$ for the washed sample and a loss of weight from washing of 8%. These values may be compared with an in-plane permeability of about $400 \mu\text{m/s}$ for the geotextile. Clearly the use of a clean washed granular backfill would be most beneficial in helping the internal drainage of the pavement. A thin layer of such material should also be laid prior to placing the lean concrete. The GED systems cannot prevent pumping where pumping might have existed before installation of the GED. While 10% of the section which exhibited severe pumping was reconstructed under Phase 1, the less distressed areas were only retrofitted with the GED under Phase 2 without increasing the structural capacity of the pavement.

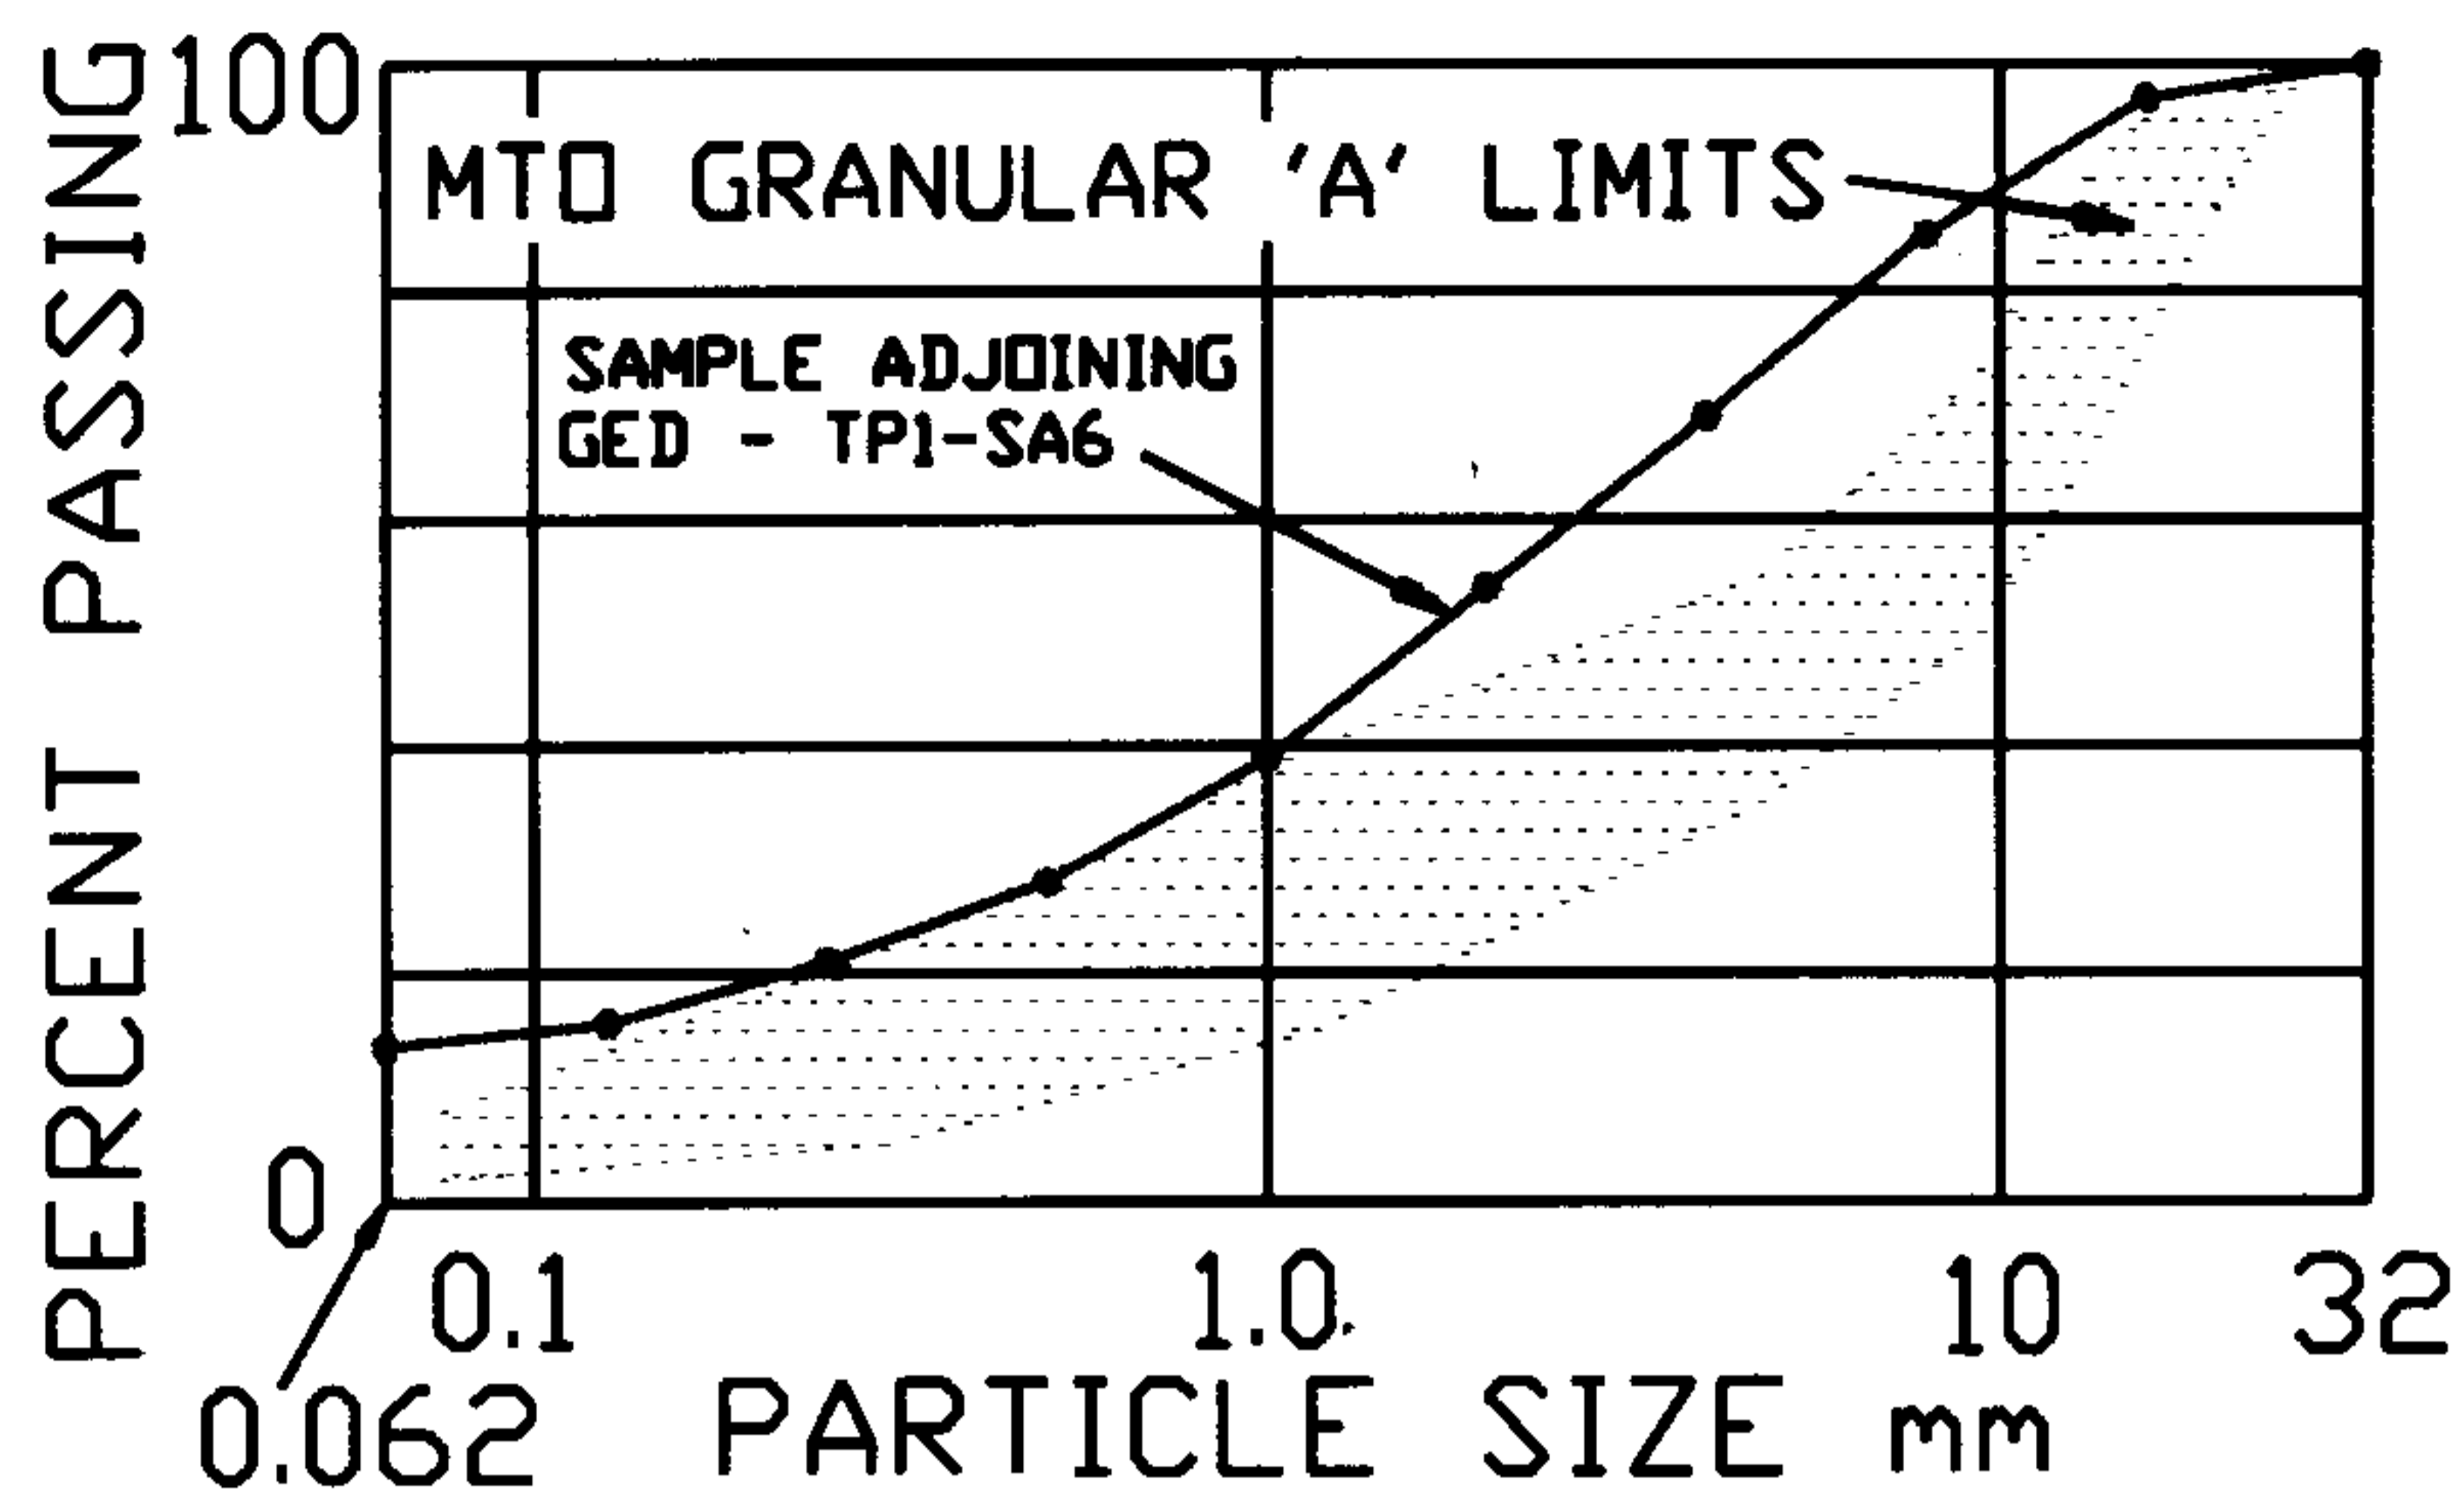
Figure 3. Grain size distribution of sample adjoining Geocomposite Edge Drain at Excavation TP1.

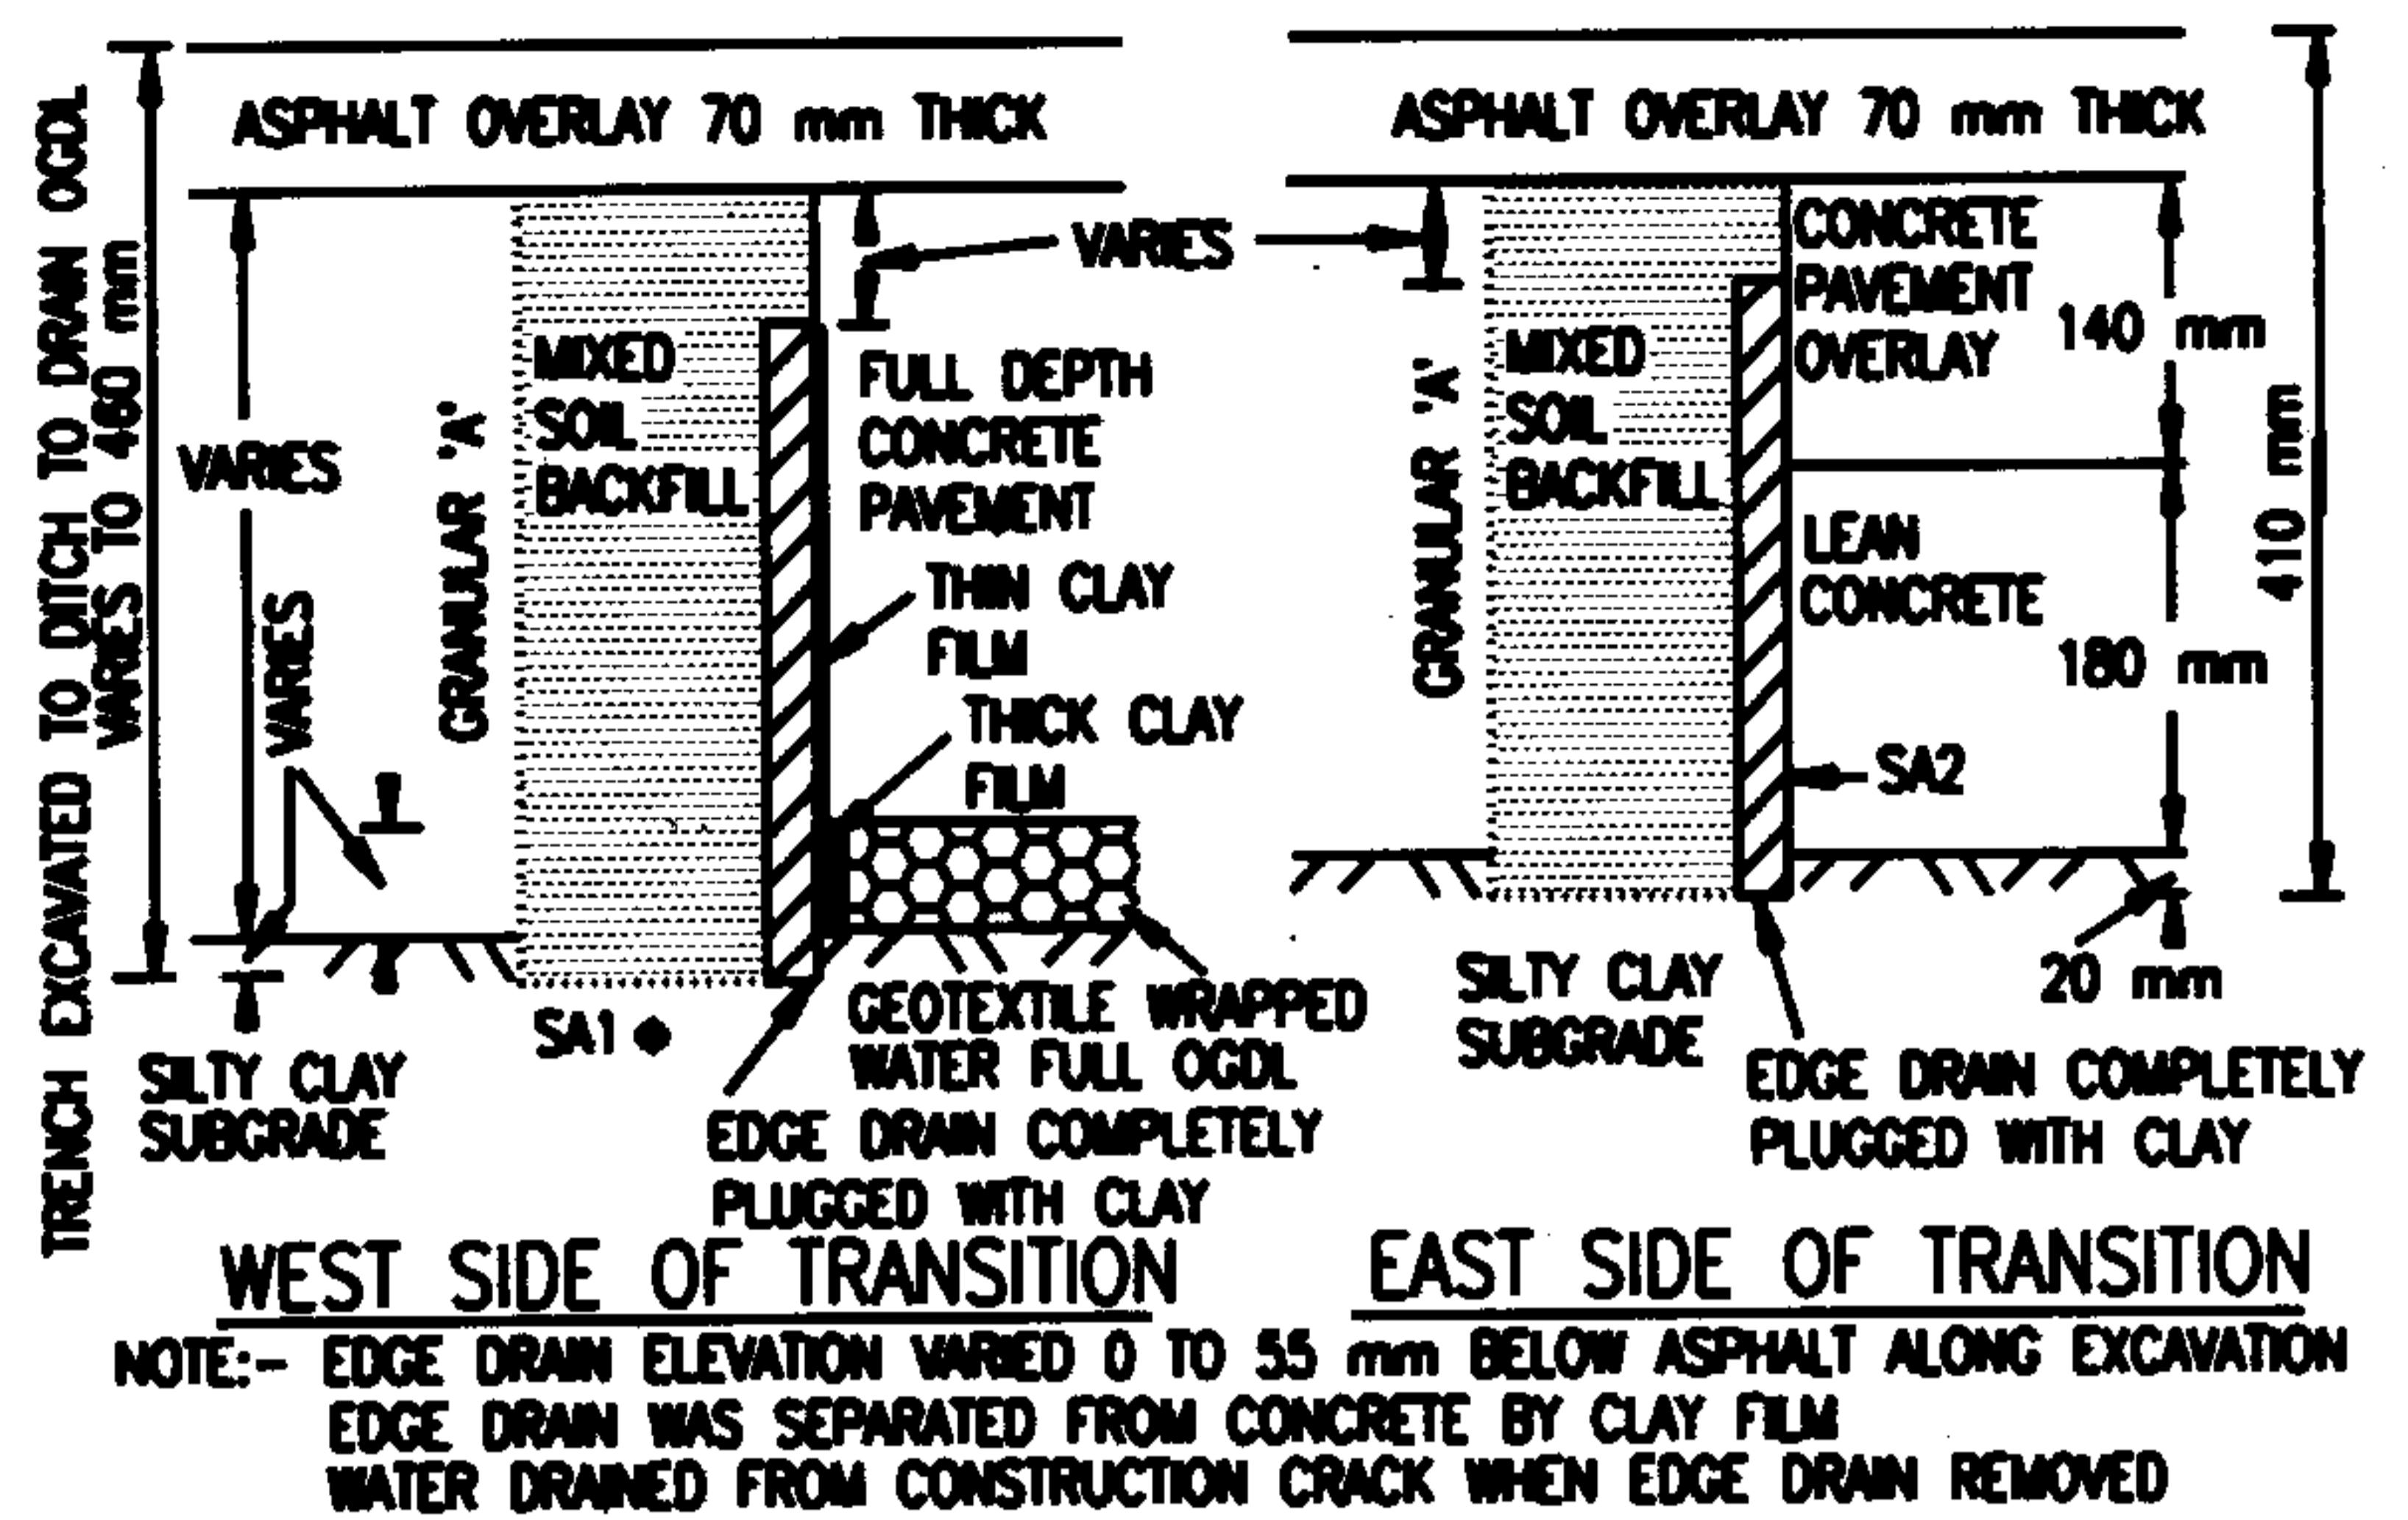
Figure 4. Cross section at Excavation TP3.

There was considerable variation in the GED base (i.e. invert) along the length of this excavation. There was a full head of dirty water in the geotextile-wrapped OGDL. A slime buildup existed on the inside geotextile surface. In addition, the OGDL was horizontally separated from the GED by about a 60 mm thick layer of pumped clay sediment mixed with backfill aggregate. Exposure of the geotextile resulted in only a very slow drainage of the OGDL. This was due to the clay particles on the surface of the geotextile and suspended within the water trapped in the OGDL. It was not until the geotextile was punctured

that considerable quantities of water exited the OGDL and the water in the pothole dropped. Note that the measured dimension of the OGDL at the pavement edge was much less than the value shown on Figure 1 and was variable. The maximum depth was 60 mm. This may be due to the loss of clay on the subgrade and movement towards the edge of the slab or due to a less than required construction depth. It is unknown what the depth is, or its variation laterally across the highway. If thicker under the highway then water is probably trapped under the slab.

As might be expected the GED was completely clogged. In addition there was a thin clay film between the edge of the pavement slab wall and the GED. Here again is evidence that the GED's geotextile should be protected from clogging by a clean granular filter.

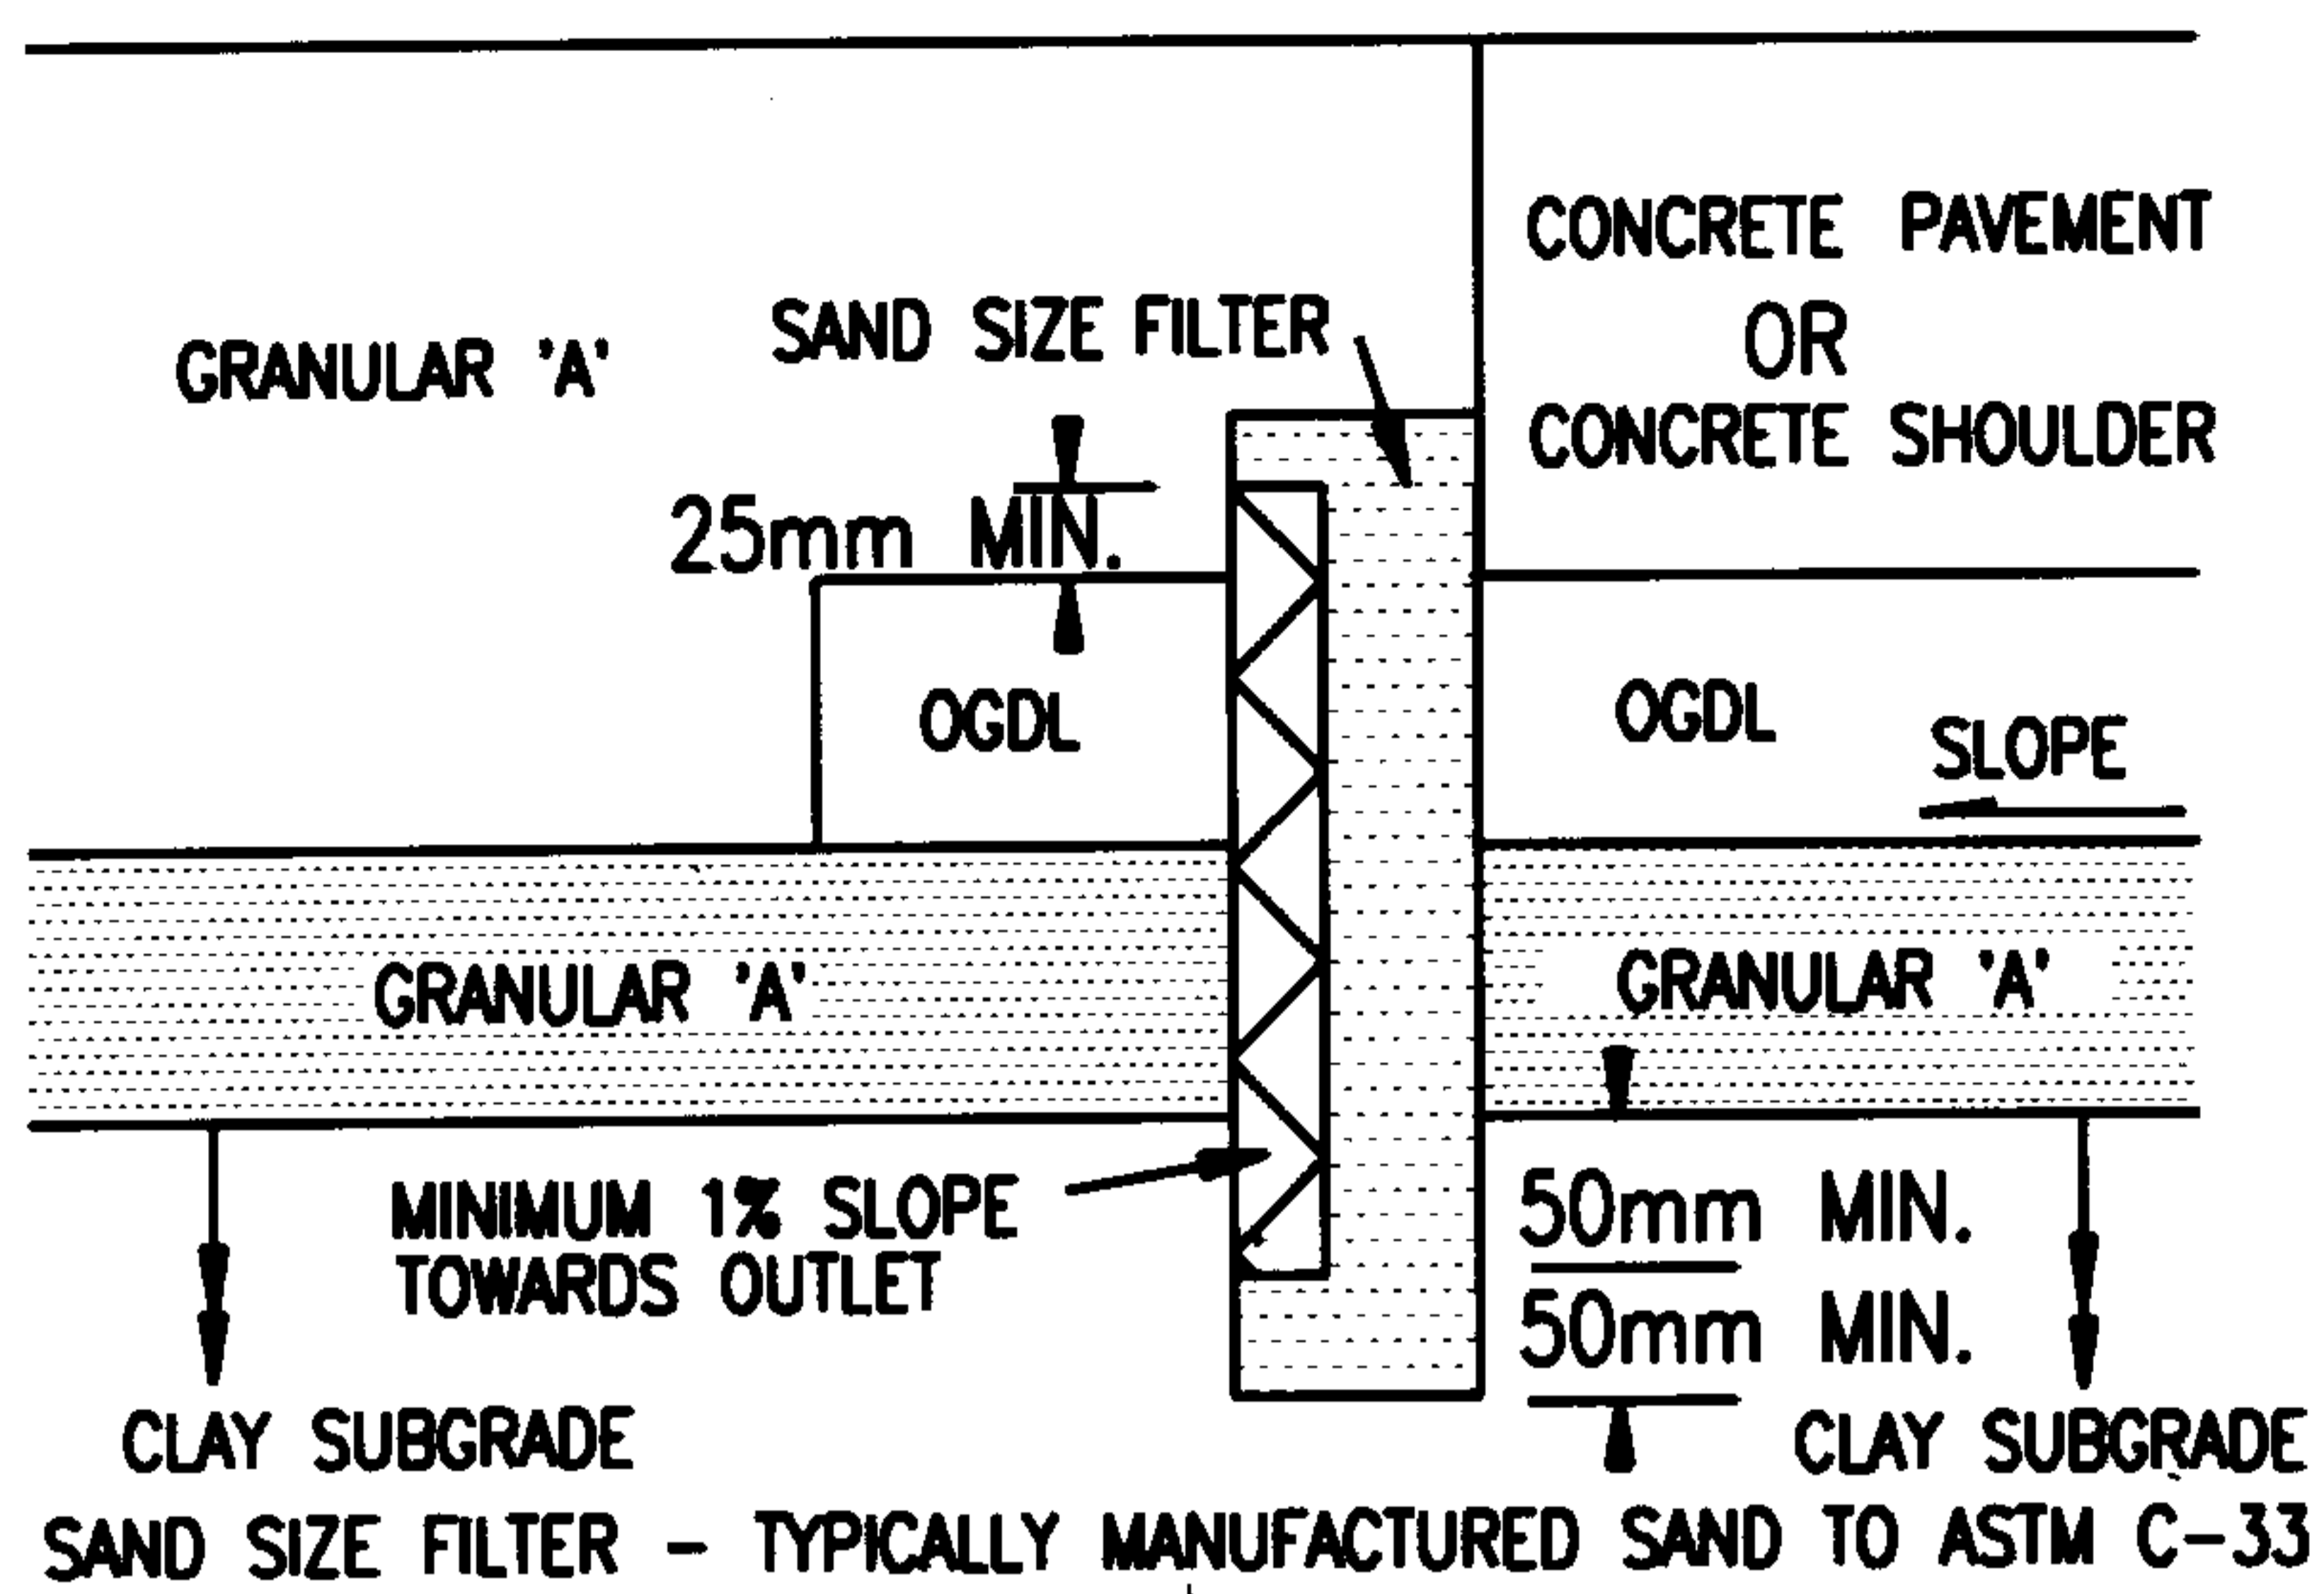
Figure 5. Recommended installation cross section.

Permeability tests on the minus 4 mm sizes of the backfill have shown that the backfill is in the range of nearly 1000 times less permeable than the geotextile of the GED. The backfill permeability should be improved by using a clean granular backfill. A recommended cross section is shown in Figure 5.

Open graded draining systems and drainage collection systems must be protected from the intrusion of fines by an appropriate granular filter layer. Recommended is a layer of the sand portion of ASTM-C33 with the addition of the limits of 0-2% passing the $75 \mu\text{m}$ sieve.

Backfill used for Geocomposite Edge Drains (GED) should have a permeability similar to the above clean sand.

The base elevation of GED must be located below that of the base elevations of the layers they are intended to drain, plus any damage that may result from frost or installation damage. A minimum 100 mm is recommended.
