Mexican Experiences with Geomembranes in Hydraulic Works

R. Murillo-Fernandez

Comision Nacional del Agua, Mexico City, Mexico

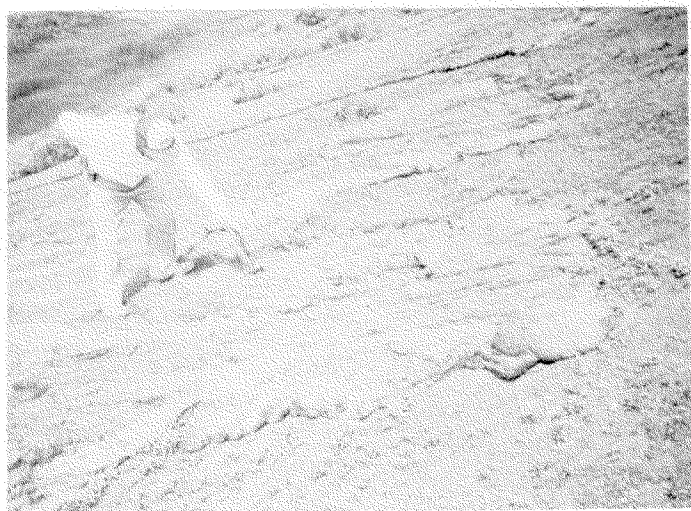
From 1983 to 1987, 40,000 m² of this material were placed at the Zumpango Lagoon, in the State of Mexico, as protection against erosion in part of the wet slope of a CH-clay levee 18-km long, 6-m high and with 2:1, 2.5:1 and 5:1 slopes. In the course of six years, half of the revetment suffered contraction and became ripped thus defaulting as protection material (Fig. 1). Damages of a lesser magnitude are evident in the rest of the revetment.

Fig. 1 Asphaltic revetment shrinkage at Zumpango Lagoon

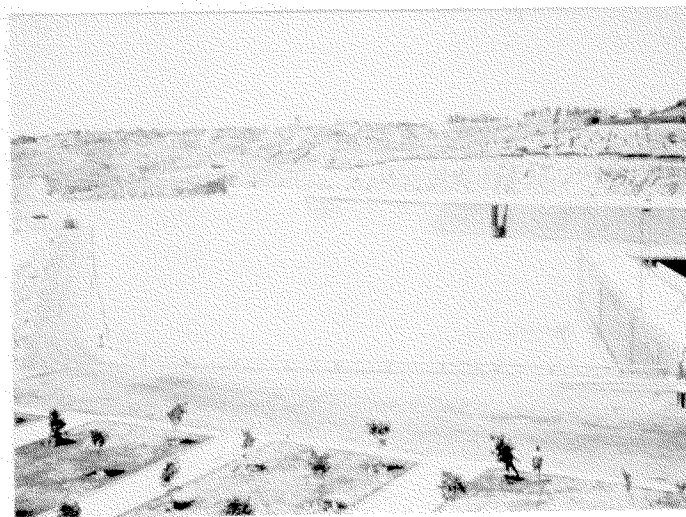
the CSPE membrane ($t_{GM} = 0.91$ mm). The membrane was anchored to the slope shoulder by means of a trench filled with concrete. The field seams were executed with an integral solvent plus hot air with an overlap of 10 cm. The overlapping between the geotextile sheets was equal to 30 cm. During the installation the membrane ripped off because of thermal effects and of the wind forces at two places. The settling tank has been operating since February 1992 and only a flow rate of 0.001 m³/s of leakage has been detected, without impairing the springs in the area, whereas the regulating reservoir has been functioning since June 1992 without appreciable leakage and only in one piezometer a raise of the water level of a few centimeters has been recorded (Fig. 2); therefore, the results obtained can be regarded as excellent.

Fig. 2 Regulating reservoir lined with CSPE geomembrane at Agua Prieta

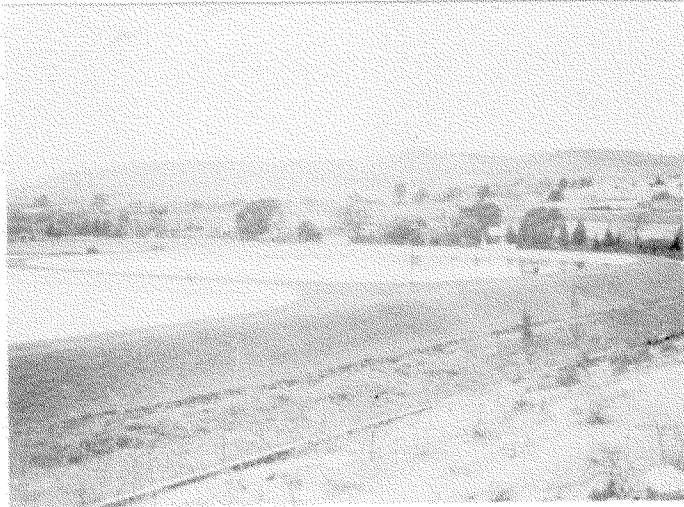
For protecting slopes against erosion, such product was used at the slopes of treatment lagoons for waste water in Santa Ana Pacueco (9000 m², $t_{GM} = 0.8$ mm, slope 2:1, 1991, Fig. 3), in Irapuato (39,000 m², $t_{GM} = 1.0$ mm, slope 1.5:1, 1992) and in Abasolo (17,500 m², $t_{GM} = 1.0$ mm, slope 1.5:1, 1992), all in the central part of the country. A PVC geomembrane was used in 1992 along a

Fig. 3 Treatment lagoons lined with PVC geomembrane at Santa Ana Pacueco
