A Geomembrane Liner Failure: Design, Installation, and Communication Lessons Learned

ABSTRACT: The world's largest single cell HDPE-lined pond, at the time of its installation in 1987, failed soon after being placed in service due to a series of installation, construction quality assurance, and material related problems. The field and laboratory analyses that identified these problems are described, together with remedial actions taken to effect repairs.

The Palo Verde Nuclear Generating Station is located in the desert 80 km west of Phoenix, Arizona. After several cycles of cooling and treatment the unusable cooling water is pumped to one of two large evaporation ponds. Problems associated with the commissioning of Evaporation Pond #2 are described.

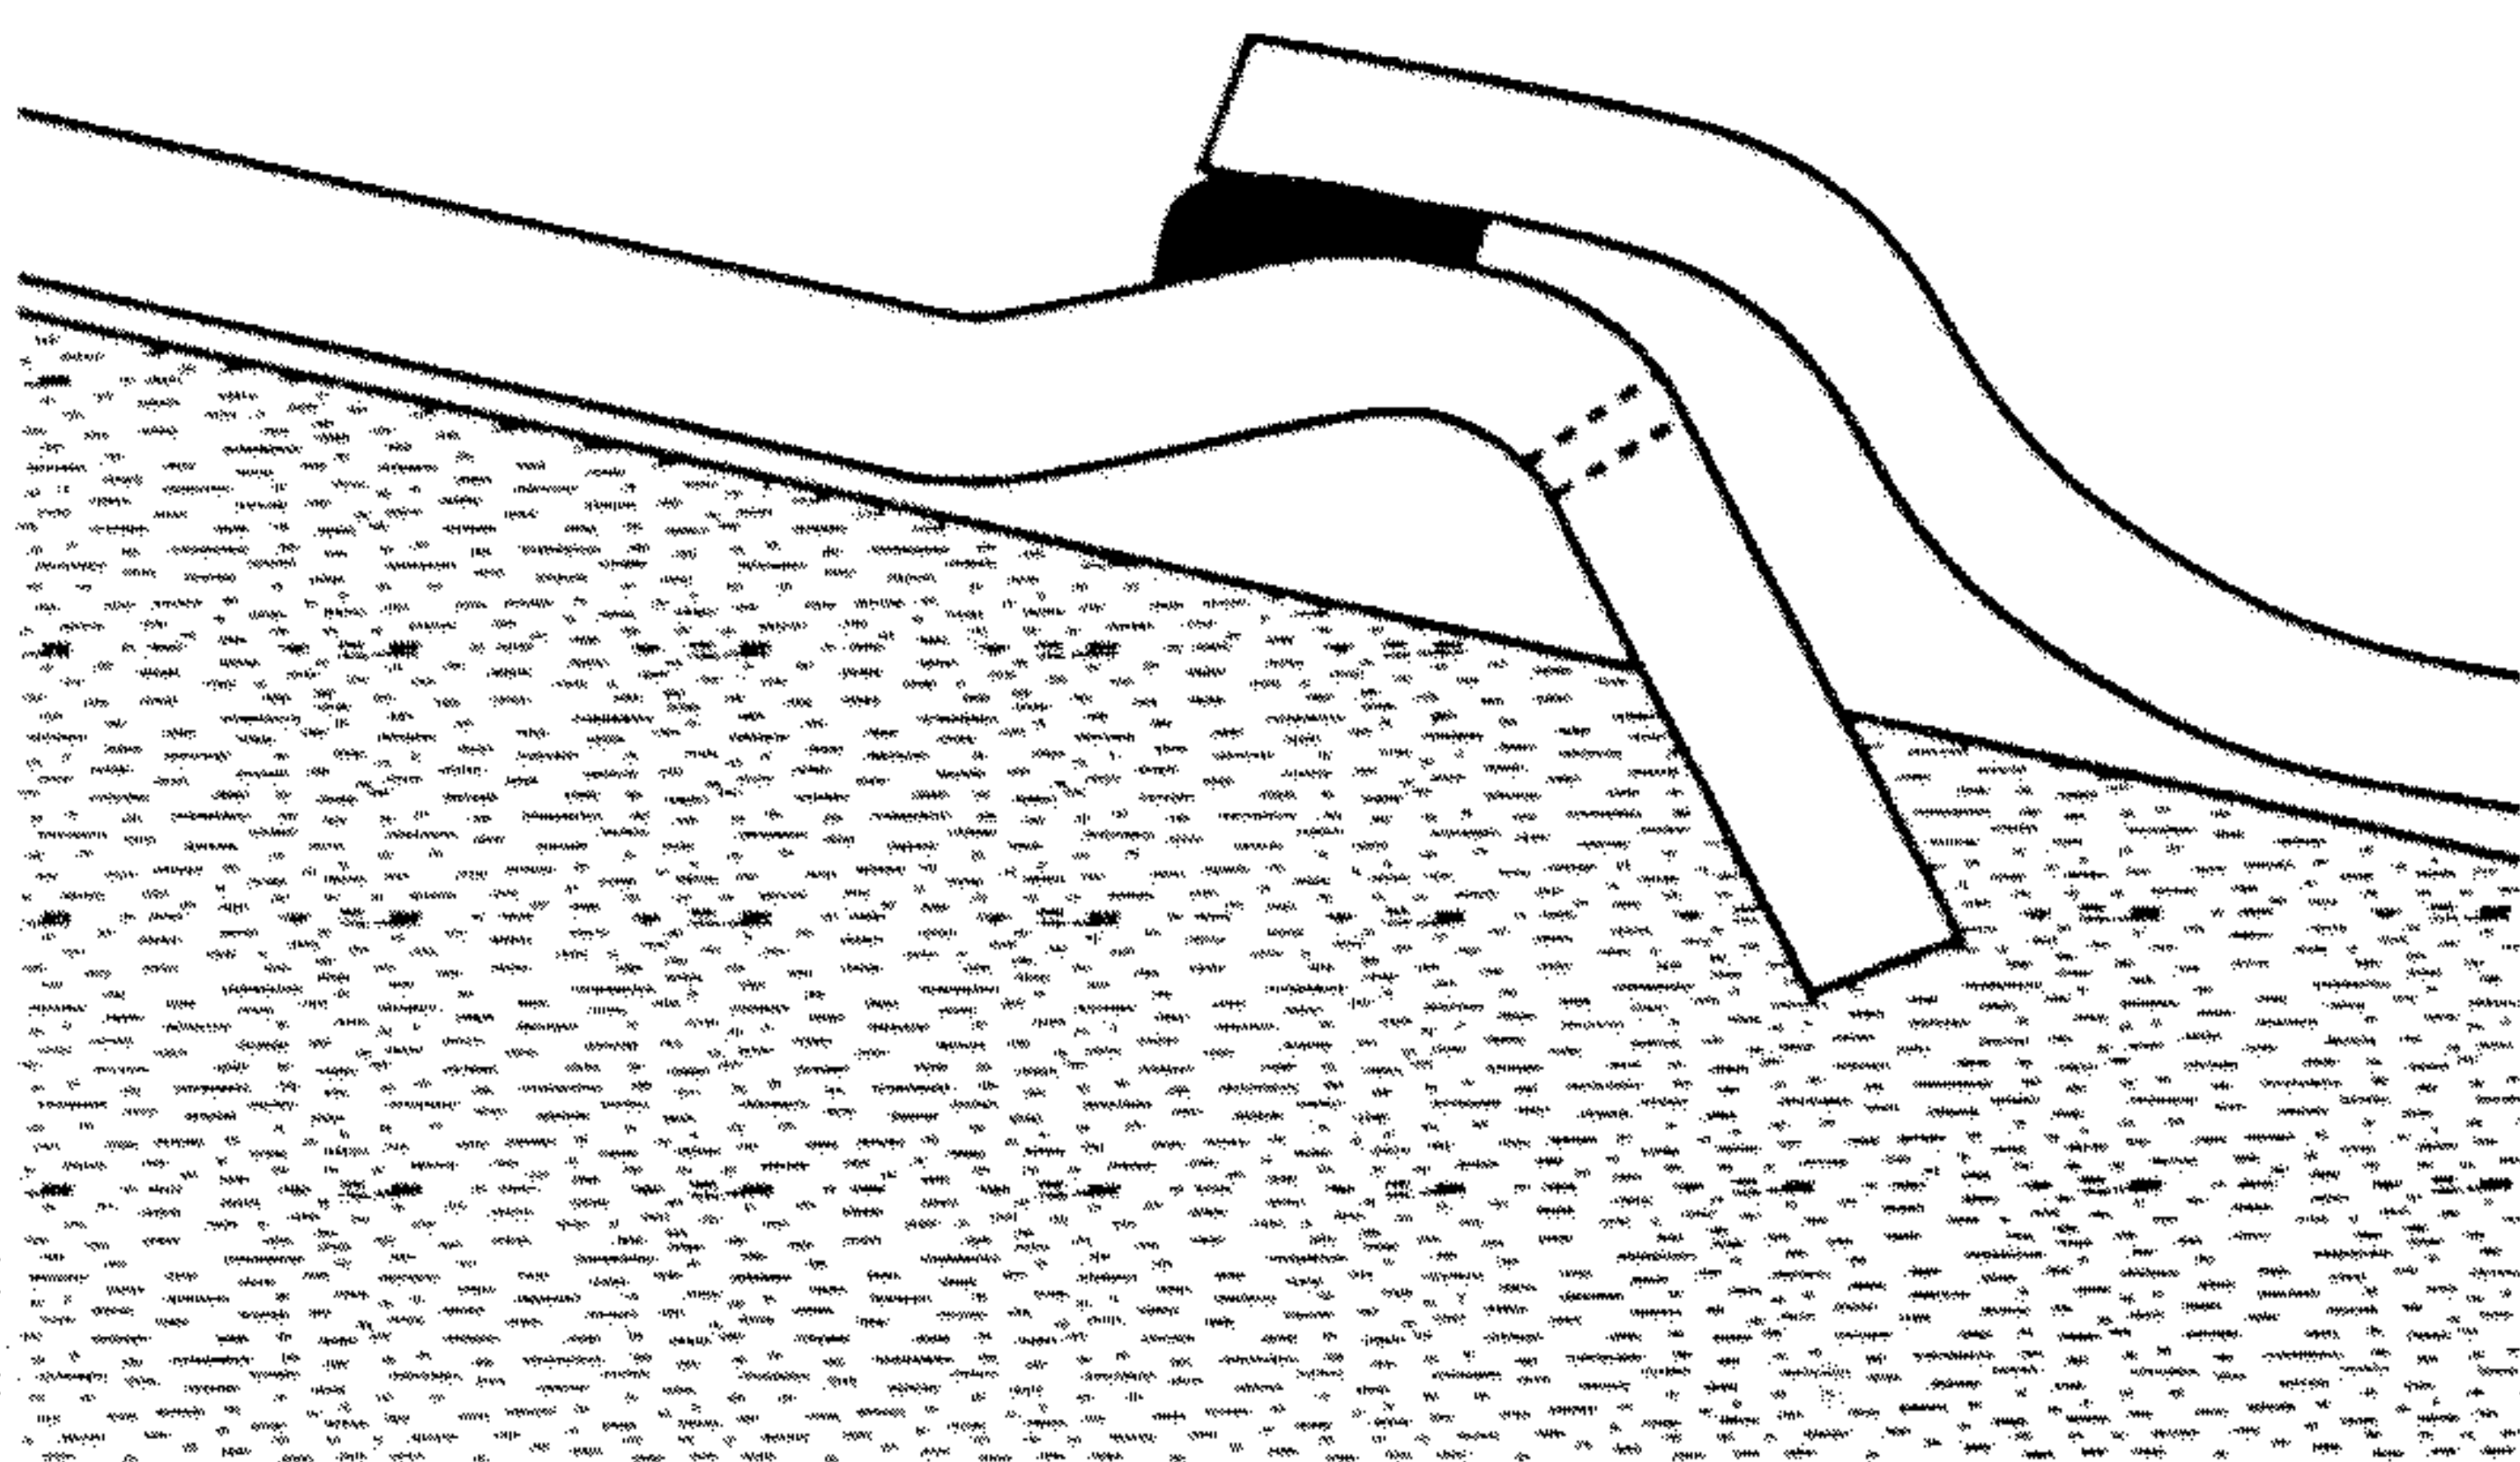
Fig. 1 Cross section of installed ballast seam

From the first buried flap at the toe of the shallow end slope the downhill edge of each large panel was

buried, and the downhill panel was seamed to the top of the uphill panel (see Figure 1). The liner was thus anchored in the ballast trench at the deep end. On cooling, the liner would contract towards the anchoring trench thus pulling the seam at the first uphill ballasted trench downhill, possibly by 1% of the distance between the two ballasted seams. The actual distance will depend upon the temperature drop, the CTE over that temperature range, and the geomembrane/soil interface shear resistance. Some of this displacement will be extended to all uphill ballasted seams. In simplistic terms, each uphill seam will also experience an additional 1% displacement due to the same thermal contraction of its adjacent downhill panel. The downhill displacement of each panel will, therefore, increase towards the shallow end, thereby increasing the peeling stress imposed on each ballasted seam and tending to pull each ballasted flap out of the trench, and finally causing trampolining at the toe of the shallow end slope, all of which were observed. Thus, the contraction problems were most evident at the shallow end and were aggravated by the underliner air pressure build-up during the filling of the pond. In hindsight, the ballasting should have been done with both edges of each panel being buried, or both edges being seamed to the top of each large adjacent panel. In this way contraction problems would not have been accumulative but would have been limited to each individual panel.

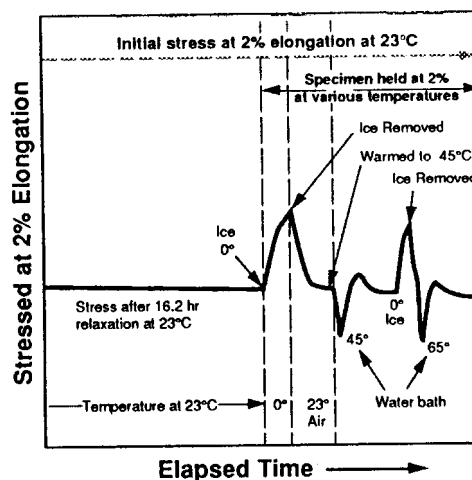
It is well known that organic polymers, including HDPE, have relatively high coefficients of linear thermal expansion (CTE) compared to conventional construction materials. Geomembranes wrinkle and contract as temperature increases and decreases respectively. The CTE of HDPE at 0°C, or between -30 and +30°C is approximately $1.2 \times 10^{-4}/^{\circ}\text{C}$ and differs with test direction and increases as the temperature increases (Peggs et al., 1990). Laboratory measurements showed that if a stress of 5 MPa (a strain of 2%) was applied to an HDPE specimen at room temperature, the stress would drop to 1.7 MPa with a temperature increase of 65°C. Conversely if an HDPE geomembrane was installed without wrinkles at an elevated temperature (80°C has been measured in summer sunshine) a significant restrained contraction stress could develop at winter temperatures of -10°C. Figure 4 shows the effects of time under stress at elevated temperatures (stress relaxation) and the effects of cyclic temperature changes such as would have occurred on the installed geomembrane: a temperature decrease of only 40°C almost doubled the stress in the geomembrane.

Fig. 4 Effect of temperature on stress in HDPE strip maintained at 2% elongation.
