# Geomembrane Liner to Control Water Loss and Create Conservational Lake - A Case Study

D. S. Saxena

Alamo/Saxena Consultants, Inc., Lakeland, FL, USA

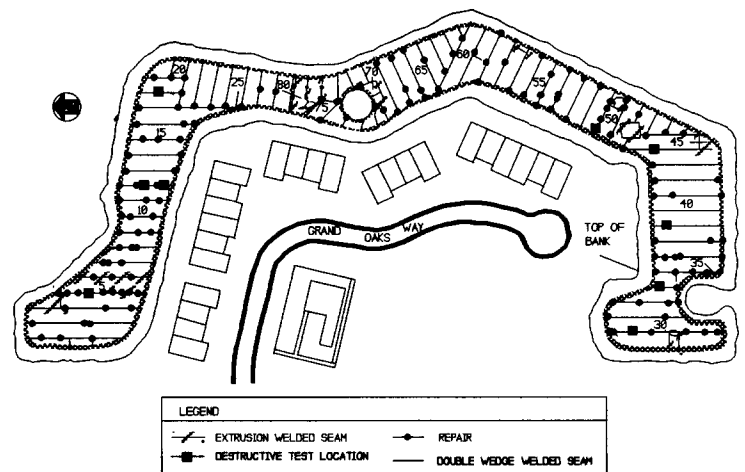
Fig. 3 As-built drawing showing test locations

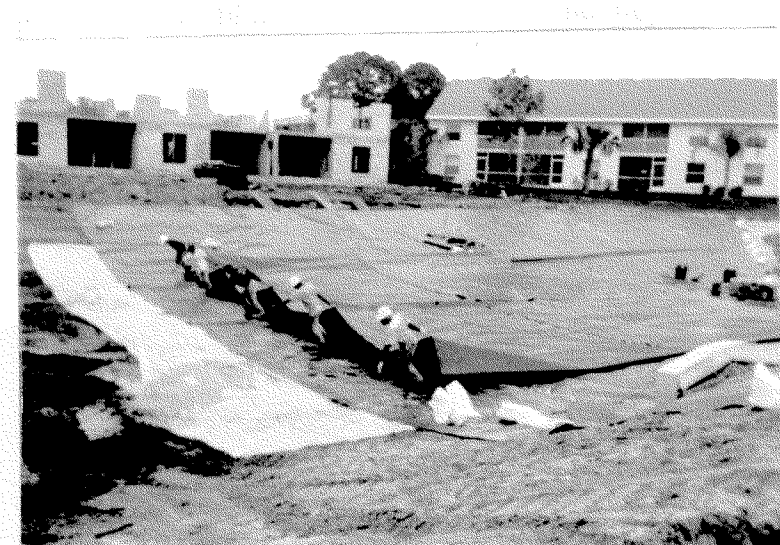
Fig. 4 Installation of geomembrane in lake bottom

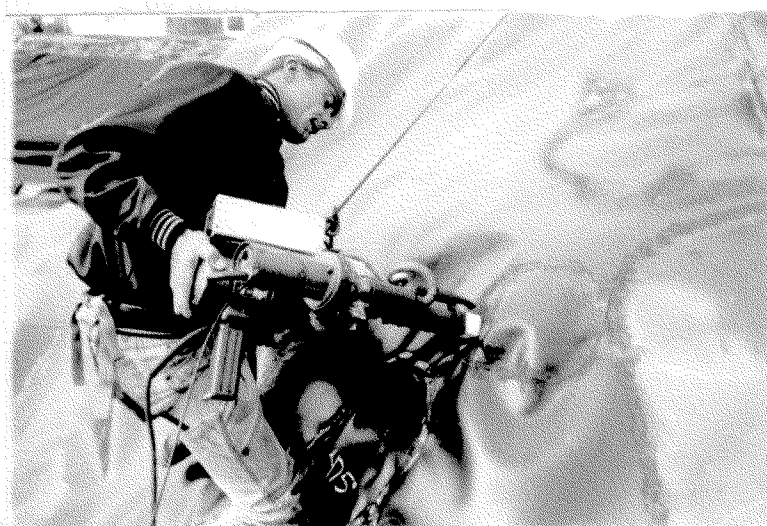
Fig. 5 Extrusion welding of seam with 10 cm overlap

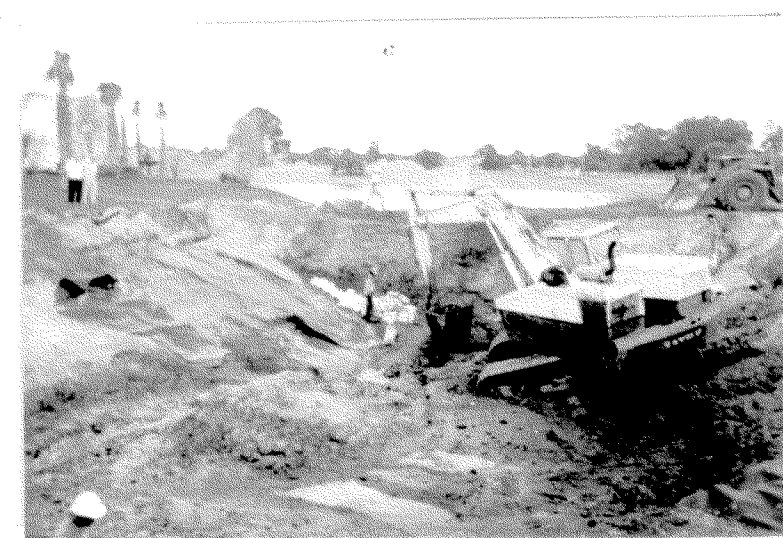
Fig. 6 Damming lake into halves and bottom grading (note rear portion of lake full with water)

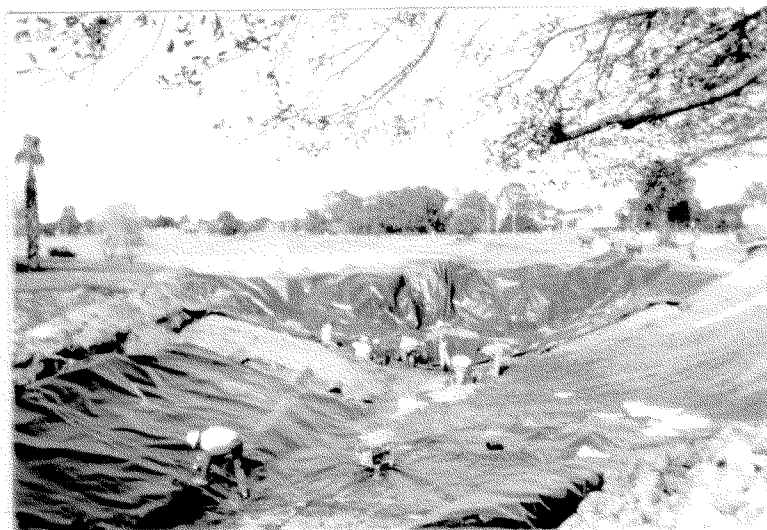
Fig. 7 Installation of geomembrane after damming of lake

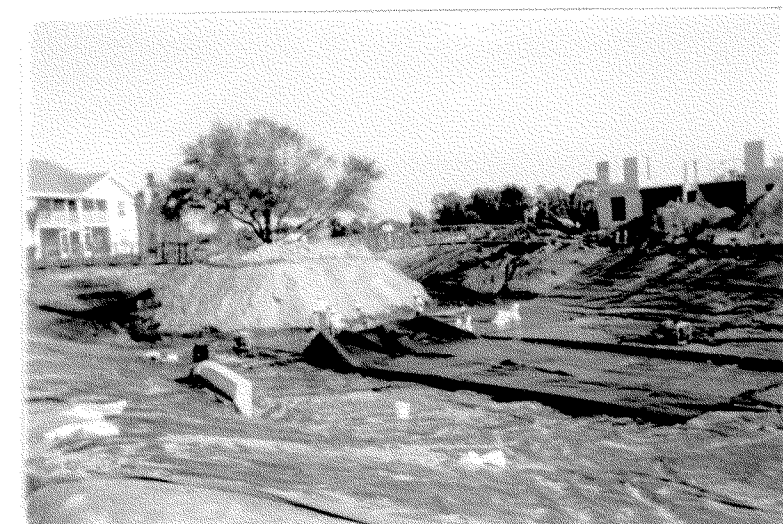
Fig. 8 Preparation of island slope with geotextile

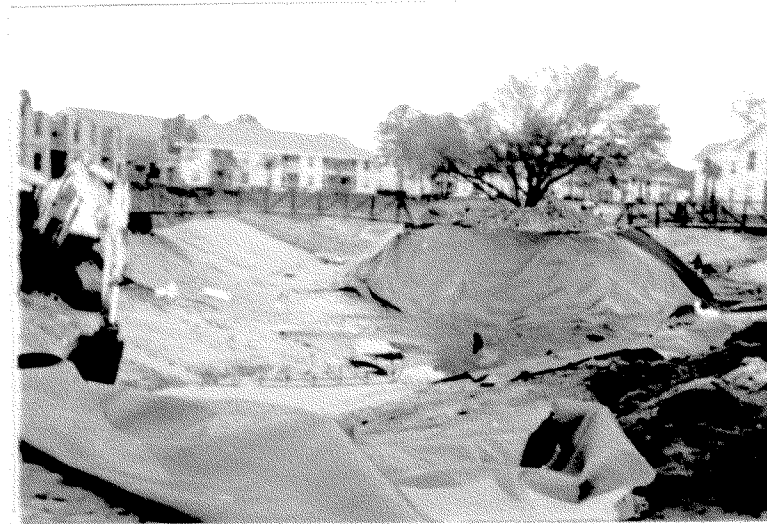
Fig. 9 Installation of geomembrane on island slope

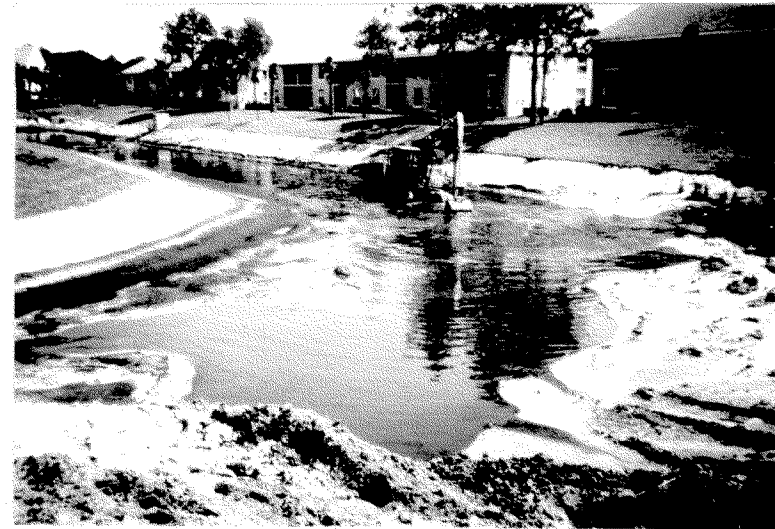
Fig. 10 Water loss and partially dried lake without liner BEFORE, June 1991

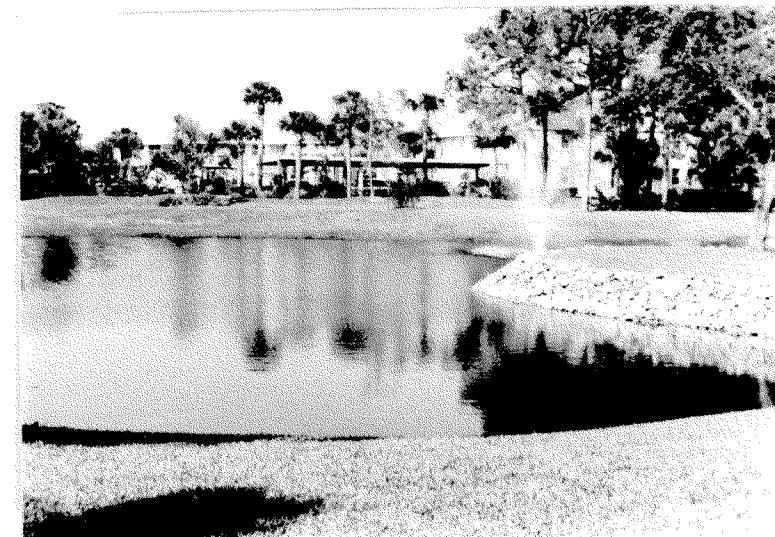
Fig. 11 Water retained in lake with liner AFTER, March 1994
