# Durability of a 13-Year Old Test Embankment Reinforced with Polyester Woven Fabric

G. H. Troost, G. den Hoedt, P. Risseuw & W. Voskamp  
Akzo Nobel Geosynthetics bv, Arnhem, The Netherlands

**ABSTRACT:** In the summer of 1980, a geotextile-reinforced steep earth dam was built, using a polyester woven fabric. The purpose was to investigate construction techniques and greening and protection systems. The dam, with an overall length of 50 m, was built with 2:1 and 4:1 slopes, using partly sand and clay as fill.

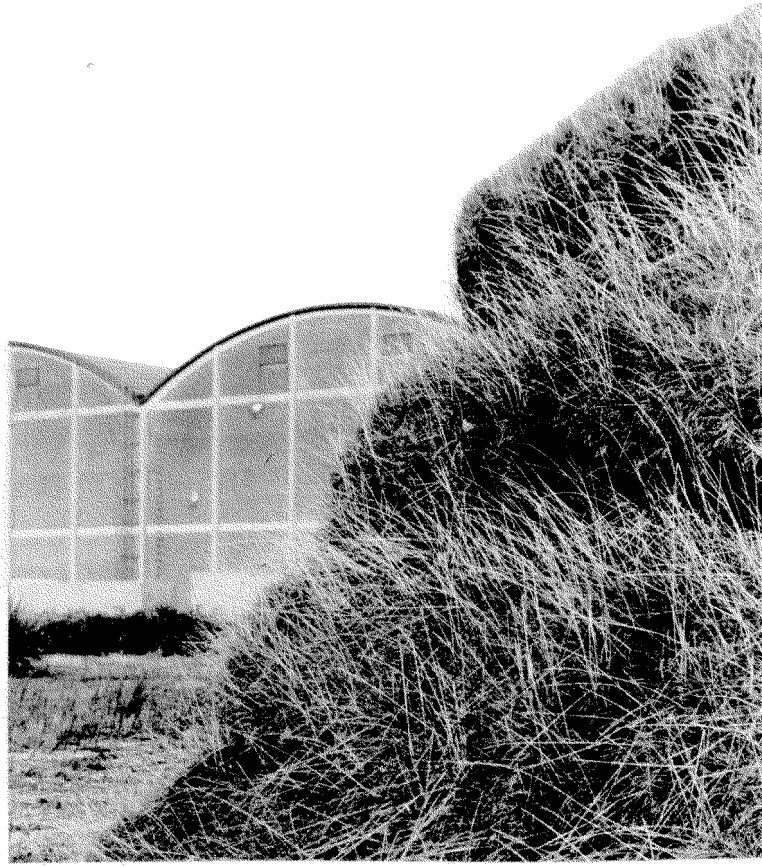
Fig.3 Hydroseeded section after one year

The stability of the dam was perfect over its entire life. There was no evidence of movements or deformations of any significance. The hydroseeded sections of the dam looked quite green one year after seeding, as shown in Figure 3.

But after 13 years, only reasonably green spots remained on the north side and a few green spots on the south side of the dam. The flat Enkamat section was fully green even after 13 years. On the sloping portions of the fabric envelope the erosion control mat was a failure, however, in that the mat lost contact with the fabric, causing the vegetation to die from lack of moisture. On the south side of the wall only the bitumen cover remained to protect the fabric against UV - radiation. The sections where ivy (Hedera) had been planted showed a fine continuous plant cover after 13 years.

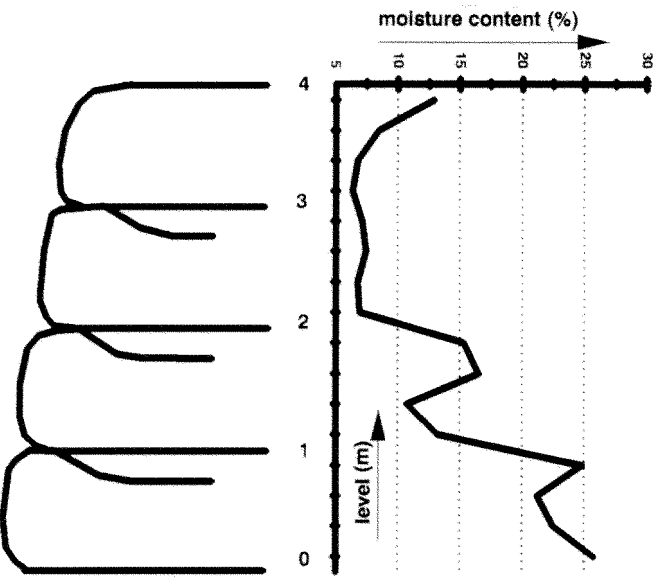
Fig.4 Moisture content through the clay layers

- = The bearing capacity of the reinforced clay layers was too high to be amenable to measurement by the Barentsen cone penetration test.
- = Moisture content measurements detected considerable variation through the layers as shown in Figure 4.

= Cohesion values vary with moisture content from 7 kN/m<sup>2</sup> to 27 kN/m<sup>2</sup>.

Laboratory measurements showed that the angle of friction and the cohesion of the clay decrease rapidly when moisture content exceeds 25 % .

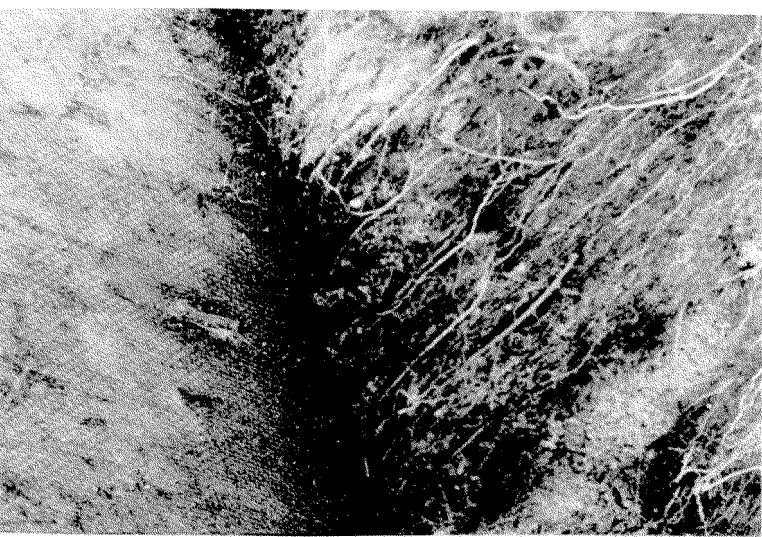
Fig. 5 Root pattern along the fabric surface

In preparation recovery of the fabric, the vegetation had to be removed. It was found that the roots generally did not penetrate the envelope; instead, they followed the fabric as shown in Figure 5.

The inference is that sufficient water was available for the roots at the fabric surface.

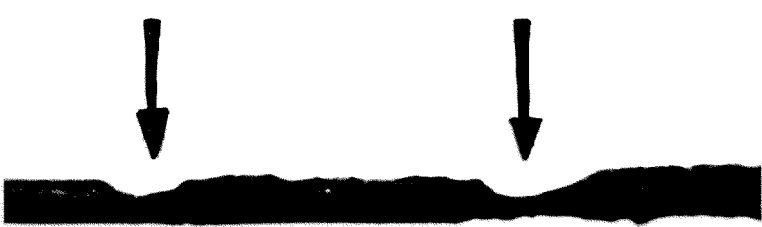
In the construction of the dam, rebar steel pins had been used to temporarily fix fabric overlaps until such time as the earth layers would be self-supporting. In the sand-filled sections of the dam, these pins exhibited extreme corrosion precisely where they pierced the fabric. Figure 6 shows a pin removed from a sand-filled section in which it pierced the fabric in two spots.

Fig. 6 Corroded steel pin. Note extreme corrosion where the pin passed through fabric

The heavily rusted pins, the root pattern of the vegetation and the moisture distribution in clay as shown in Figure 1 all point to the fabric's serving as a sort of wick which conducts the flow of water, also into the inner part of the dam.

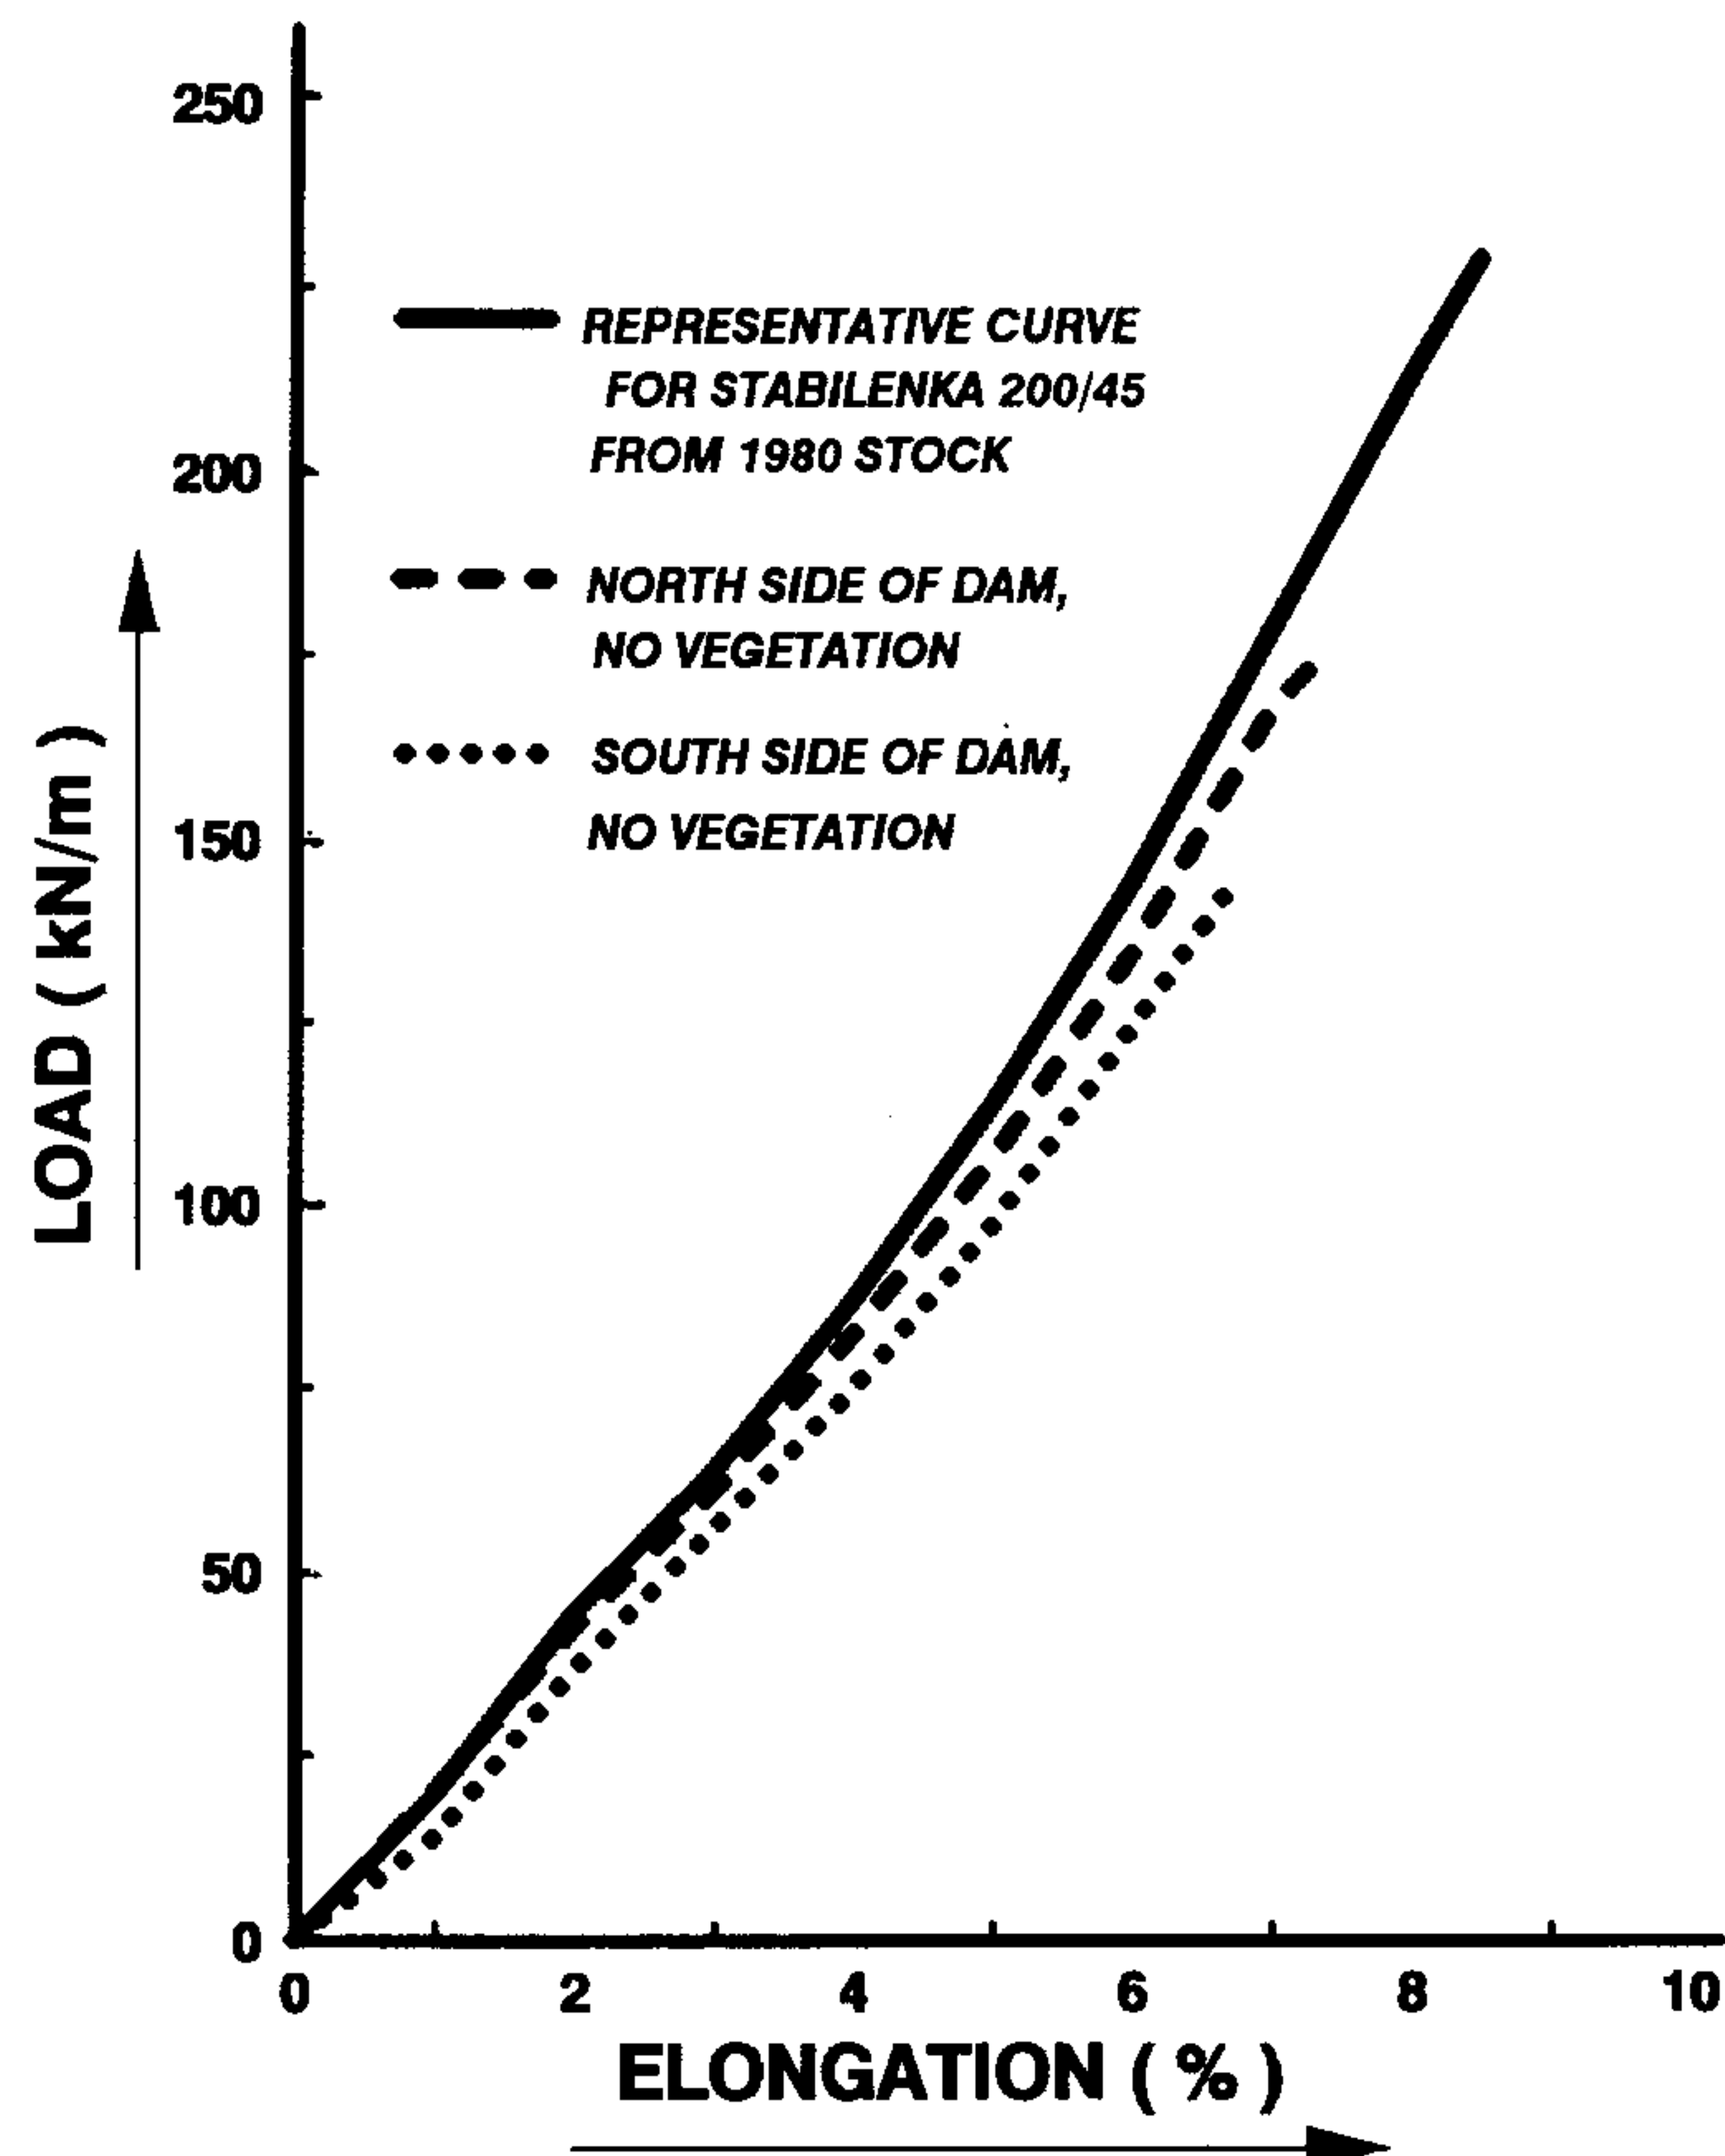
The fabric on the outside of the dam covered by the hydroseeding layer only but no vegetation shows the load - elongation curves presented in Figure 7.

The samples taken from the ivy-grown sections show 12 % strength loss and no loss in modulus ( FASE 6 ). Most of this strength loss is probably due to mechanical damage caused by scraping and scuffing when the wooden forms used in

Fig. 7 Load - elongation curves of the reinforcing fabric taken from the outside of the dam without vegetation, compared with the original curve

construction were removed (Troost et al., 1990). A fraction of the loss may be due to UV-radiation, however.

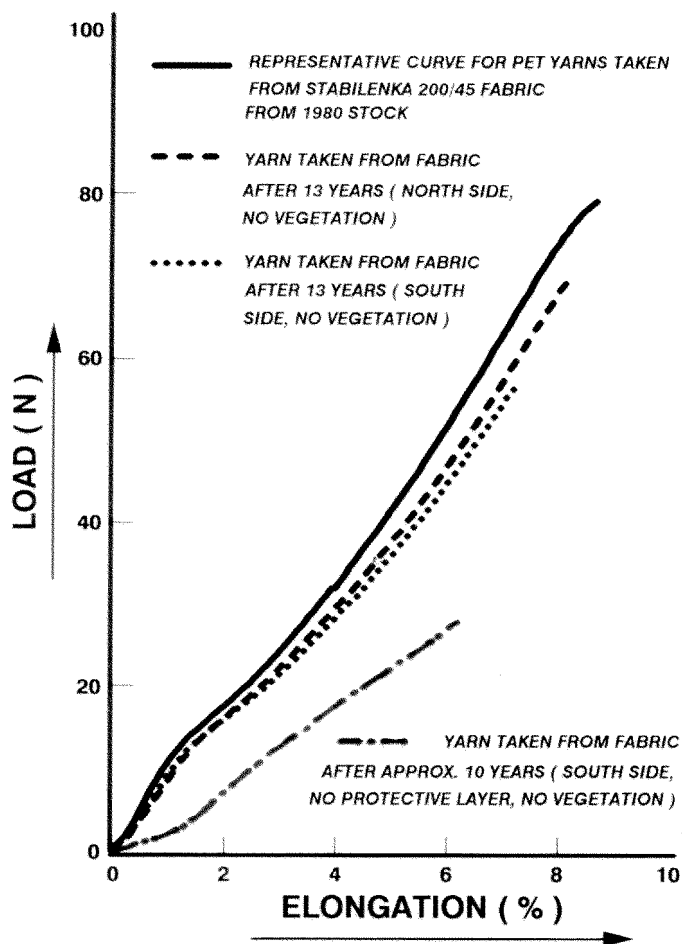
The residual strength and modulus pattern of yarns removed from the samples is similar to that for the fabric (see Figure 8).

Fig. 8 Load - elongation curves of yarns taken from fabric samples from the outside of the dam without vegetation, compared with the original curve

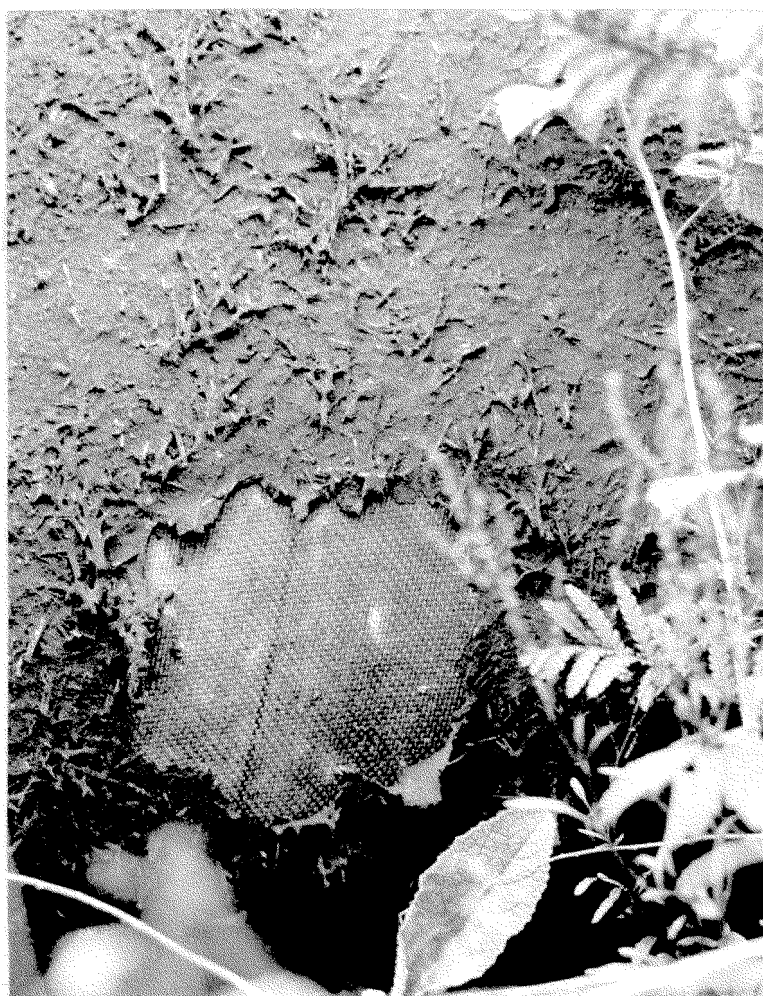
Fig. 9 Unprotected spot on the south side

Some spots on the south side of the dam covered with bitumen only lost their protective layer in the first two or three years. Samples from these spots were taken to establish the effects of exposure to UV-radiation.

Yarns taken from a bald spot on the south side (see Figure 9) were wide open to UV-radiation and lost 60 % of the breaking strength and 55 % in modulus.

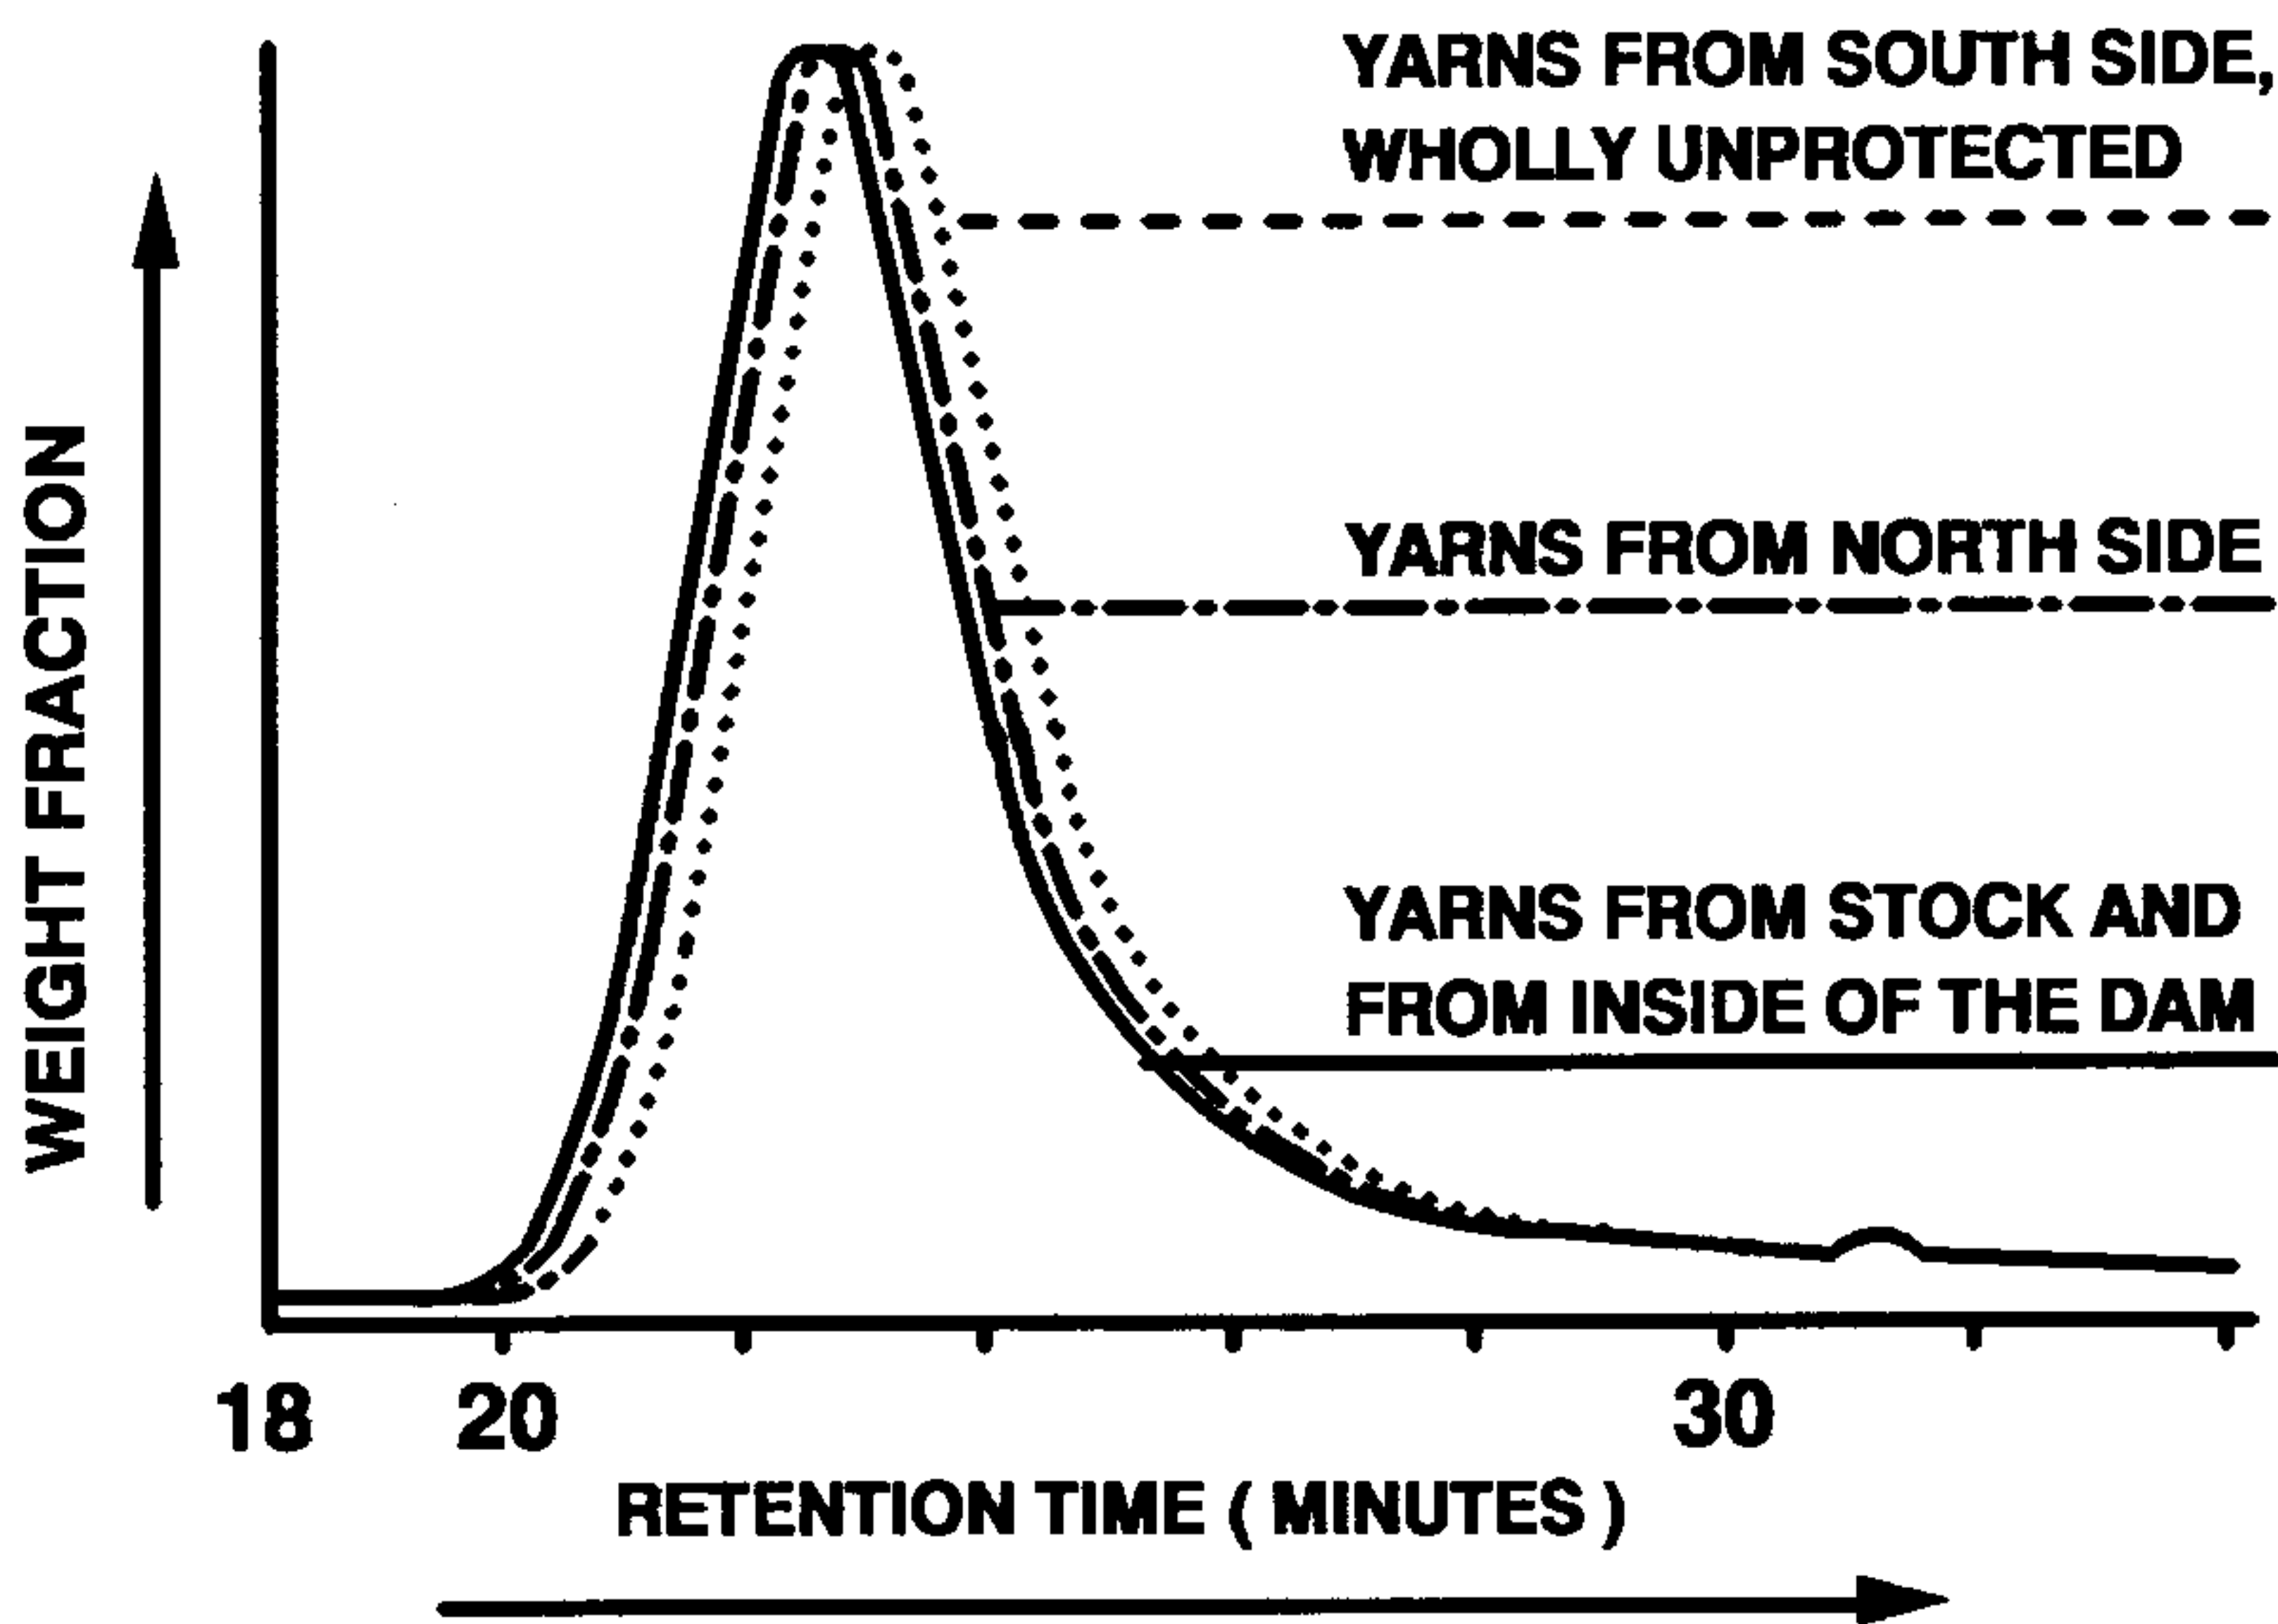
Fig. 10 Size exclusion chromatography curves

Figure 10 illustrates the relative change in molecular weight distribution curves, compared with that of yarns from stock.

- = For yarns taken from the inside of the dam ( 13 years at +10°C and 100% R.H. )
  - Zero hydrolytic degradation
- = For yarns taken from the north side covered by hydroseeding layer only (13 years at -10°C to + 20°C and 100% R.H. )
  - Approximately 5% strength loss, based on Mn and Mw values, due to degradation factors such as UV-radiation in the first 6 weeks of construction, before application of the hydroseeding layer.
- = For yarns taken from the south side, wholly unprotected to out door weathering (approximately 10 years at -10°C up to +40°C )
  - Significant strength loss as a result of degradation caused by such factors as UV-radiation.
