Infrared Thermographic Nondestructive Testing of HDPE Geomembranes Seams

ABSTRACT: A preliminary evaluation of infrared thermography (IRT) as a method for nondestructively testing geomembrane seams is described. IRT will identify nonpenetrating defects within seams and shows potential for broadly assessing seam bond strength, thus potentially obviating the need to destructively test good seams.

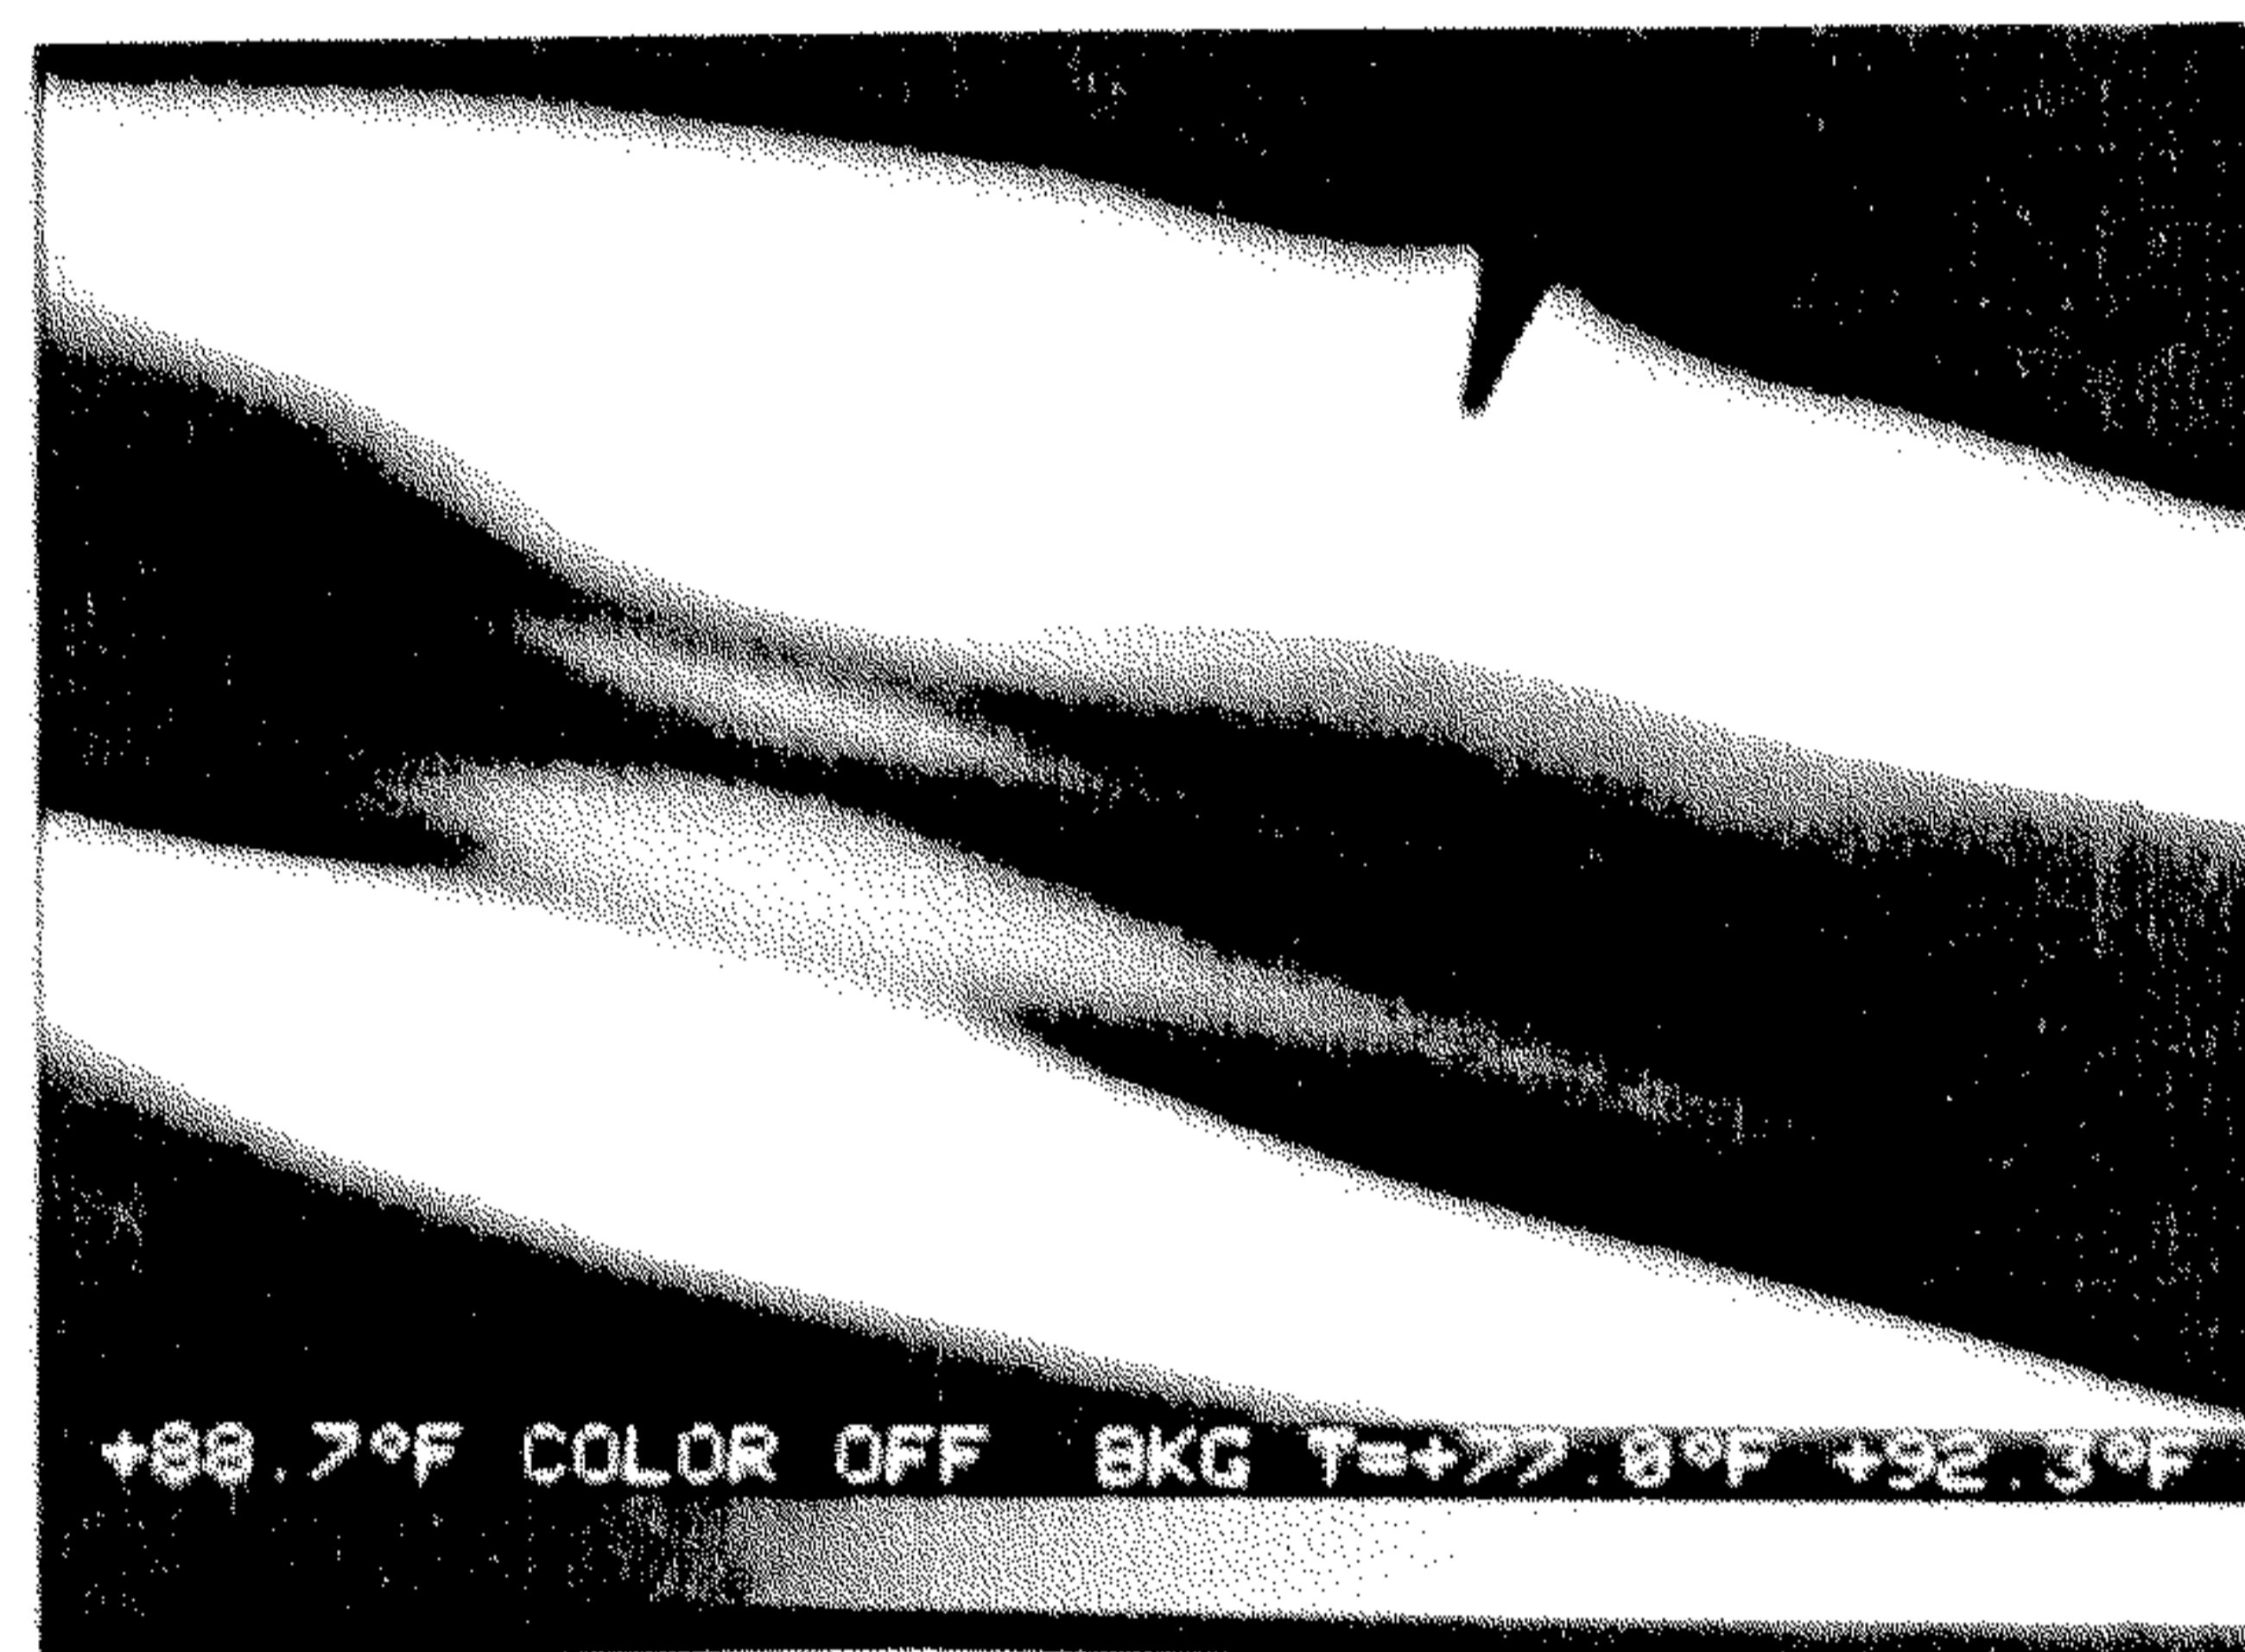
Fig. 3 White glare at soil within seam.

Subsequent laboratory work on additional seam samples containing various artificially induced defects showed that IRT can clearly detect moist soil within the seam (Figure 3), and a thin (< 1.0 mm diameter) piece of wire within a seam (Figure 4). The wire was placed across the seam with the intent of removing it to leave a hole, but the wire could not be removed. The wire was clearly bent within the seam. At the location shown in Figure 5 the outer track is lighter than the inner track. Specimens cut across the seam showed more peeling at the inner track. As the shading changed along the length of the seam so did the amount of peel separation. Work is continuing, using an IR camera with a temperature resolution of 0.002°C, to relate IRT signal to actual bond strength (strength

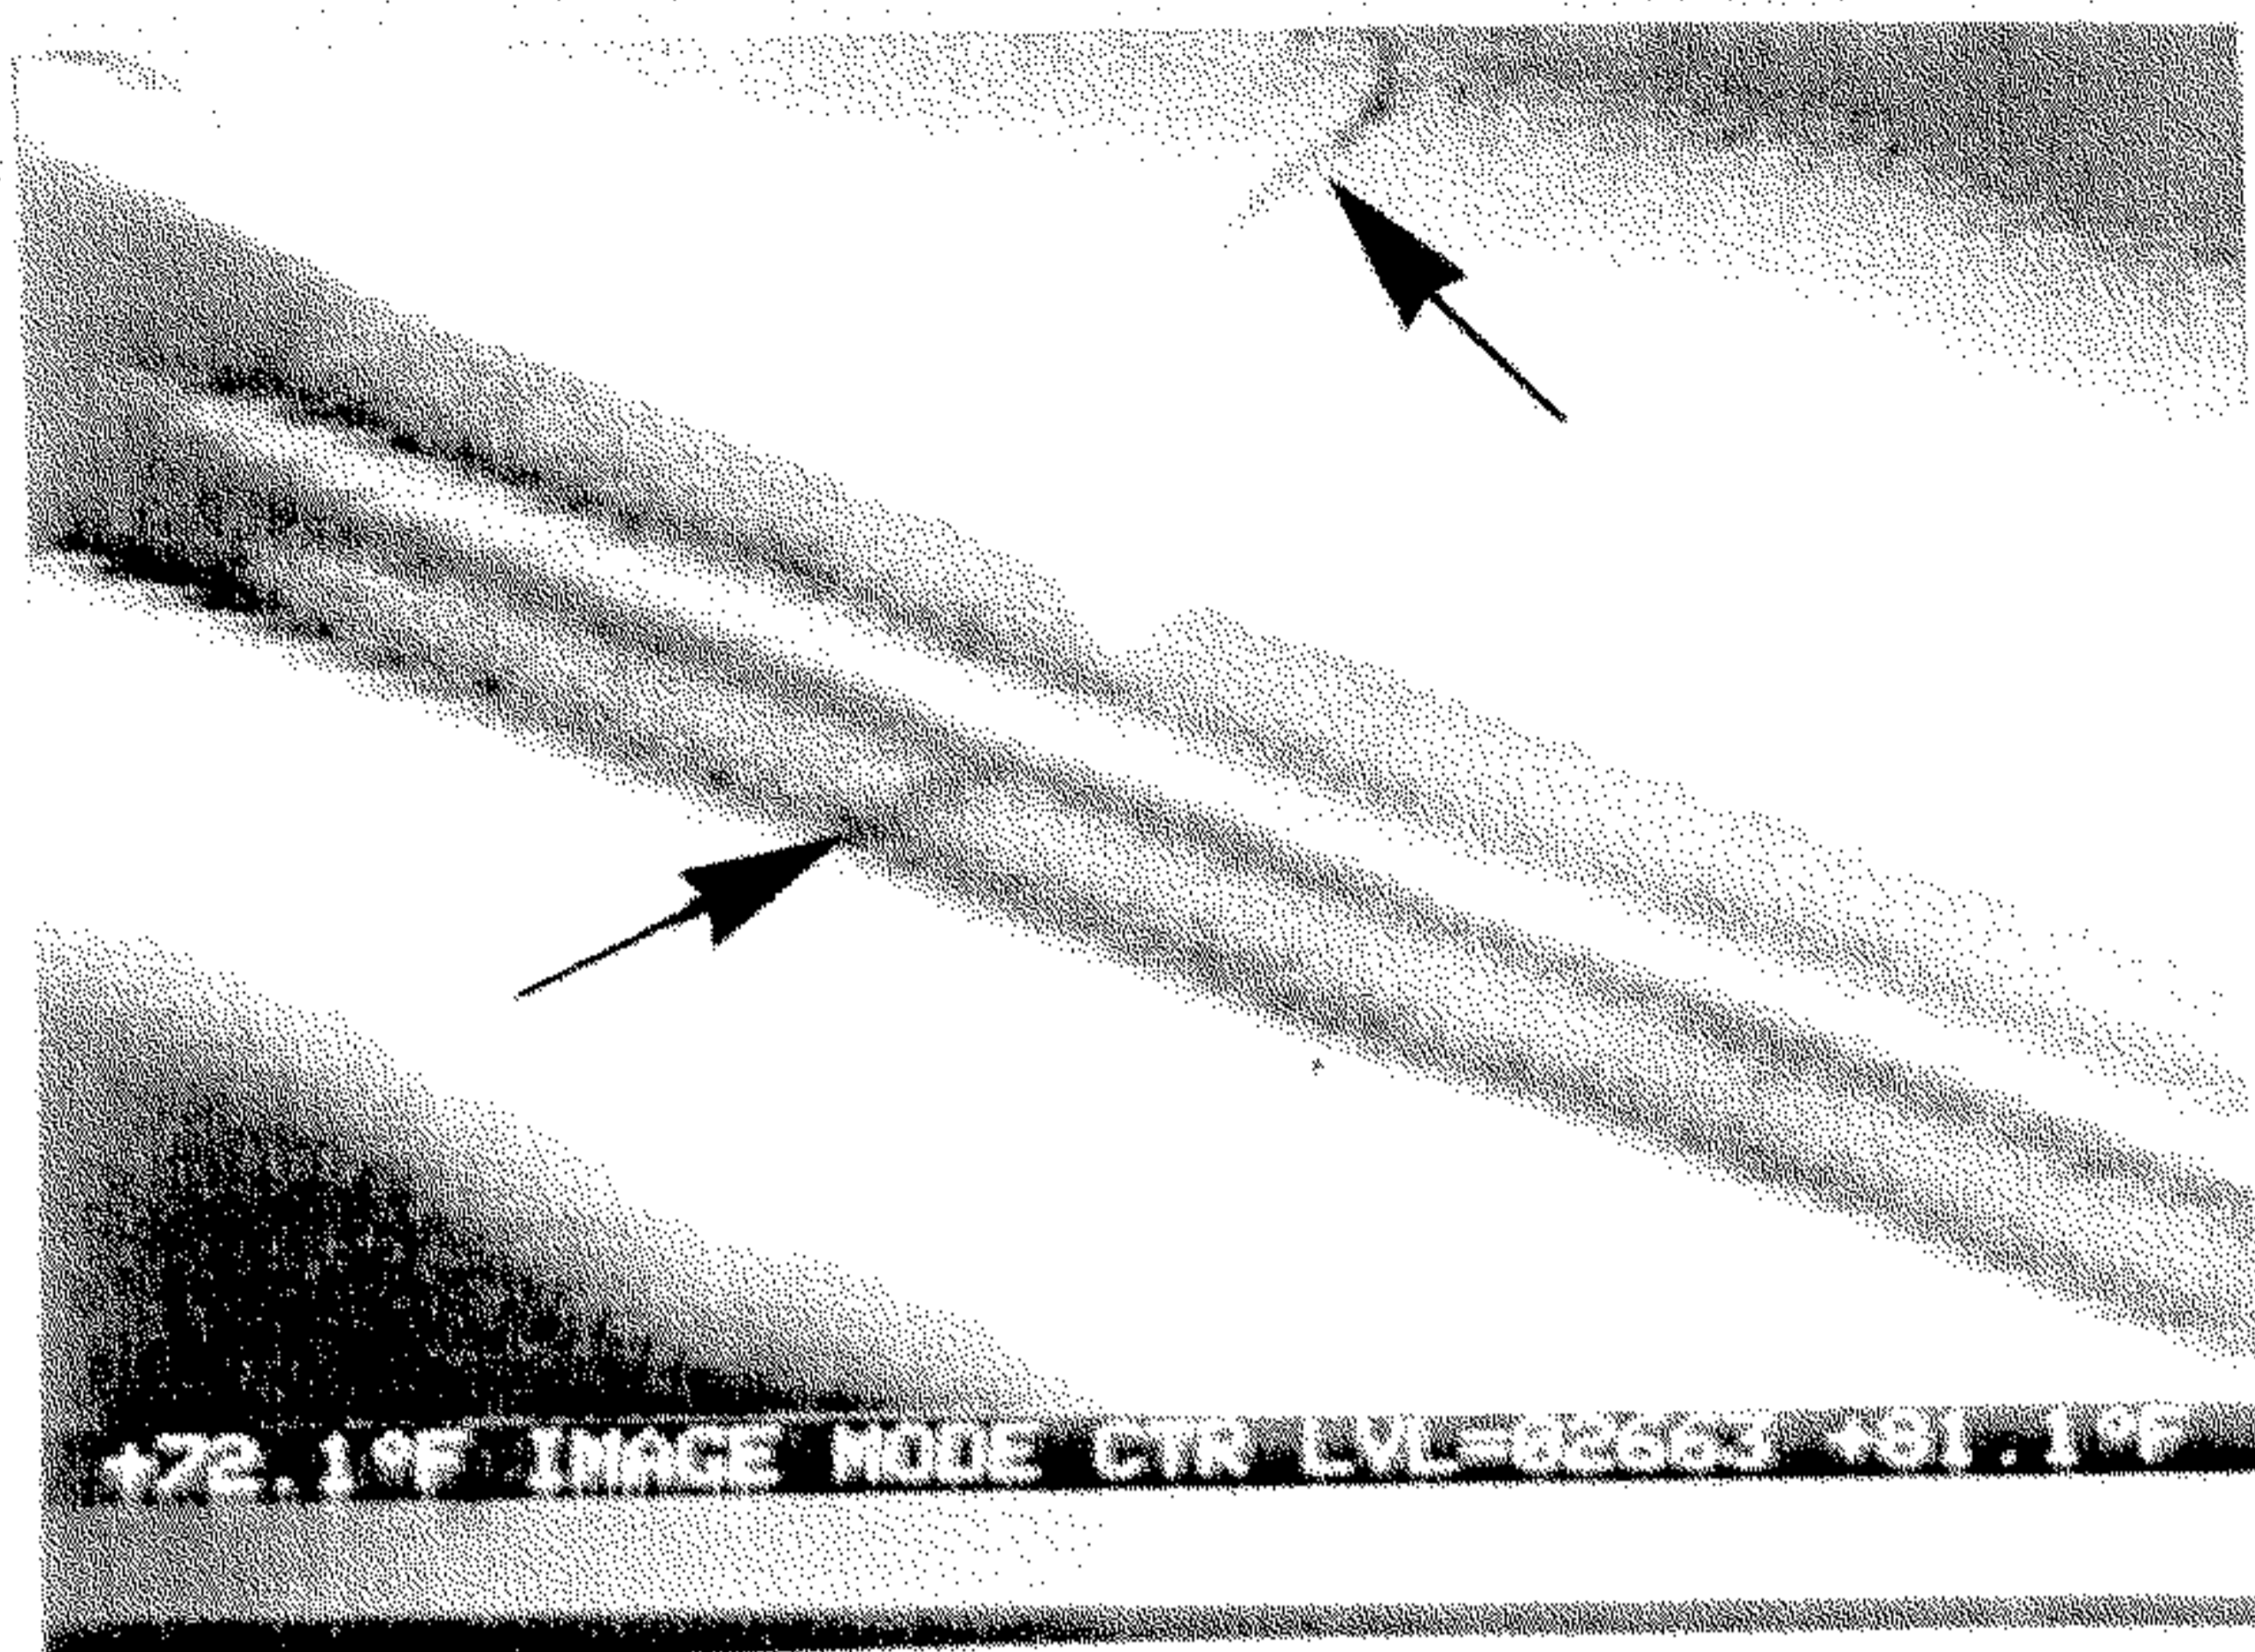
Fig. 4 Wire (arrowed) within seam.
