## APPLICATION AND MONITORING OF A COMPLEX SOIL REINFORCED STRUCTURE NEXT TO FAULT ZONE

### ABSTRACT

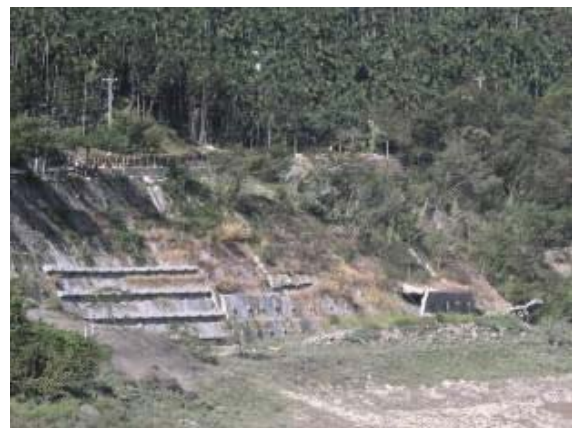
On June 8, 2007, a great landslide up to 80 meters wide and 30 m high was caused by a torrential rainstorm. The existing anchored slope was severely damaged with main structure being pulled out and exposed after the landslide, forming a huge heave on the toe of the slope. Image of collapsed slope and tumbledown betel nut trees are shown in Figs. 1 and 2.

Fig. 1 Severely damage of original slope

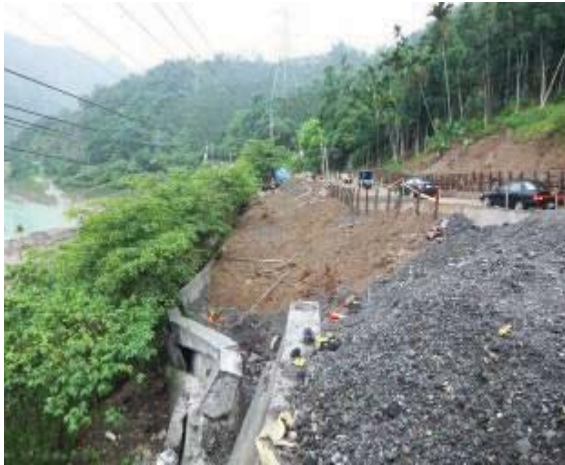
Fig. 2 Temporary solution for upper slope

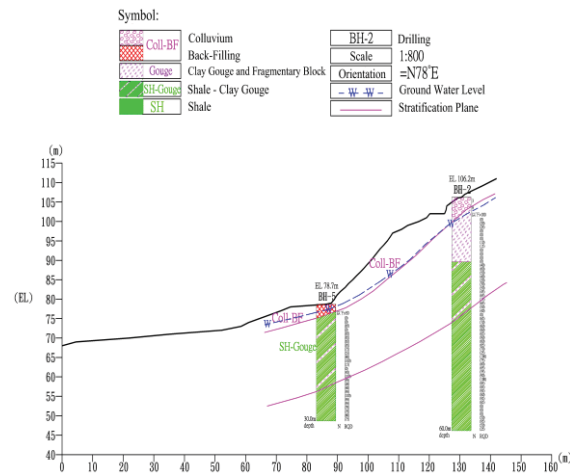
The regional geologic map shows that there are several fault zones cuts through the job site area, rock mass is fragile and weak. It was assumed that the layer at landslide area was affected by fault, see Figs. 3 and 4. According to the on site boring hole results: 0m to 5m is colluvial soil, 5m to 35m is crushed stiff shale rocks and more complete stiffer shale rocks distributes at 35m to 60m. Groundwater level is between the colluvium layer and crushed stiff shale rock layer. Moreover, fault gouge is also mixed in the crushed shale layer, as Fig. 5. Table 1 shows the soil properties of each layer.

Fig. 5 Layers and groundwater level distribution

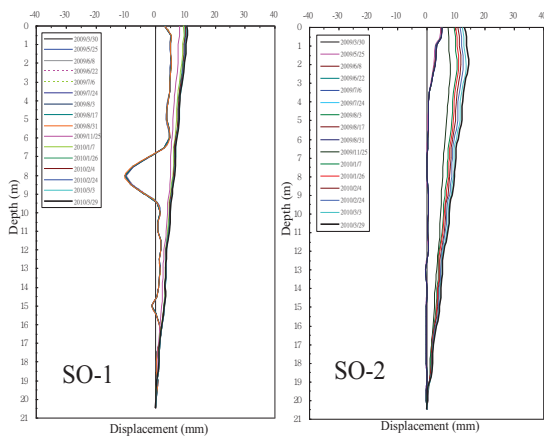
Four 20 m long inclined tubes were installed behind concrete retaining wall and reinforced zone of the structure respectively (SO1~SO8). The maximum displacement occurred at 2 meters under orifice approximately within the 4 tubes in upper slope. It was assumed that backfill material of the structure was the factor which caused the displacement at first stage. Displacement became smaller and smaller when the depth reaches 18 meters. Maximum accumulated displacement was 14 mm after one year; displacement rate changed from 0.0004~0.01 mm per month in first half of the year to 0.002~0.003 mm per month after one year, see Figs. 12 and 13.

Fig. 12 Monitoring of inclined tube in upper slope

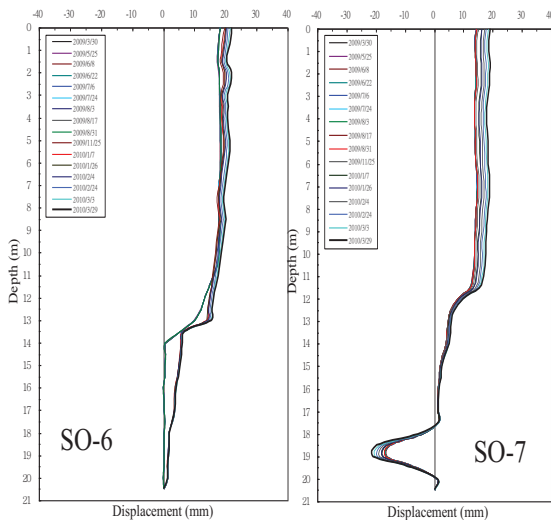
In reinforced zone, the maximum displacements were on the orifice and that of 9 meters under orifice. Both SO-6 and SO-7 had the inflection point at depth of 13 meters where the concrete retaining wall located and constrained the displacement. Obviously, displacement became smaller when it got deeper and deeper. Figure 14, shows the comparison between displacement and layer distribution. Maximum accumulated displacement was 32 mm, displacement rate reduced from 0.01~0.03 mm per month to 0.002~0.007 mm per month after one year.

Fig. 13 Monitoring of inclined tube in reinforced zone

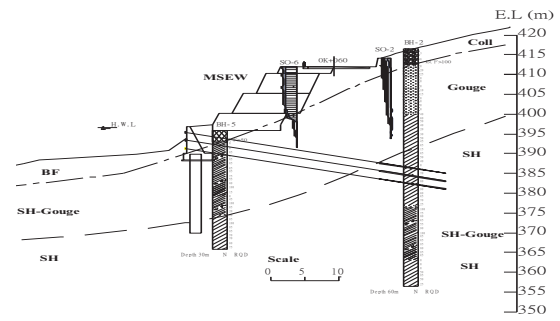
Fig. 14 Comparison between displacement and layer distribution (B-B')

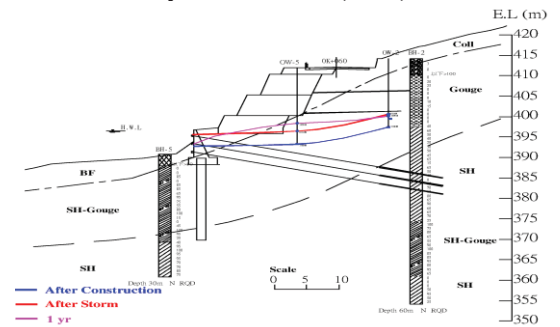
The groundwater observation data indicated that it was dry season when the construction was just finished, the lowest water level was 10~15 meters, lower than fragmental shale layer. Water level rose 2.5 meters after the attack of Typhoon Morakot, which caused most serious flood to Taiwan since 1949. After one-year observation, the water level of upper slope kept at same level while that of reinforced zone rose 2.5 meters. Figure 15 shows data of three phases, after construction, after attack of Typhoon Morakot and after one year; water level was mostly reached the lowest stage of the reinforced structure.

Fig. 15 Comparison between variation of underground water level and layer distribution (B-B')

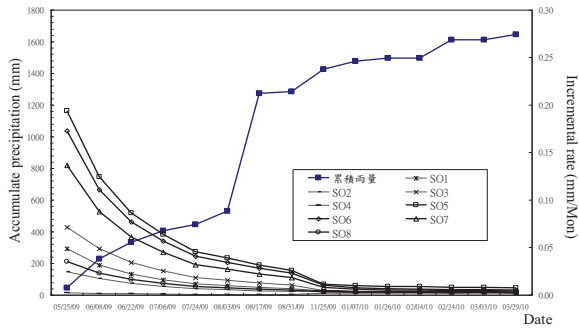
These figures present that displacement rate was high when the construction was just finished, especially in the reinforced zone. However, the displacement rate in reinforced zone reduced after the particles of backfill rearranged and consolidated. The groundwater level of upper slope rose 2 meters due to the heavy rainfall brought by Typhoon Morakot, and that of reinforced zone rose 4 meters even. But, the water level of both zones was quite similar when the monitoring was close to end. Moreover, the displacement rate didn't increase with the rise of underground water level and got stable instead. Summarily, with proper design and construction of drainage system, complex reinforced method is applicable in high filled structure located in fragmental geology area.

Fig. 16 Comparison between accumulated precipitation and displacement rate

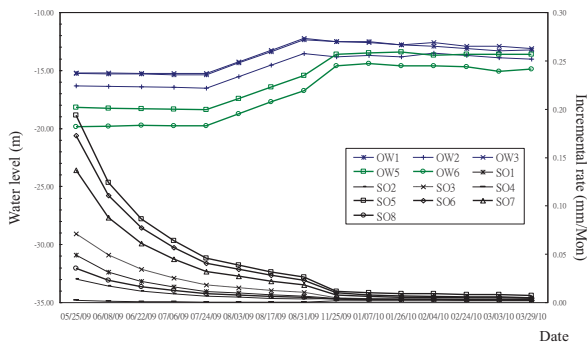
Fig. 17 Comparison between variation of underground water level and displacement rate
