## A FAILURE CASE STUDY ON REINFORCED SOIL SLOPE OF A 220KV SWITCHING STATION

G. Xu<sup>1</sup>, Y.M. Shang<sup>2</sup>, T. Mei<sup>2</sup>, R.S. Tang<sup>2</sup>, and K. Gao<sup>1</sup>

### ABSTRACT

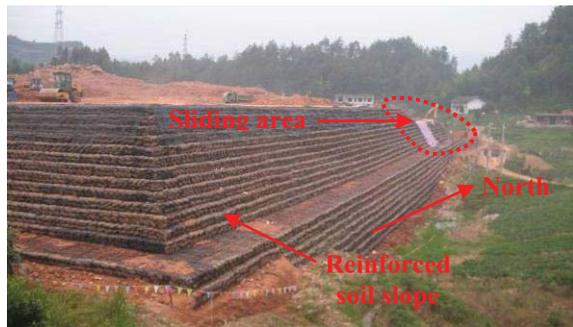
The reinforced soil slope was designed with dimensions of approximately  $230\text{m} \times 280\text{m}$ ; the shape of it was nearly rectangle. Its height varied between 4-16m, which largely depended on the condition of original ground surface. During the construction, a series of sliding evidences were found at the northeast side of the slope.

Fig. 2 Panoramic view of the reinforced soil slope.

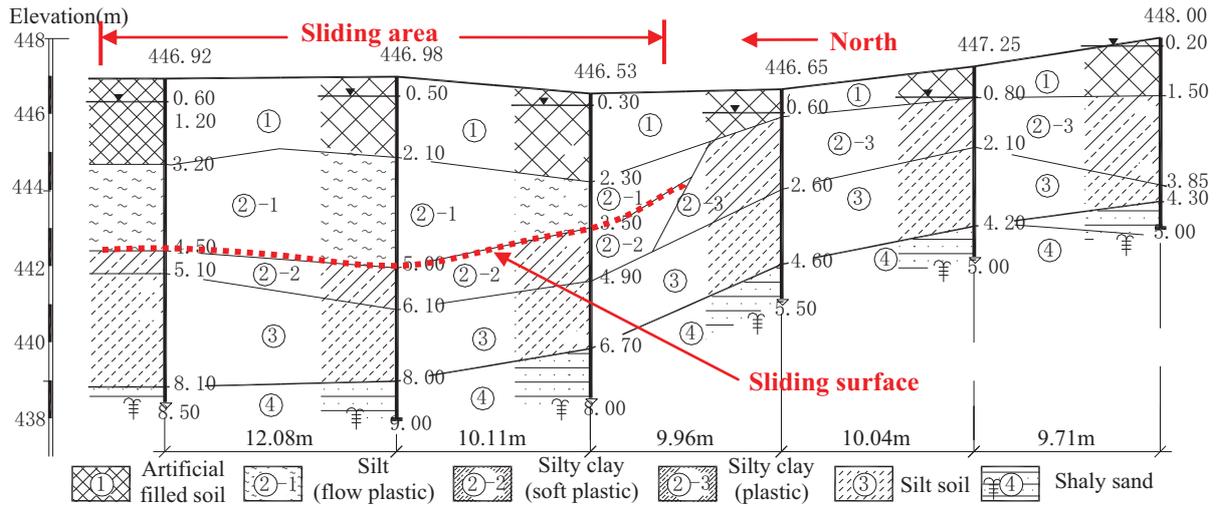
A longitudinal section of the site, with a cutting direction perpendicular to the sliding direction, is shown in Fig. 3.

Fig. 3 Longitudinal section of the site.

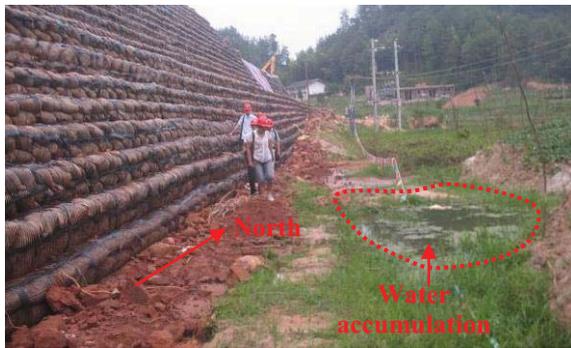
Because of the filling work, runoff conditions of surface water and groundwater are changed. Coupled with rainfall infiltration and bad drainage of the slope body, the burial depth of groundwater level was 0.0-6.0m, which was higher than the initial site. Water was accumulated at the slope toe (Fig. 4).

Fig. 4 Water accumulation at the slope toe.

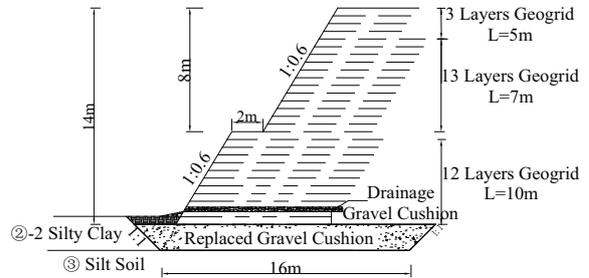
Fig. 5 Designed sketch of the reinforced slope.

According to the reinforced soil slope design (Mei et al., 2010), the switching station site should be backfilled with surrounding soils. The slope top should reach a ground elevation of 459.8m. The embankment is of 4-16m in height, and is reinforced by TENSAR geogrid reinforcement (Tensar, 1997). The slope ratio is 1:0.6, the tensile strength of geogrid is 70kN/m, laying length is 8-12m and laying spacing is 0.5m. Before the construction work, silt and soft-flow silty clay existed in the ground surface should be cleaned and replaced by gravelly cushion, to reach a high friction coefficient between the foundation and the slope body. Drainage cushion should be set at the bottom of the slope (Fig. 5).

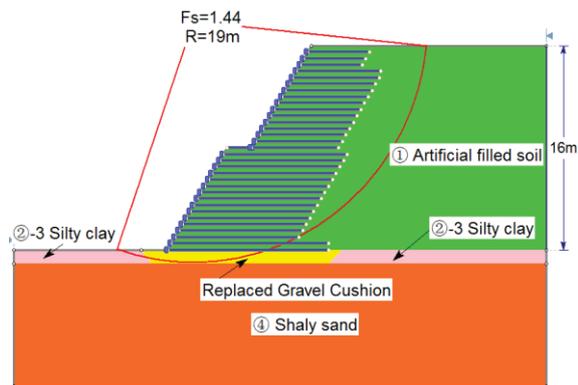
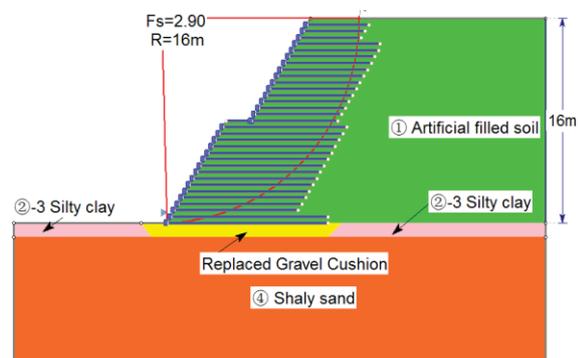
Fig. 7 Minimum safety factor of the external stability of the designed slope.

Fig. 8 Minimum safety factor of the internal stability of the designed slope.

Both of the external and internal stability of the designed reinforced soil slope are calculated using the Slide 6.0 package. According to the calculation, the minimum safety factors of the external and internal stability are 1.44 and 2.90, respectively (Figs. 7 and 8). The calculation results indicate that the designed slope, in terms of both the external and internal stability, is stable. And the internal stability is higher than the external stability.

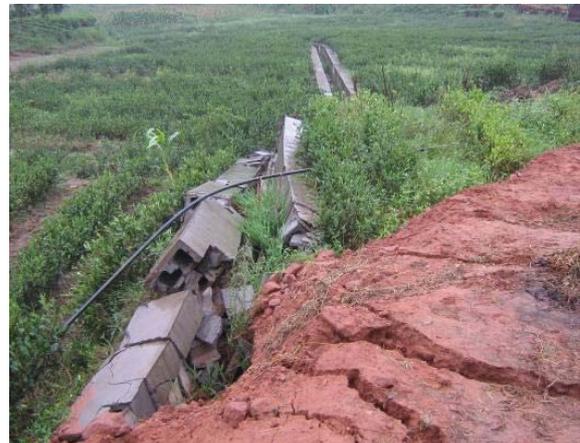
Construction of the reinforced soil slope started since May 15, 2009, and 75% of the backfilling was finished by July 26, 2009. When it was backfilled about 8m in height, in the morning of July 27, 2009, the workers found that a series of sliding evidence, such as fissures, initiated in the northeast corner of the slope. Then uplift, drainage ditch and road damage began to occur at the front and the toe of the slope. Pinnate fissures can be observed on the road and the slope berm (Figs. 10 and 11). On the basis of field judgment, the whole slope slid, while

Fig. 10 Uplift and drainage ditch damage at the toe of the slope.

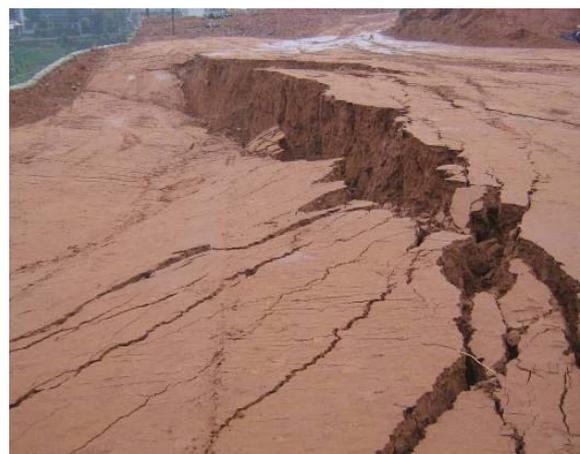
Fig. 11 Tension and pinnate fissures occurred at the berm of the slope.

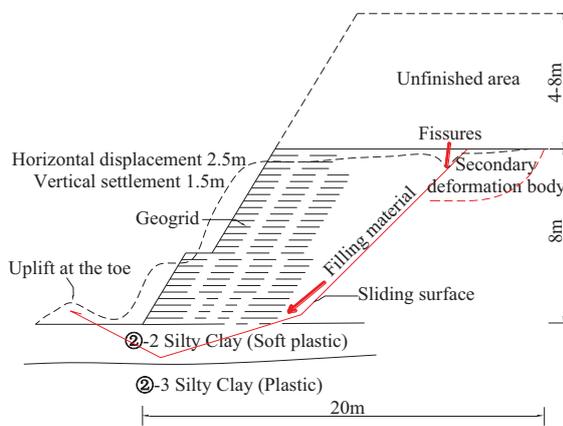
rear of the slope, which formed a slide wall out of the reinforced region with a height of almost 2.5m. At the toe of the slope, because of the uplifting and tension fissures, a maximum horizontal displacement and vertical settlement of 2.5m and 1.5m, respectively, were developed. The dimensions of the landslide were 35m in width and 20m in length. The ground surface of the south part was higher than that of the north and west part. The sliding surface is along the boundary between the filling material and soft-plastic silty clay, partly cutting through the layer of flow-plastic silty clay or silt. The dip angle of the sliding surface is slightly bigger than the angle of the original ground surface. The horizontal thrust increases as the height of the slope goes up. Since the sliding source is at the rear of slope, this sliding could be classified as push-sliding type (Li et al., 2008) (Fig. 12).

Fig. 12 Failure model of the reinforced soil slope.

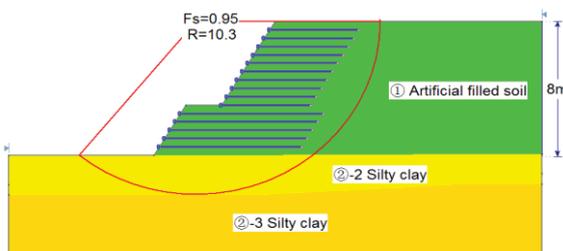
In order to work out the exact causes of the sliding, Slide 6.0 package (Rocscience, 2012) is used again to calculate the safety factor of the failure model. The dimensions of the model are 14m in height and 30m in width (Fig. 13). Because the replaced gravel cushion was not set according to the design sketch during the construction, it is removed and replaced by silty clay (②-2) in this calculation.

Fig. 13 Minimum safety factor of the external stability of the slope without gravel cushion.

Because of the removing of the replaced gravel cushion, safety factor of the external stability is decreased to 0.95 from 1.44 (Fig. 13). The entire slope slides along the layer of silty clay (②-2), which clearly demonstrates one of the main causes of the sliding. Besides, safety factor of the sliding surface in the failure model (Fig. 12), which is 0.97, is also calculated and shown in Fig. 14. This also thoroughly indicates that the construction of the reinforced soil slope is unstable. All these calculation results agree with the judgment of the previous section. While in terms of the internal stability of the slope, it is the same as the previous calculation, because no element is changed within the geogrid-reinforced area of the slope when compared with the previous calculation model.

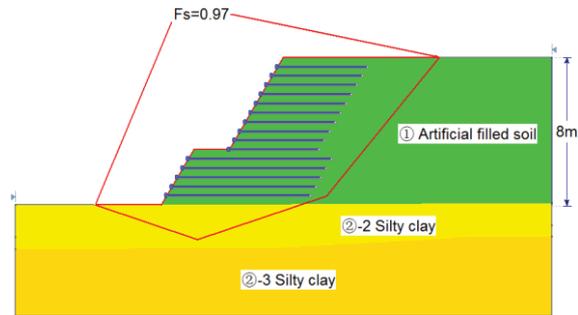
Fig. 14 Safety factor of the sliding surface in the failure model.
