# Mechanically stabilized earth (MSE) wall failures due to hydraulic situations

George Koerner & Robert Koerner  
*Geosynthetic Institute, Folsom, USA*

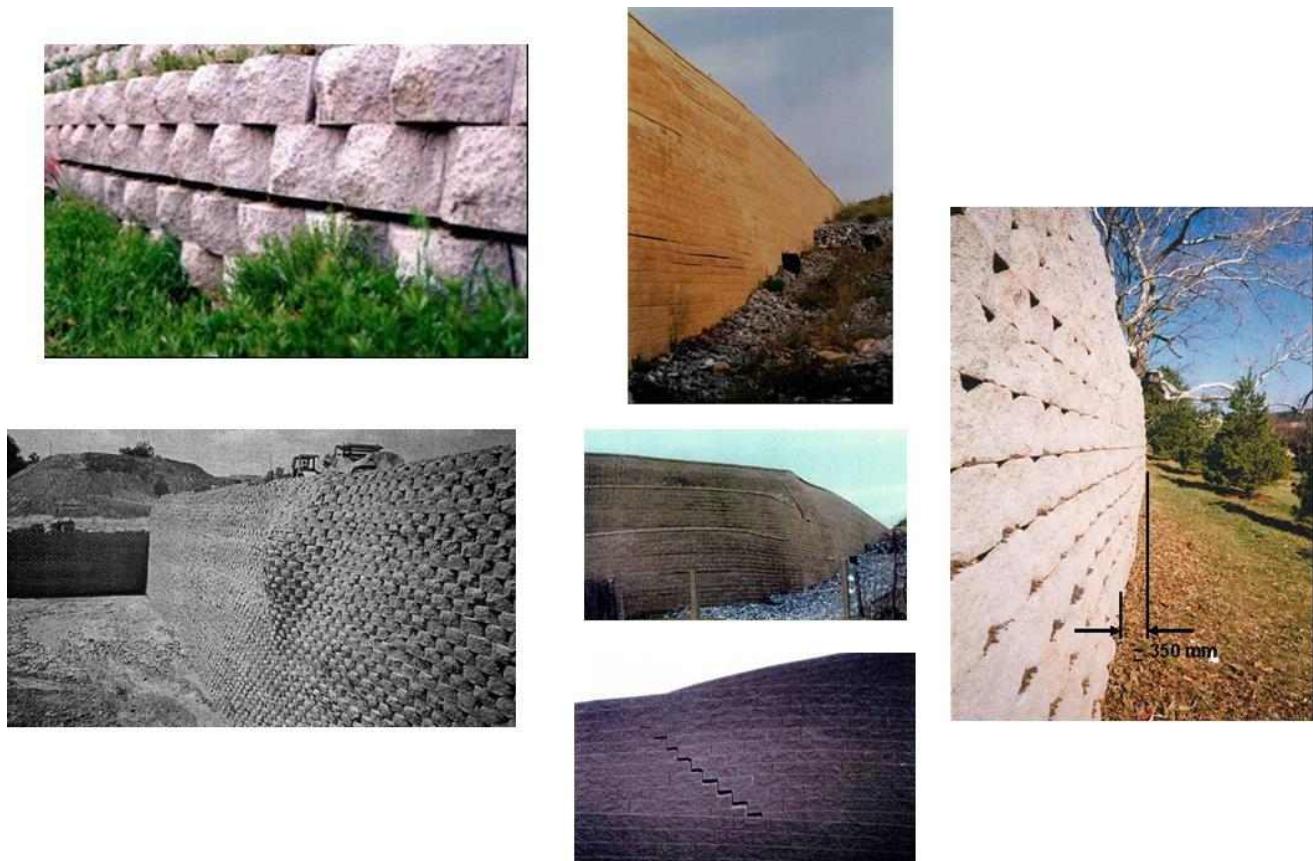
Figure 1. Cases of excessive wall deformations. (Photos by GSI and others)

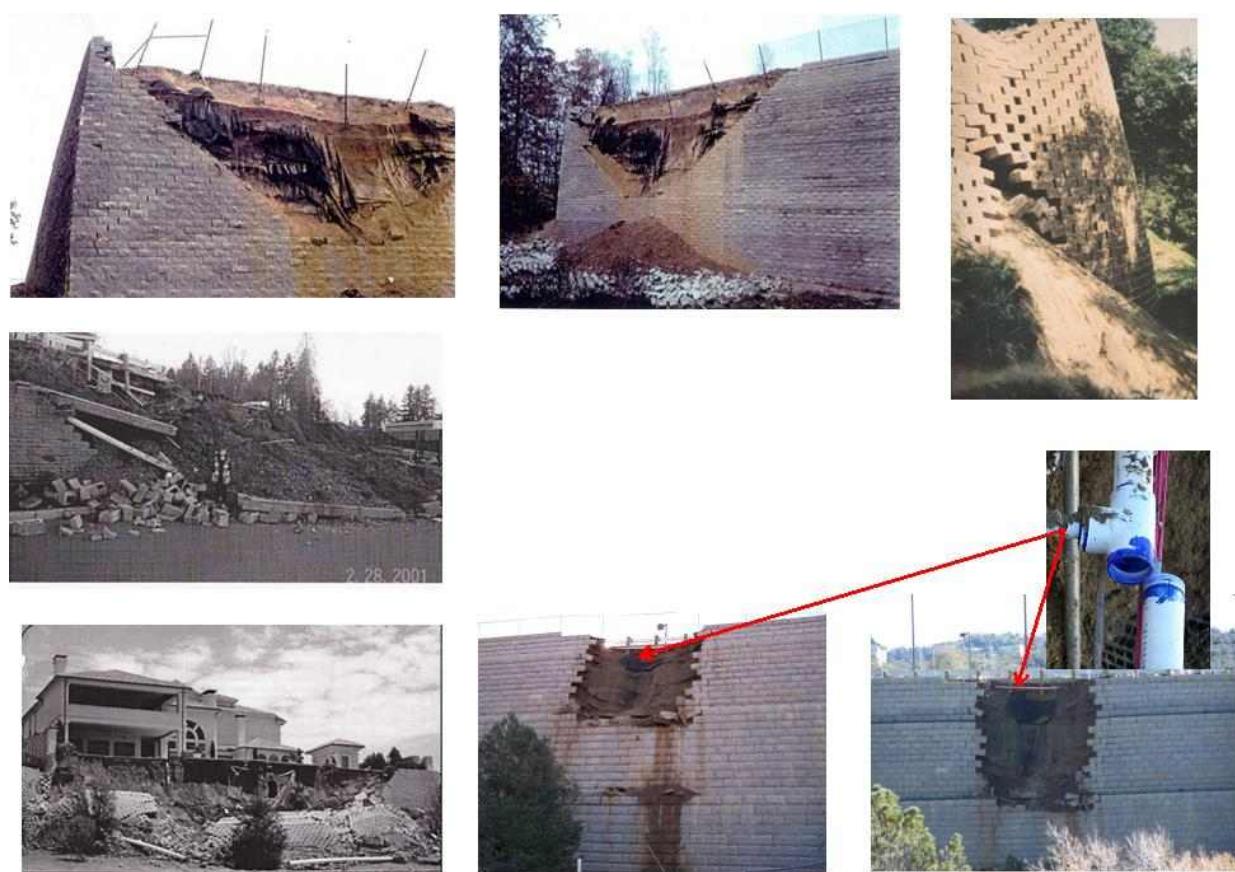
Figure 2. Cases of partial or complete wall collapses. (Photos by GSI and others)

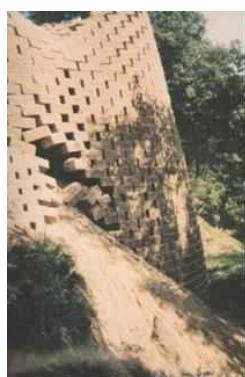
Clogged Front Drain

Figure 3. Internal water failures. (Photos by GSI and others)

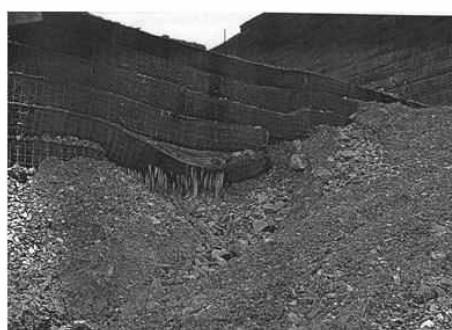
Saturated Backfill

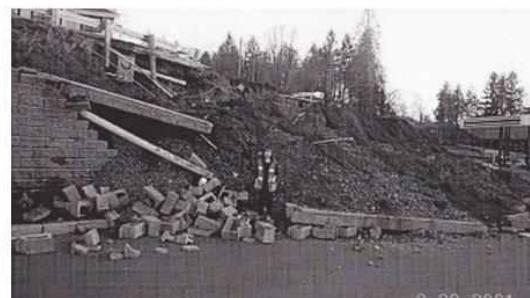
Internal Plumbing

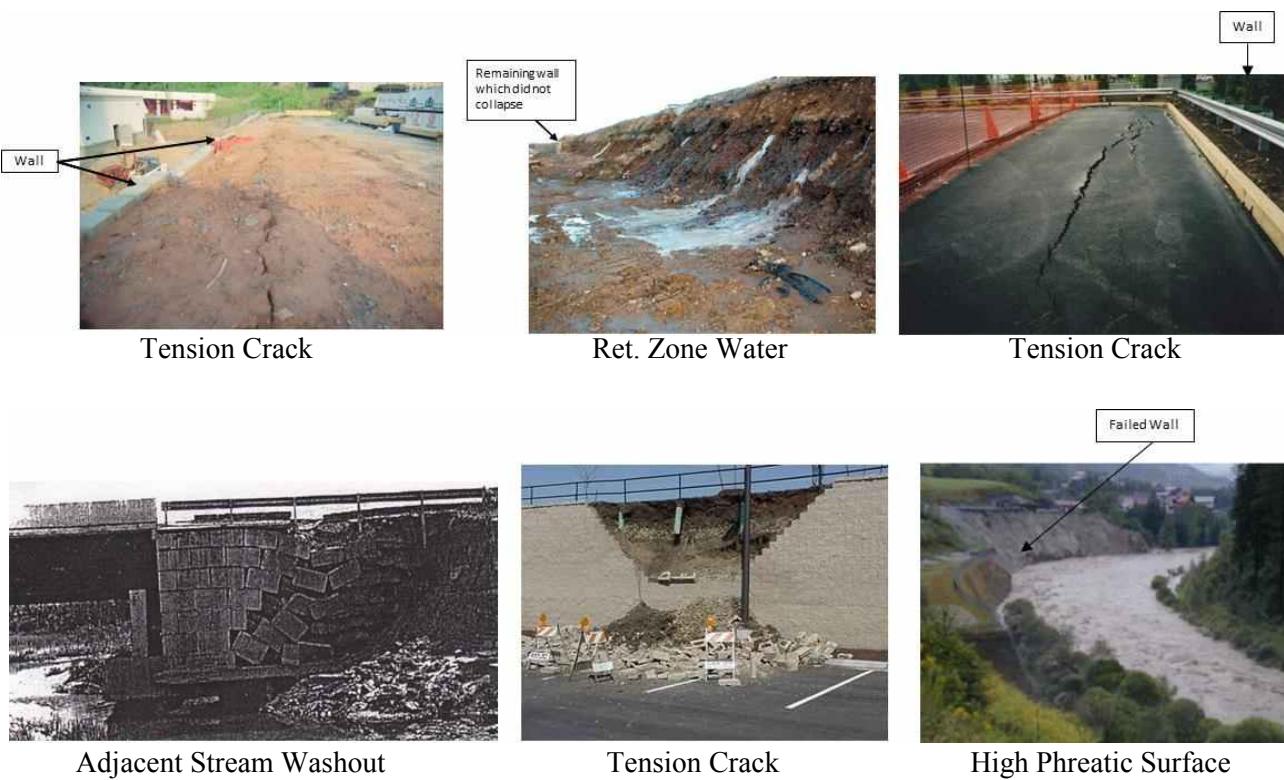
- retained soil seepage
- tension crack water pressure
- surface infiltration
- high phreatic surface
- soil erosion at wall toe

Figure 4. External water failures. (Photos by GSI and others)

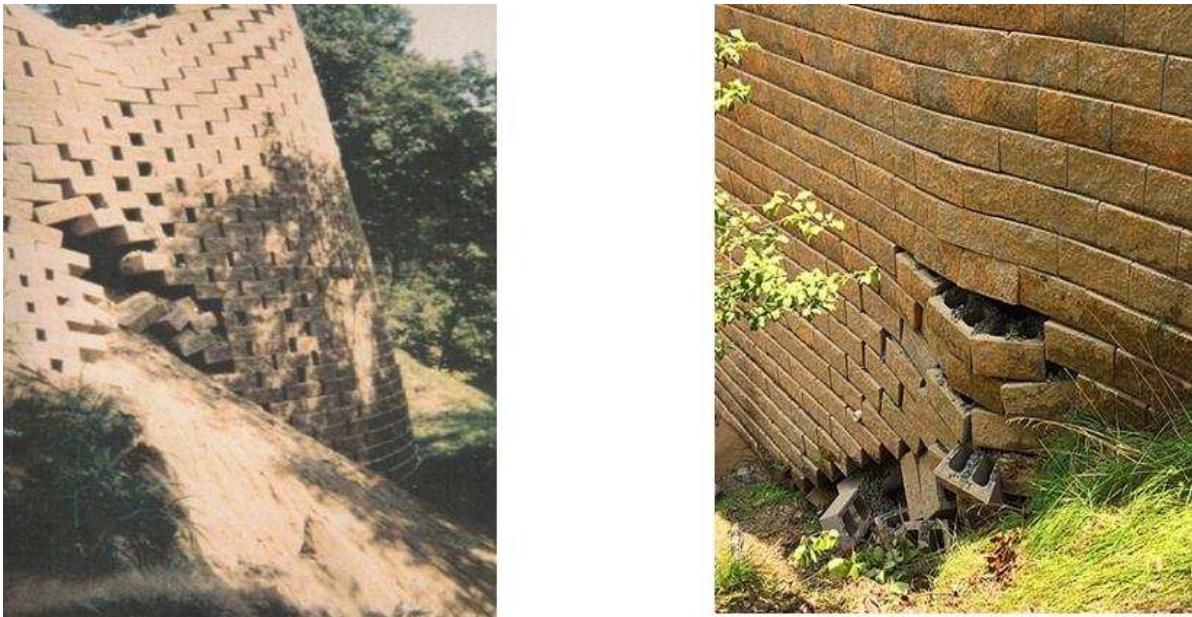
Located immediately behind the wall facing system is a layer of gravel for the purpose of eliminating water flow through the masonry block, gabion or other wall facing; recall Figure 5. This gravel layer is typically 300 mm thick and actually fills in hollow block voids if they are used. The accumulated water flow is gravitationally transmitted to the toe of the wall and exits either by periodically spaced weep-holes through the toe of the wall, or is collected by a drainage pipe to exit at the ends of the wall. *Absolutely essential is that the gravel layer must be separated from the fine-grained backfill soil with a geotextile filter; see Koerner and Koerner, 2017*). This filter layer must be wrapped around each soil lift between the individual layers of reinforcement. That said, it is generally omitted, not from a cost motivation, but from an construction inconvenience perspective. The obvious reason for such a filter is that individual silt or clay particles coming along with water from the reinforced soil zone will eventually contaminate the lower portion of the front drainage gravel causing toe failures as shown in Figure 6.

Figure 6. Toe failures of MSE walls caused by hydrostatic pressures. (Compl. Wikipedia and Google)
