Exhumation of geotextiles from a geosynthetic reinforced bridge abutment after 17 years of service

Maxwell Koerner, George Koerner & Robert Koerner
Geosynthetic Institute, USA

Keywords: MSE wall, GSRBA wall, geotextile installation damage, geotextile durability

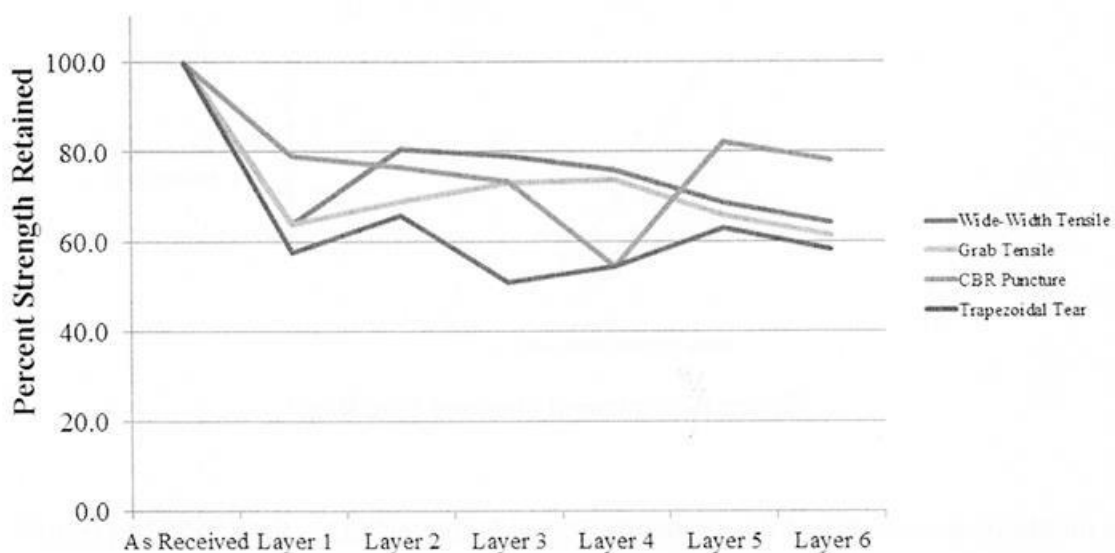
Far more revealing were the mechanical tests, which include wide-width tensile (ASTM D4595), grab tensile (ASTM D4632), CBR puncture (ASTM D6241), and trapezoidal tear (ASTM D4533). On average, the exhumed material experienced a 30% decrease in strength from the original material; however the difference in strength loss between layers 1 through 6 were not very great. See Table 2 for each property, respectively. The mechanical test results are subsequently illustrated collectively in Figure 9.

Figure 9. Average mechanical test results, showing the exhumed material's percent strength retained on each layer.

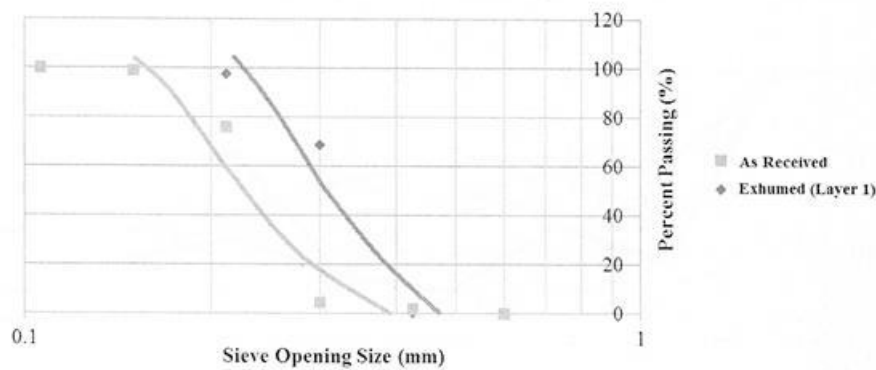
The hydraulic tests conducted included permittivity (ASTM D4911) and apparent opening size (ASTM D4751, shown in Table 3 and Figure 10. Both test results show that the exhumed material has larger opening then it did when manufactured.

Figure 10. Apparent opening size results.

The increased opening size between the textile's fibers can be attributed to the strain put on the individual fibers during the installation process. Also the soil particles, and other foreign matter, being forced through the already existing voids, made them larger as time progressed.

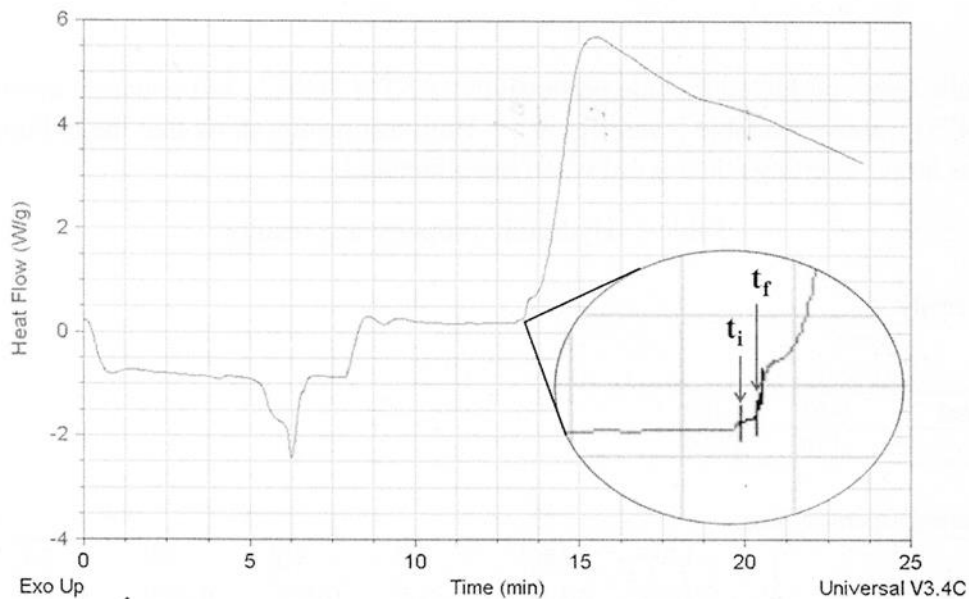
As a durability assessment of the geotextile, an oxidation induction time (ASTM D3895) endurance test was conducted, however the results proved mute. Since polypropylene slit film geotextiles such as this typically only contain high temperature antioxidants for production stability, not long term durability, the OIT time for this geotextile was expectedly small (less than 30 seconds); see Figure 11.

Figure 11. Oxidation Induction Time results for 'as received' material.

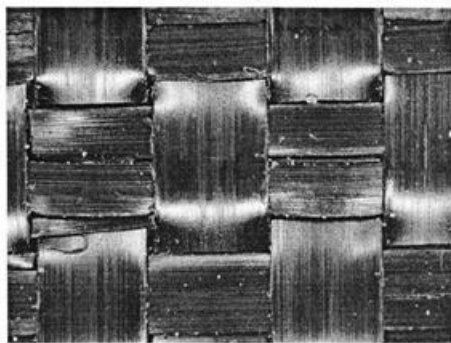
Figure 14. 'As Received' geotextile.

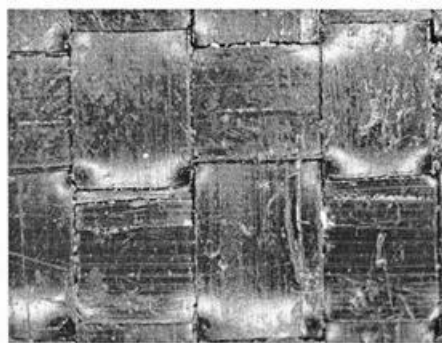
After analyzing the accumulated data, the 30% average decrease in overall strength, resulting in a reduction factor of 1.43, is accredited to damage that occurred during the installation and backfill of the geotextile.

As seen from the photographs taken under a microscope at 20X magnification (Figure 14 and 15), the exhumed material exhibits some signs of wear, such as surface scratches and foreign matter. This damage, typically caused during the installation of the geotextile, is felt to account for the mechanical strength decrease of the material. There also could have been minor cases of damages as a result of the exhumation process, despite our best efforts to be careful with the material.

Figure 15. Exhumed geotextile
