Estonian guideline for pavement geosynthetics

Sven Sillamäe

TTK University of Applied Sciences, Estonia

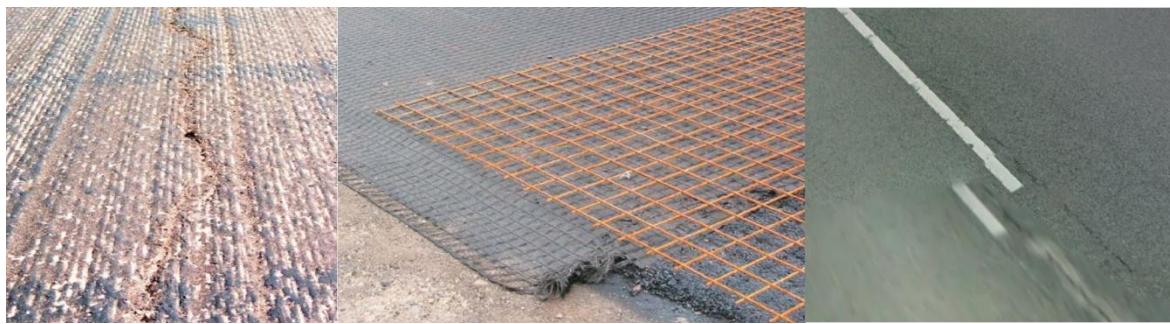
Table 2 shows summarized info about inventoried defects data from 2011 and 2017. Especially interesting is info about narrow longitudinal cracks in the middle of the road as these are assumed to be caused by frost heave action. It can be seen that with reinforcement not all the cracks have been eliminated, but nevertheless the extent is relatively low compared to the original situation in 2004 as see in the figure 1, also crack widths are considerably narrower compared to previous situation. Some of the cracks have been sealed with patching thus this distorts the data. When compared alligator crack amount and patches, noticeable difference can be seen between polyester and steel grid sections from where it can be concluded that latter has been more effective. Difference, although not too considerable, can be seen also from FWD data: polyester grid section average d_0 deflection was 173 μm and SCI parameter 41.8, in steel grid section respectively 169 μm and 32.1. For comparison from previous and following unreinforced sections in average $d_0 = 272 \mu m$ and SCI = 78.1 was measured.

Figure 1. Longitudinal frost heave crack before rehabilitation, installation of PET and steel grid, longitudinal frost heave crack 7 years after roadworks [photo courtesy: Enno Vahter]

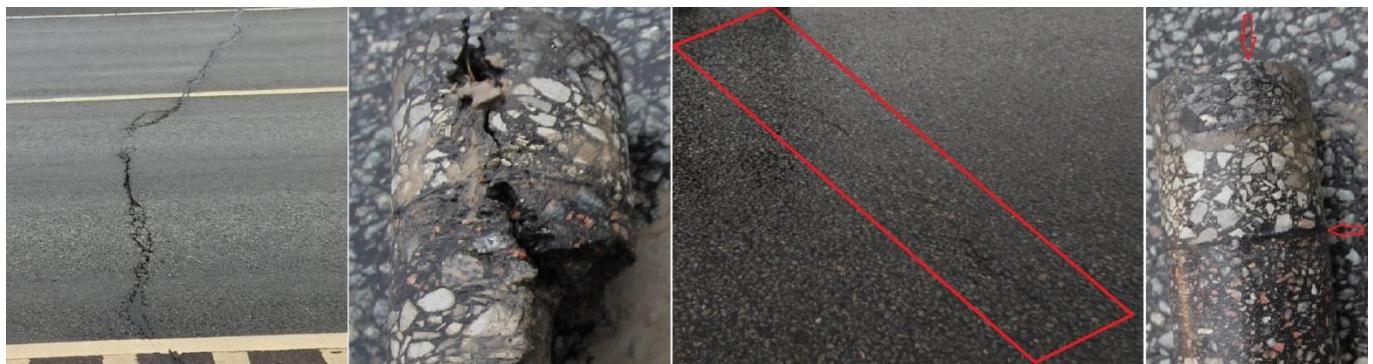
The pavement was cored in each sections in order to evaluate the situation visually. According to the visual inspection of the cores, some of the cracks have appeared on the same place where they used to be previously (crack continued in the old pavement) and some of them where new (crack was found only on top of the pavement geosynthetic). Also different crack ages were noticed – some of them were already widened and repaired, some were narrow and unsealed (figure 2). All of this indicates that at least some of the cracks are originated from top layer which suffers temperature induced top-down cracking rather than reflective cracking. Aavik *et al.* 2015 studied bituminous binders used in Estonian market and concluded that most of them does not meet to the needed requirements to withstand winter negative temperatures especially considering reversible ageing thus our pavements are susceptible to temperature induced transverse cracking. It was also discussed that changes in pavement stiffness (e.g. existence of old crack) could promote new top-down crack to appear to the same place. Thus SAMI layers are ineffective against this kind of mechanism and reinforcement is needed to strengthen the areas where old cracks used to be, but even more importantly, top layer properties need to be chosen carefully in order to avoid cracks caused by its insufficient performance.

Figure 2. Transverse cracks in different stages – one is repaired and has appeared to the same location as it used to be and second one is new, unrepaired. In both cases paving fabric was used.

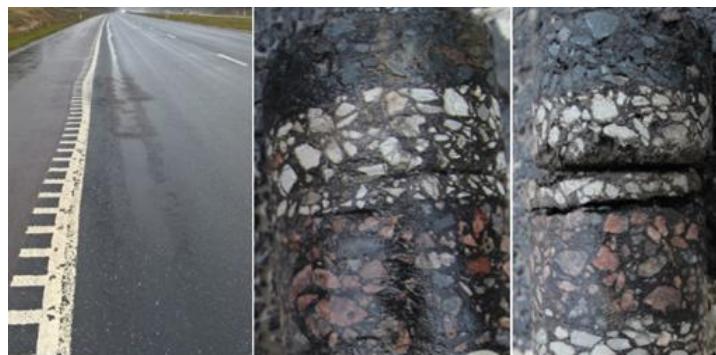
Positive effect from stiff reinforced layer was seen on glass fibre grid section where only 3 transverse cracks were found. All of these were concentrated to the same small area where also significant rutting was observed. Coring revealed problems with layer bonding (Figure 3). The same problem with glass fibre materials has been described by Nguyen *et al.* 2013 based on the literature review, but afterwards it was concluded that problems with glass fibre rises mainly when installation has been executed poorly and otherwise glass fibre grids significantly improve the fatigue life.

Figure 3. Bonding problems between glass fiber grid and pavement was noticed.

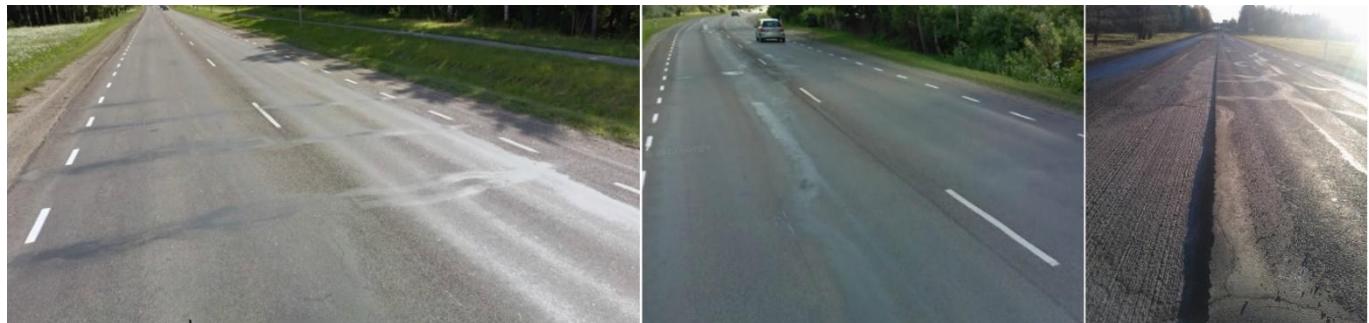
Third test section was built on support road in 2013 which report was published by Sillamäe 2017. Existing pavement was severely cracked – there were many transverse and longitudinal cracks as well cracks caused by frost heave (Figure 4). It was decided to use three different products – steel mesh bound to slurry seal, 100 kN/m glass fibre composite with 130 g/m² PP geotextile and 120/200 kN/m glass fibre grid with glass fibre filament paving aid between ribs. The road was levelled by milling and levelling course, the aforementioned products were installed and whole process was monitored very carefully, after what 4+4 cm asphalt concrete (AC) followed. There were no wrinkles during the placement of the products, adhesion between geosynthetic and pavement was adequate according to Leutner test. Frost heave damage did appear on the reference section (with 4+4 cm asphalt overlay) in 2016, but no defects has been found on reinforced sections. Monitored test section was followed by pavement where only 4 cm of overlay was placed to the existing road. First cracks (both transverse and longitudinal) appeared to that section approx. 2.5 years after rehabilitation works.

Figure 4. Defects found in third test section before rehabilitation works.

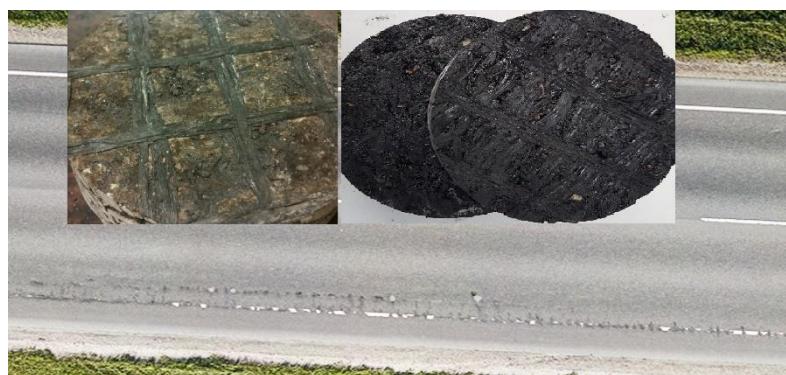
The important role of sufficient amount of tack coat was seen among many others in one site constructed 2015. Reason for using pavement reinforcement was to avoid potential longitudinal crack caused by road widening. Geosynthetic was supposed to be placed under 4 cm wearing course which was supported by the base course asphalt concrete (AC) layer. The construction was finished in autumn at temperatures around +5 °C. Next year defects started to appear and the situation in 2017 is shown in figure 5 along with two different core samples. Damaged sections and areas were cored in order to inspect asphalt concrete quality and adhesion between geosynthetic by Leutner test. Latter was not possible as cores did not stay intact and after curing it was seen that geotextile has not been saturated with bitumen and white spots which were not covered by bitumen, were noticed (Figure 5 left core sample). In contrast, cores were taken from sections where no damages appeared, the cores were intact. On the previously mentioned undamaged sections another kind on reinforcement product was used and it was properly adhered between asphalt layers and it was possible to see that needed amount of tack coat is present (Figure 5 right core sample).

Figure 5. Left core sample was taken from damaged (shown below) and right undamaged section

Analysis of the described project's documentation showed that contractor used tack coat according to manufacturer recommendations, although in the reality it was not enough as base layer was relatively porous (air voids content approx. 10%) thus allowing emulsion to seep into the base course layer. Placing thin layer of surface course asphalt layer during cold weather did not have enough residual heat to attract bitumen to rise up in order to saturate the textile for sufficient saturation and adhesion. So, there would have been a need for more tack coat, even greater amount what manufacturer had suggested. From this conclusion another problem arises: when contractor uses more tack coat, under paving machinery bitumen usually penetrates geotextile thus sticking to the truck tyres which starts to tear up and buckle the placed geotextiles and this is the main reason why workmen limit the tack coat dosages.
