Coupled hydro-mechanical analyses of a multi-tier geosynthetic-reinforced soil slope subject to rainfall infiltration

ABSTRACT: This paper presents a case study and numerical investigation of a failure of a geosynthetic-reinforced soil slope with marginal backfill subject to rainfall infiltration. The investigated slope is a 26 m high, 4 tier geogrid-reinforced slope constructed for stabilizing the existing highly weathered and fractured sandstone road embankment. Contrary to the backfill recommendations in design guidelines, locally available low plasticity silty clay (CL-ML) with over 60% of fines, was used as backfill in the reinforced zone. The GRS slope first experienced excessive deformation after seasons of typhoon and heavy rainfall from 2010-2013. The measured settlement and horizontal deflection at slope crest were 140 and 80 cm from June to December 2012. Although an immediate remedial action had been taken, the slope final collapse was caused by two sequential typhoon events with total accumulated rainfall of over 600 mm in August 2013. The failure mode was identified as the compound failure which had the failure surface partially cut through the reinforced zone at the

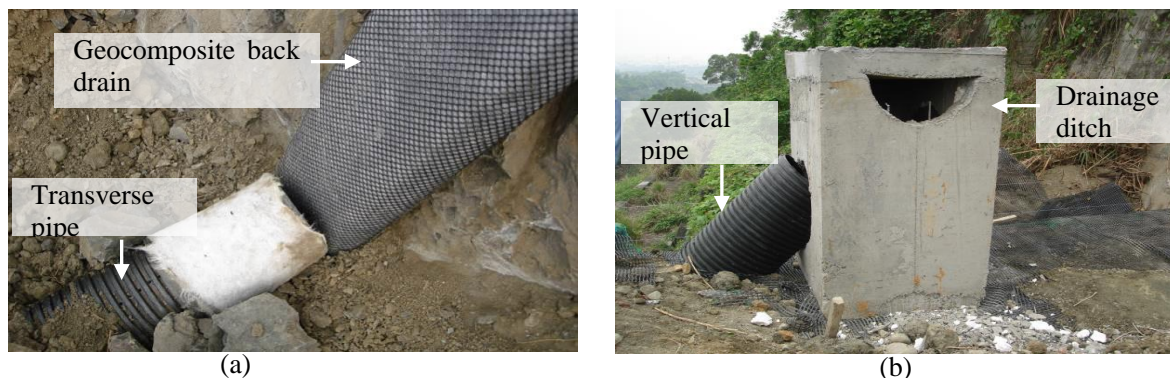
The slope construction process consisted of placing reinforcement, the front and rear sand bags, placing of backfill, backfill compaction process, and wrap around at the front and the rear side. Geocomposite back drains were placed at the back slope and connected to 150 mm transverse drain pipes which were laid at a spacing of 2 m at the bottom of each tier. The 150 mm transverse drainage pipes were perforated on the upper surface to allow seeping out of accumulated water from the backfill soil into the pipe. To prevent soil particles from getting into the pipe, nonwoven geotextile was used to wrap the transverse drains. However, no filtration check to prevent clogging of nonwoven geotextile was reported. The 300 mm surface drains were provided at the slope surface to guide the collected water to an open drain at the bottom of each tier. Figure 2 shows the drainage joint connection details were poorly done and attention was not paid for easy of getting disconnected during settlement.

Figure 2. Drainage installations: (a) connection joint between back drain and transverse pipe; (b) connection joint between drainage ditch and vertical pipe (from Taiwan Professional Geotechnical Engineers Association report, 2014)

- g) Excessive deformation of marginal soil could occur upon rainfall infiltration. Hence flexible drainage joints should be used to avoid drainage joints disconnection caused by slope deformation.

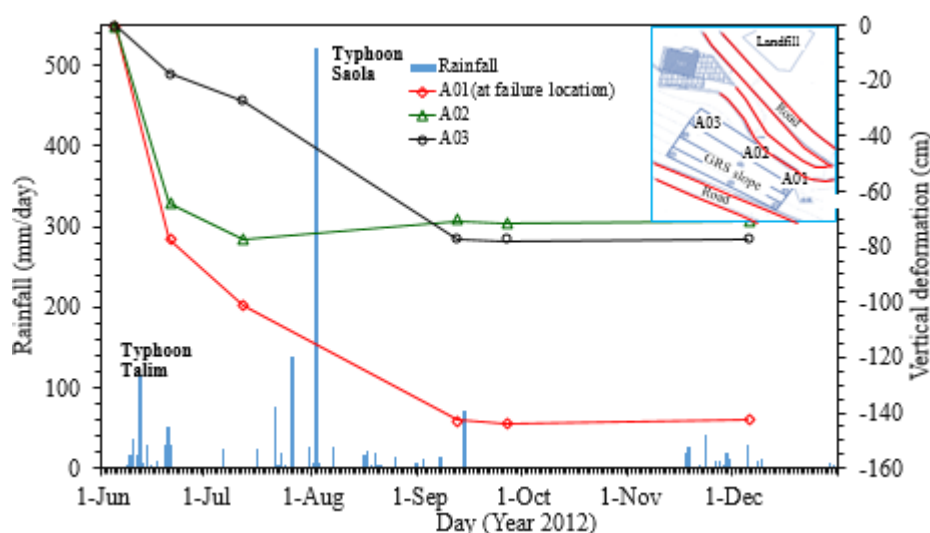
However, after typhoon Muifa on August 2011, crack development and settlement continued. With intention of designing for the remedial measures, slope deformation was monitored for a period of 7 months between June and December 2012. Deformation monitoring was done by means of recording relative heights of three established points on the top of 3rd and 4th tier using a dumpy level machine. Figure 3 shows recorded settlement of the top tier during this period. During this duration, the slope was subjected to two major typhoons, typhoon Talim (cumulative precipitation, $R = 350$ mm) and Typhoon Saola (cumulative precipitation, $R = 563$ mm). It was observed that after seasons of heavy rainfall (typhoon), considerably settlement of the top tier was observed (Figure 3)

Figure 3. Relationships between rainfall and slope settlement

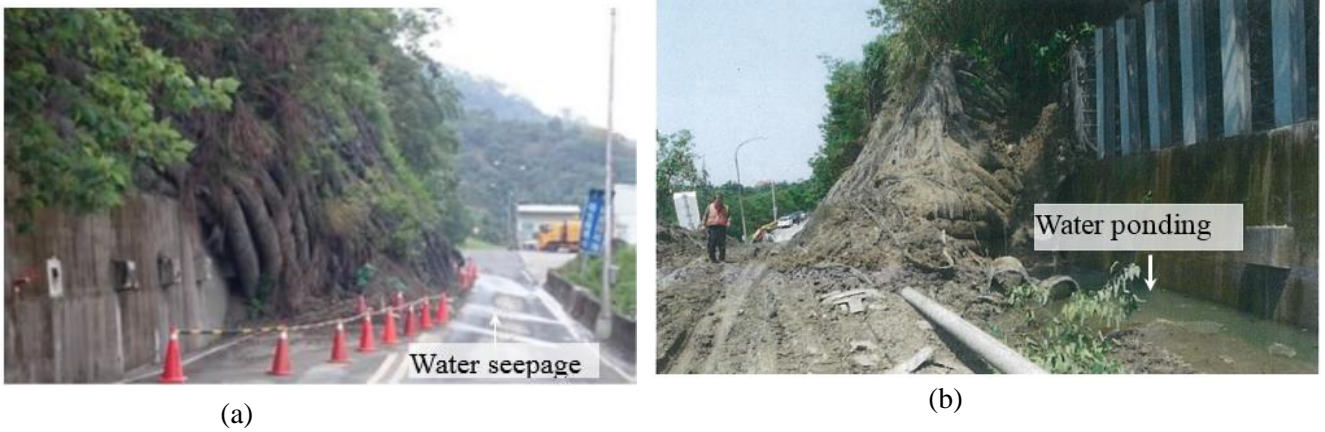
The slope final collapse happened on September 1, 2013, (Figure 4) exactly three years after completion. The collapse was preceded by two consecutive typhoon events, typhoon Trami (cumulative precipitation, $R = 338$ mm) and typhoon Kong-rey (cumulative precipitation, $R = 310$ mm) bringing a total precipitation of 647 mm. A few hours after the slope failure, ground water seeped out of the backfill soil and ponded at the slope toe (Figure 4). This suggested that pore water brought about by typhoon may have accumulated within the backfill soil.

- i. The use of marginal soil (over 60% of fines) as backfill contrary to the backfill recommendations in design guidelines. Porewater pressure developed within the poorly draining backfill soils
- ii. The original design and site investigation overlooked the existence of retained weathered rock layer, which has shear strength properties less than that of intact rock.
- iii. Settlement and tension crack at the slope top surface allows rain water ponding at the slope top surface and consequently infiltrating into reinforced zone.
- iv. Drainage system malfunctioned because drainage joints were poorly connected during construction and likely dislocated due to excessive slope deformation.
- v. The soil fine particles may have clogged the nonwoven geotextile filter and hence retarded the drainage capacity.

Figure 4. Slope failure: (a) slope toe with water seeping out from backfill; (b) another view at the slope toe with water ponding (from Taiwan Professional Geotechnical Engineers Association report, 2014)

- d) Because high positive pore water pressures accumulated at the slope toe, sufficient drainage should be provided, especially at the bottom tier of the GRS slope.

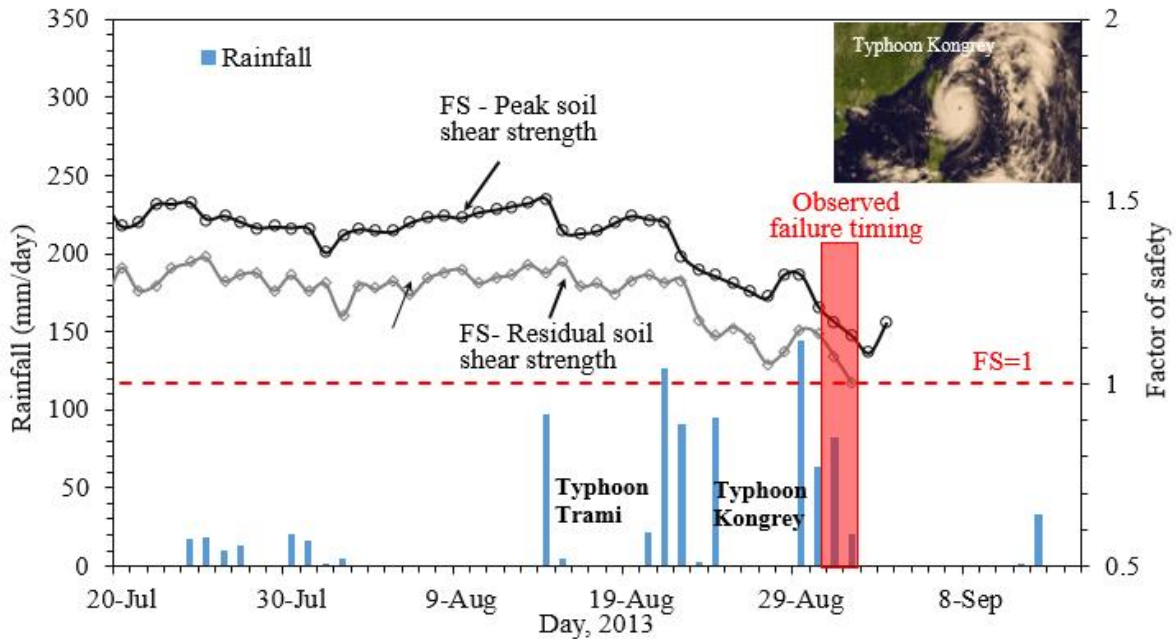
Fully coupled flow deformation module was implemented into the PLAXIS (version 2D 2015) finite element (FE) program (Brinkgreve et al., 2016). Figure 6 shows model validation results for the failure of GRS slope in 2013 by comparing the predicted and observed failure timing. The FS of the slope dropped at each rainfall event and recovered during dry days because of the effect of modeling evapotranspiration. It is observed that the predicted failure timing (FS=1) using residual soil shear strength corresponds with the observed failure timing. Slope had undergone excessive deformation before failure hence shear strength properties at failure were considered to be residual properties. This indicates that the developed hydro-mechanical model is capable of accurately predicting the timing of rainfall-induced slope failure.

Figure 6. Predicted factor of safety variation results.

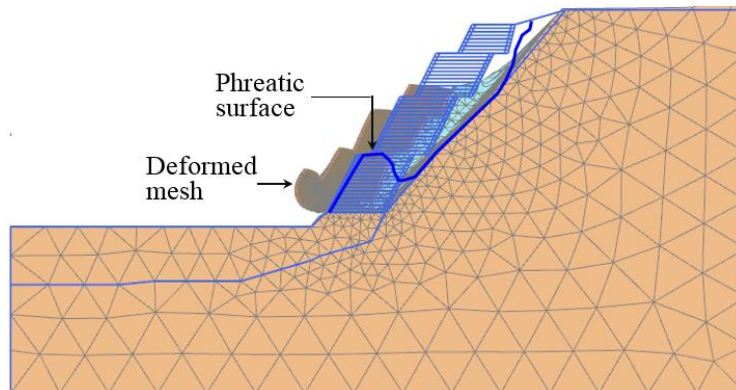
Predicted deformed mesh at failure is shown in Figure 7. The deformed mesh shows that large deformations occurred in both the backfill soil and the weathered sandstone layer. The failure surface partially cuts through the bottom tier of the GRS slope and partially passes through the weathered sandstone (Figure 8). This suggests compound failure mode occurred within the slope. Weathered sandstone layer, though overlooked in the initial reinforced slope design may have been unstable and contributed to slope failure. The predicted deformed shape imitates the shape of the failure mass observed after slope failure (Figure 4).

Figure 7. Deformed mesh and phreatic surface at slope failure

From Figure 7, it is also observed that the GWL had risen to the top of the bottom tier. The bottom tier is fully submerged. This is contrary to the initial design assumption where GWL was assumed to be at the middle of the backfill soil (between retained fill and ground surface). Therefore, slope failure was attributed to the increase of PWP (loss of soil matric suction) due to the rise of phreatic surface level.

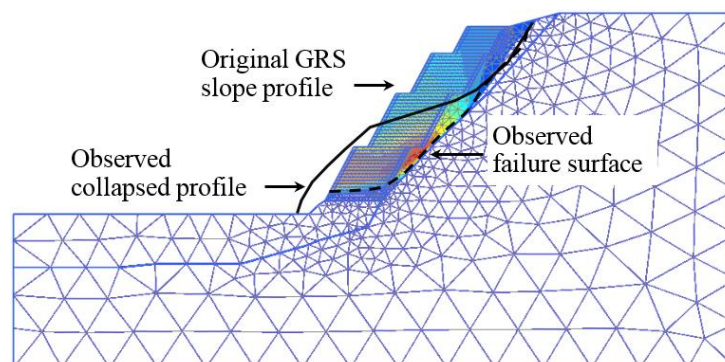
Figure 8. Incremental displacements contours at slope failure and compared with observed failure plane surface

- c) Because of the compound failure mode, it is crucial to stabilize unstable weathered rock prior to the construction of the GRS slope in front of it.
