Case history of a 22-year old geomembrane liner at a domestic waste landfill

ABSTRACT: This paper presents a case history of an exhumed geomembrane beneath a landfill in New Jersey, U.S.A. The geomembrane taken from the landfill has been in service for the past 22 years. The liner was exhumed due to a lateral expansion at the site. The owner plans to tie into the existing liner system along with the new cell's construction. Hence the opportunity arose to exhume a section of textured 1.5 mm (60 mil) HDPE geomembrane that was in service and experiencing actual field conditions of compression, temperature and leachate exposure since its installation.

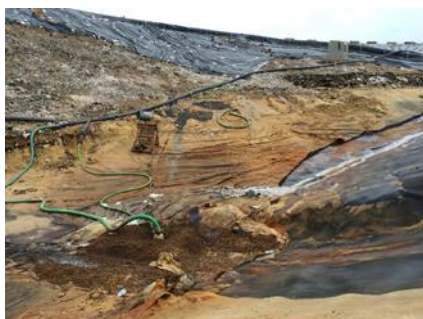
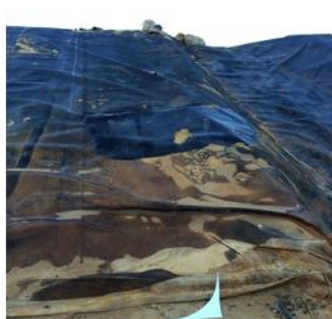
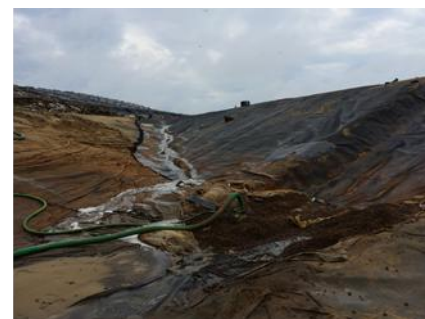
Figure 3. Overview photograph of the excavation showing sump and sample area.

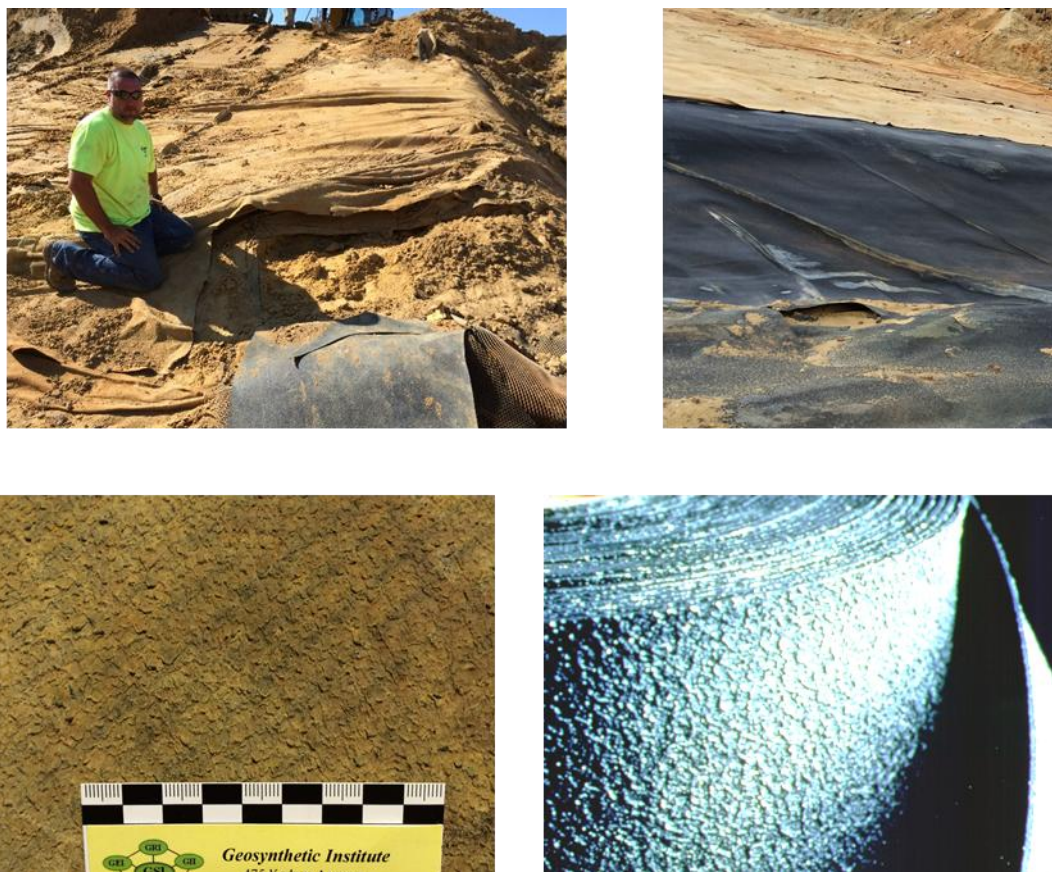
Figure 4. Field sampling of geomembrane.

- original and aged thicknesses are similar and both are above the specification value,
- density of the aged material has increased slightly over the specification value, but not over the original value
- original and aged tensile properties (yield and break stress, and yield and break elongation) are similar and above specification values,
- original and aged tear resistances are similar and above the specification value,
- original and aged puncture resistances are similar and above the inspection value,
- stress crack resistance is at or above original values and higher than specification value,
- original and aged carbon black contents are similar and meet the specification range of value,
- original and aged carbon black dispersion categories are similar and meet the specification value, and
- oxidative induction time has remained constant over time.

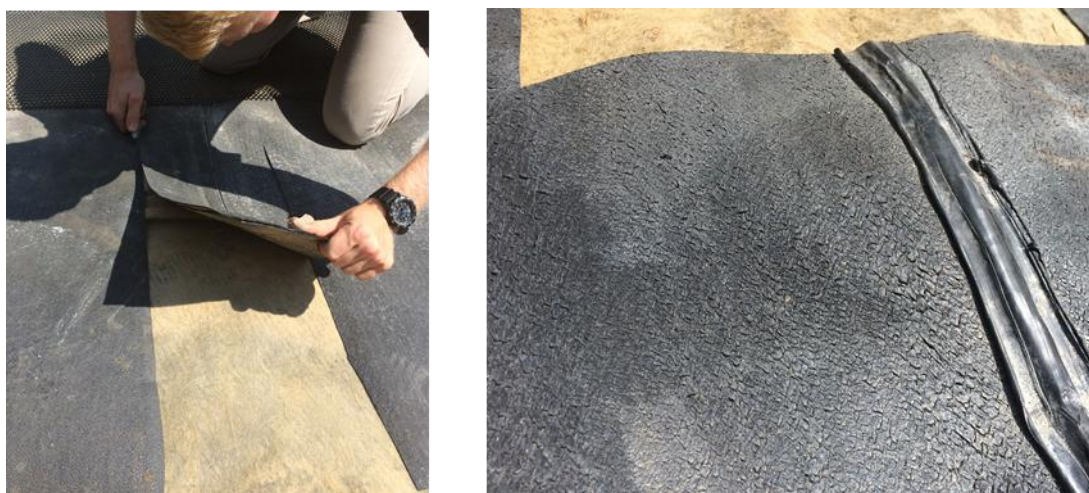
Figure 5. Field sampling of sheet removal and various seams.

Regarding both the dual track hot wedge and fillet extrusion seams, both shear and peel strengths are similar in their original and aged conditions and both pass the current specification. Also, seam elongation and type of break are acceptable. All seams were in excellent shape after twenty-two (22) years of service.
