Repairs underwater of a HDPE liner by using a bituminous geomembrane of a density more than 1

ABSTRACT: A case of history will be given of a gold mine in Spain, the Tailing reservoir (TMF) waterproof with HDPE presented various defects (around 256) The mine asking extension, repairs on these defects were requested by the authorities to be fixed to obtain the necessary authorizations to operate and manage the installation.

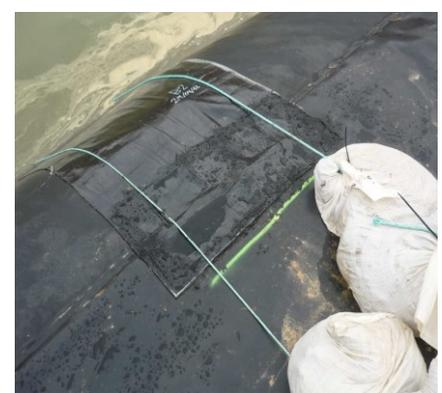
Figure 5. Final result of a repaired defect

The inspection carried out showed that 100% of the patches were without any defects, well-sealed and without lateral displacement. Only to mention that a line of sandbags was out of place due the welding of the mechanical fixation.

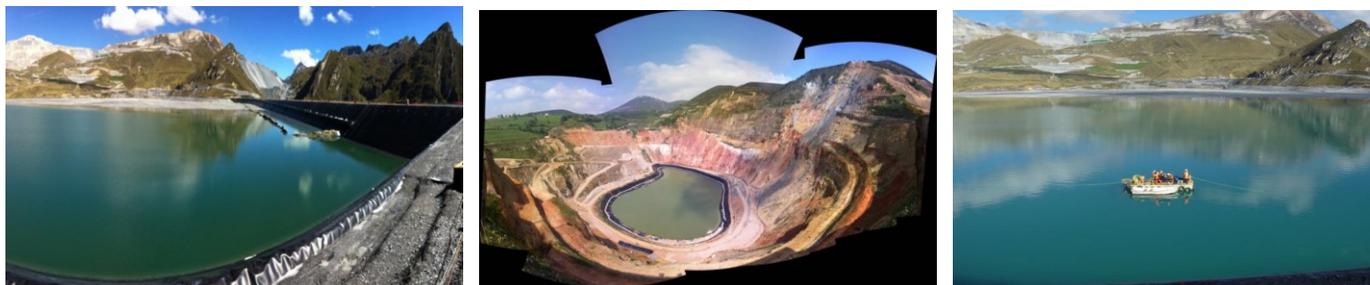
Once obtained all the permissions, they began to realize the inspection of the bank for the evaluation of the damages produced by the blowing-up. During the labors of inspection, there were crossed 170 m of bank, in which they were 31 scratches to repair with 29 patches plus 75 affected meters.

HDPE out of water was repaired by the traditional method: a second sheet HDPE of 2 mm of thickness joined to the first by traditional welding. These repairs were realized up to 50 cm on water.

Finally, it was decided to use a method of repair used in Spain, which was consisting of using patches of BGM, welds to the HDPE by means of an adhesive mastic.

The process was similar to this described above: adhesive bituminous mastic with permanent weight above the joint during 4 weeks to guarantee a permanent contact between the 2 liners HDPE and bituminous geomembrane. The weight was by means of sand bags.

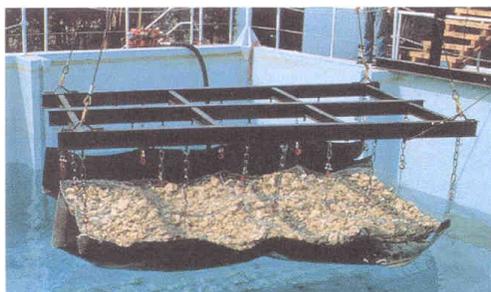
Figure 6. Test

But our answer is clear: we did tests in swimming pool of such welds HDPE/BGM with mastic and we measure the shear resistance following EN and ASTM standard after 4 weeks, the resistance is less in the membrane than in the joint.
