Case study on deformation of reinforced soil wall using geo-textiles

Hijiri Hashimoto, Takahiro Yamanashi & Hirochika Hayashi
Civil Engineering Research Institute for Cold Region, PWRI, Japan

ABSTRACT: When an unsoundness reinforced soil wall was built by some kind of factors, it is necessary to elucidate the mechanism by a detailed field work how deformation occurred, and we must take the measures that a similar phenomenon is not generated in future. This paper is findings to grasp factor of deformation of the geo-textiles reinforced soil wall which did be large deformation. The data which used of the subsidence of a history at the time of the construction, a physical characteristic, the bowling investigation into used laying earth on the ground materials, the rain and ground water level after the construction, the reinforcement domain pass, and is a change at time. We considered factor of deformation of the geo-textiles reinforced soil wall to a base by these data. The point concerned was the topography condition that the rain and melting snow water concentrated on a reinforcement soil wall, and, as a result of investigation, there was it in the environment where the ground wat

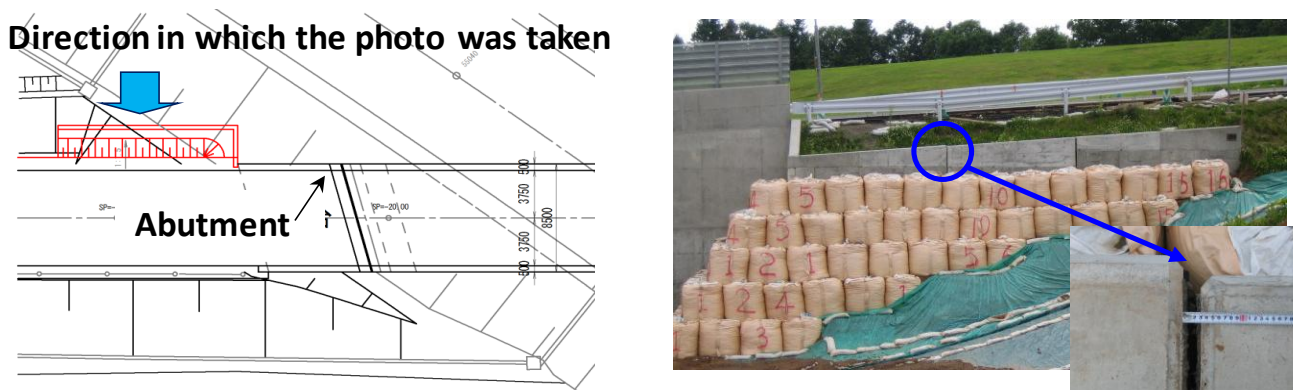
Figure 3. The deformed reinforced soil wall and the deformation control work.

After the embankment was constructed to the design height of the reinforced soil wall, construction of the base course and pavement were sequentially done. The road entered (opened) service in late January 2013. In late June 2013, which was about 5 months after the road section entered service, deformation of the wall constructed with the wall panels and subsidence in the embankment at the back of the abutment were found. Measurement and visual observation of the deformation of the wall and measurement of subsidence in the reinforced region were started after the wall was found to have deformed and the embankment was found to have subsided.

Figure 3 shows the reinforced soil wall, whose joints between the wall panels had become irregular in height and whose horizontal displacement of wall panels had become conspicuous. The wall was supported by large sandbags. On November 29th, which was about 5 months after the start of measurement, it was judged that the horizontal and forward displacement of the wall panels would not stop, and the deformation of the wall was controlled by banking up large sandbags in front of the wall panels.

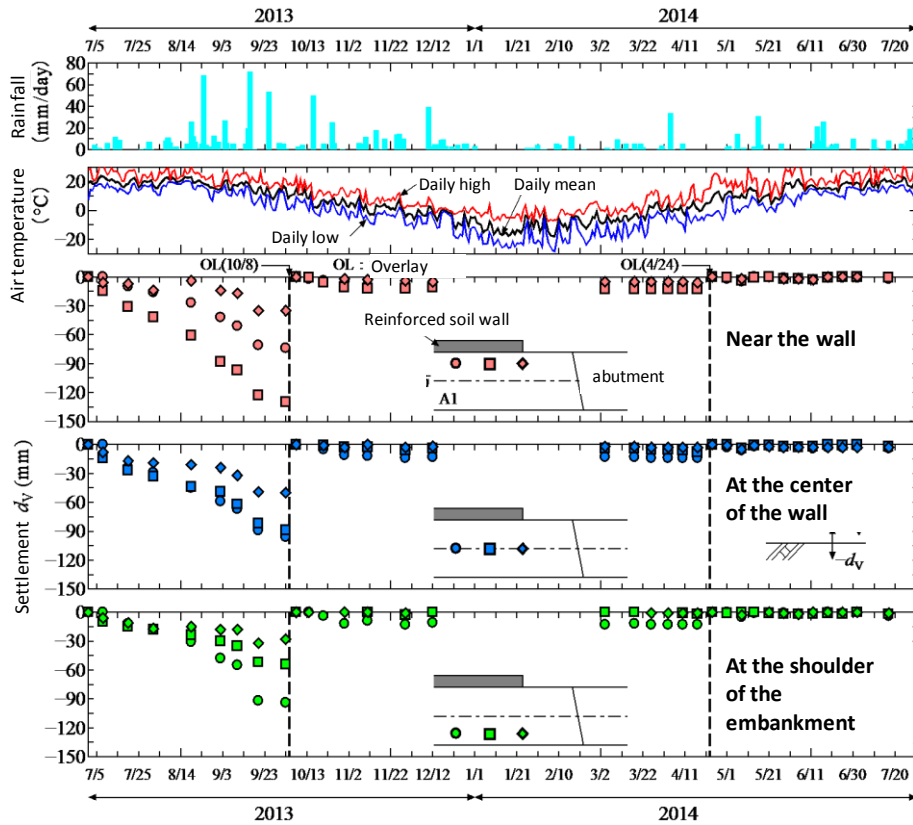
Figure 4. Settlement of the reinforced soil wall with time, and rainfall records.

Figure 4 shows the daily rainfall (mm/day) and air temperature of the area around the site of the reinforced soil wall obtained from the Automated Meteorological Data Acquisition System (AMeDAS). It also shows the subsidence measured 1) near the wall (indicated by red marks), 2) at the center of the road (blue marks), and at the embankment toe (green marks). The measurements for each of 1) to 3) were done at three locations distributed longitudinally to the road axis, i.e., measurements were done at 9 locations in total.

Settlement of the embankment tended to increase with time after the start of measurements in late June 2013. The subsidence before the overlay of October 8th had a maximum of about 135mm near the wall (i.e., 3.25m to the reinforced soil wall side from the center of the road), a maximum of about 110mm at the center of the road, and a maximum of 100 mm at the embankment shoulder (i.e., 3.25m to the embankment shoulder from the center of the road). Subsidence at these three locations rapidly progressed after heavy rainfall of about 70mm/day in late August and mid September, all of which characterized the subsidence. The interpretation of the mechanism of this subsidence will be discussed in a later section. On 8th October, overlay was done on the reinforced region at the back of the abutment; however, a second overlay was done on 24th April 2014, because further subsidence with a maximum of 15 mm occurred after the first overlay. After the second overlay, measurements for subsidence were continued until late July 2014. No behaviors that indicated further progress in subsidence were found.

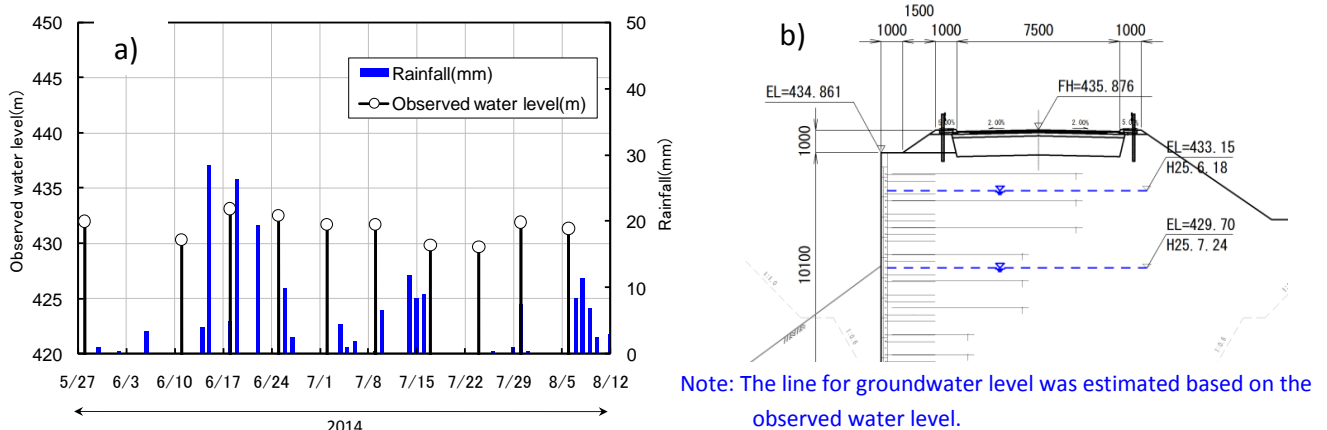
Figure 5. The deformed reinforced soil wall and the deformation control work.

To estimate the groundwater level inside the reinforced soil wall, manual measurements were taken regularly by using a tape water level meter from 28th May to 6th August 2014. A polyvinyl chloride pipe (VP 150) was installed in the bore hole near the reinforced soil wall (Figure 1). The polyvinyl chloride pipe was a strainer pipe with holes that secure the smooth inflow of groundwater. The outer surface of the pipe was covered with non-woven fabric to prevent the intrusion of sand into the pipe. Figure 5 a) shows the changes with time in the observed groundwater level and the daily rainfall obtained from AMeDAS.

From this graph, the tendencies of increase/decrease in daily rainfall and in groundwater level roughly agree. For example, the groundwater level observed on 18th June is the highest in the observation period, and a rainfall of about 30 mm/day was observed on the day before 18th June. Figure 5 b) shows the water level inside the reinforced soil wall estimated from the maximum and minimum groundwater levels measured in the bore hole (Figure 5 a)). If the crown of coping concrete is assumed to be at the design height when the observed groundwater level is the highest (EL=433.15m) during the measurement period, the groundwater level inside the reinforced wall could be estimated at the height of about 1.7m lower than the observed groundwater level. Because of this groundwater level, it was possible that the saturation for most of the soil in the reinforced region was high.

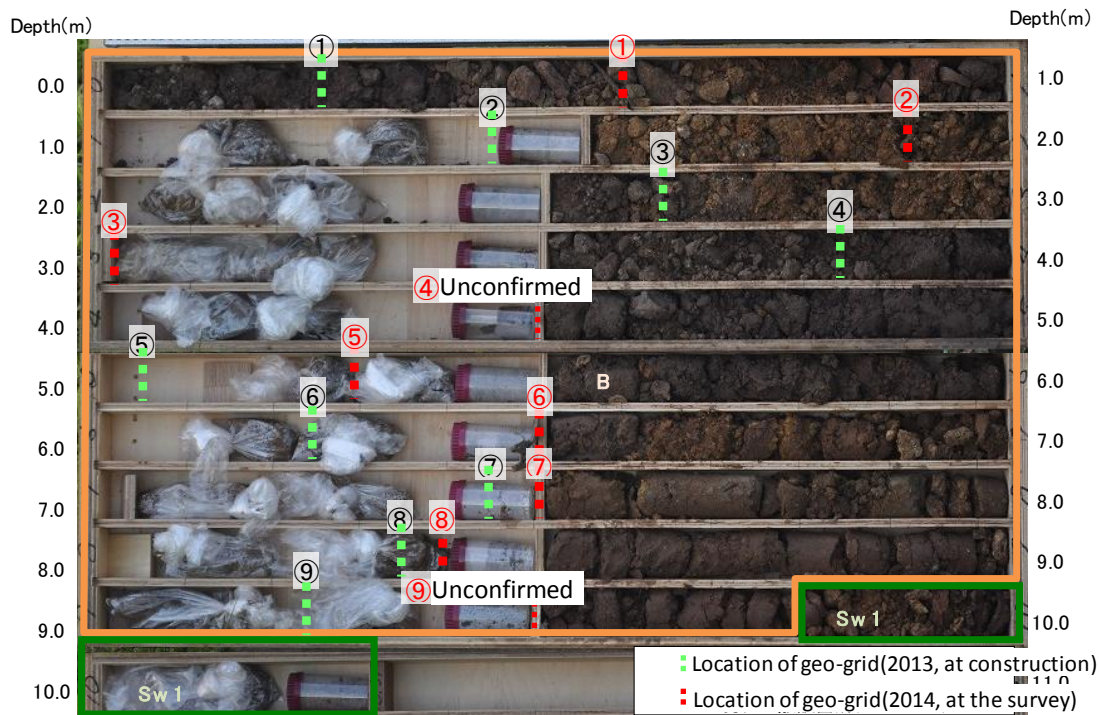
Figure 6. Settlement of the reinforced soil wall with time, and rainfall records.

Figure 6 shows a photo of the sample bore core. In this photo, the depths of laid reinforcing material at the sampling are indicated together with the design installation depths of the reinforcing material. The broken green line shows the location of reinforcing material installed at construction. The broken red line shows the location of the reinforcing material identified in this survey. The difference between the location at construction and that at survey (the depth of the broken green line minus the depth of the broken red line) is the subsidence, which was 25 - 45cm in the layers at the depth of 6m and shallower, and about 5cm at locations deeper than 6m. This showed that the embankment subsided in the short period of one and half years after construction was completed.

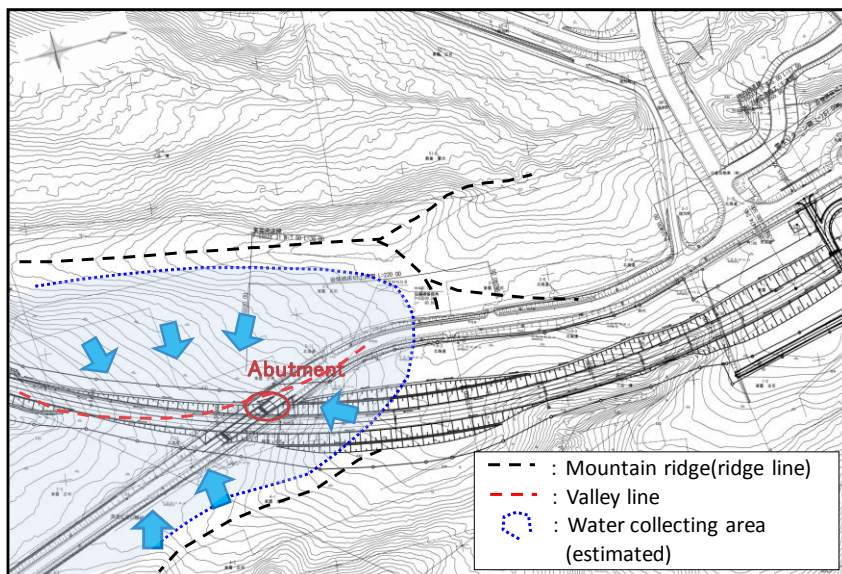
Figure 7. Topography of the land behind the reinforced soil wall.

Figure 7 shows a topographic map and the catchment of the area that includes the reinforced soil wall. The area at the back of the reinforced soil wall is land with gentle hills (a meadow), and the shape of the site where the reinforced soil wall was constructed is a concavity that collects rainwater and snowmelt down toward the abutment (reinforced soil wall). The reinforced soil wall in question was constructed in a shallow valley whose shape makes water tend to collect there. It was found in the boring survey that the bearing stratum for the reinforced soil wall and the abutment was weathered shale with low permeability; therefore, the rainfall and snowmelt water from the hilly area, which was higher in elevation than these two structures, was estimated to flow down toward the abutment (and the reinforced soil wall) through the ground over the weathered shale with low permeability (Figure 8). The factors described above are thought to have contributed to the increase in the degree of saturation inside the reinforced soil wall at times of rainfall and in the snowmelt season.

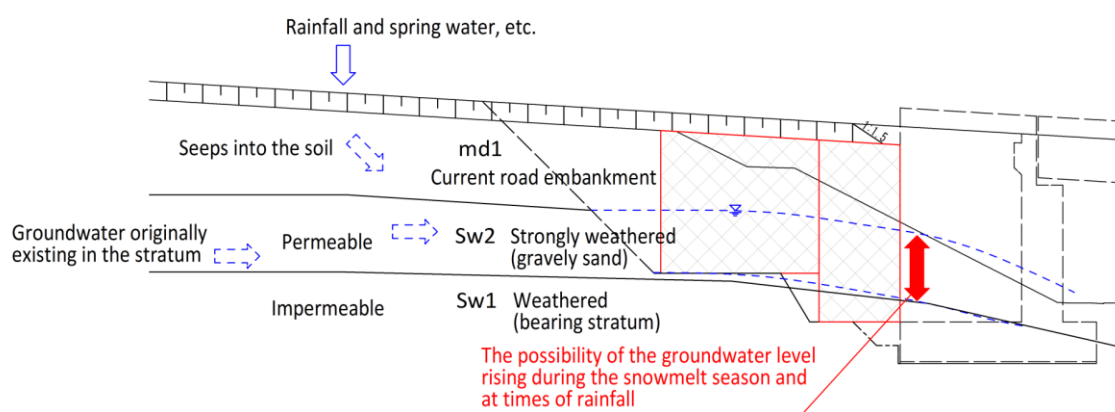
Figure 8. Concept of movement of seepage water toward the reinforced soil wall.

The reinforced soil wall was constructed in a small, shallow valley on a hillside whose shape made the site prone to collect water. The rainfall and snowmelt water from the hilly land flowed into the ground, over the weathered shale with low permeability, and into the ground through the boundary between the cut and fill sections toward the abutment. The embankment subsidence rapidly progressed after rainfall of about 70mm/day in late August 2013, which was immediately after the reinforced soil wall was completed, and in mid September 2013. The rapid subsidence was attributed to large amounts of rainwater having intruded into the reinforced region and raised the saturation of the embankment material in the reinforced region, which lowered the interlocking effect between the reinforcing material and the embankment materials. The soil pressure acting on the wall panels exceeded the design friction resistance when the friction resistance between the reinforcing material and the embankment material decreased from the increase in saturation and the delay in recovery of friction resistance, which were caused by the existence of a high fine fraction content in part of the embankment. It is inferred that, because of the factors described above, the horizontal and forward displacement of the wall panels increased with time and the subsidence of the embankment crown also progressed in the reinforced region.

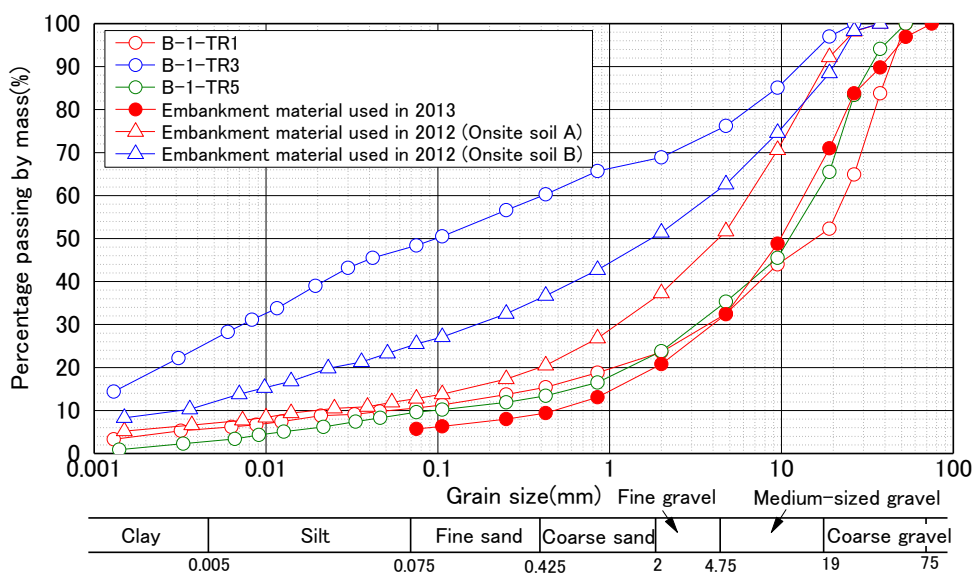
Figure 9. Grain size distribution curves of the embankment materials.

Figure 9 shows the grain size distribution curves of the embankment materials as clarified in the pre-construction survey. The fine fraction content of the embankment material was about $F_c=10\%$, which should raise no problem for the embankment material in a reinforced soil wall. However, material with a fine fraction content of nearly 50% was used at the depths of 5.30 - 6.14m (TR3) from the embankment surface from which the base course was removed.
