Condition assessment of a 30-year old pond liner

ABSTRACT: An acid containment pond, constructed in 1987 with an HDPE geomembrane liner is at the end of its functional life. A condition survey conducted in 2016 identified a very large number of damaged and deteriorated locations. Prior to exhuming the geomembrane preparatory to replacement, a program of sampling and laboratory testing was conducted to quantitatively assess the liner condition. The test results were assessed with regard to their serving as an indicator of the deterioration, and by extension, the remaining functional life. The determination of index and ageing-related

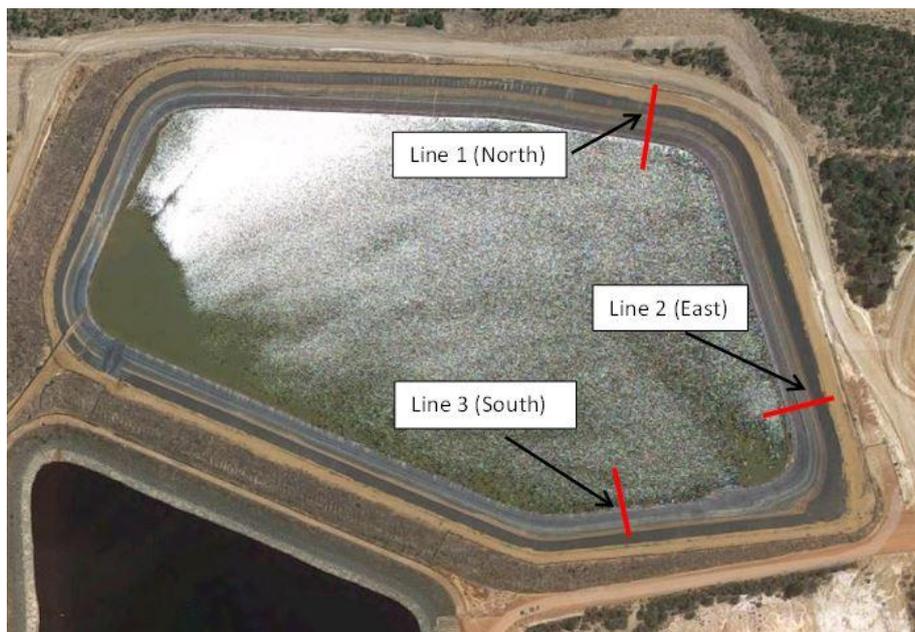
Figure 1. Pond SEP2A

Pond SEP2A is shown on Figure 1.

Figure 1 also shows the locations of the sampling lines in SEP2A (dated photo - pond is currently near empty). Although difficult to make the distinction from the test data, it should be noted that in the southern hemisphere, the exposure of the liner on the south (north-facing) slope will be more pronounced than on the other sides. This is discussed further in the evaluation of the test results.
