The effects of the 2016 Kumamoto earthquake on multi-anchored reinforcement wall

Takeo Hayashi, Shinji Nakamura & Takeharu Konami
Okasanlivic Co.,Ltd., Japan

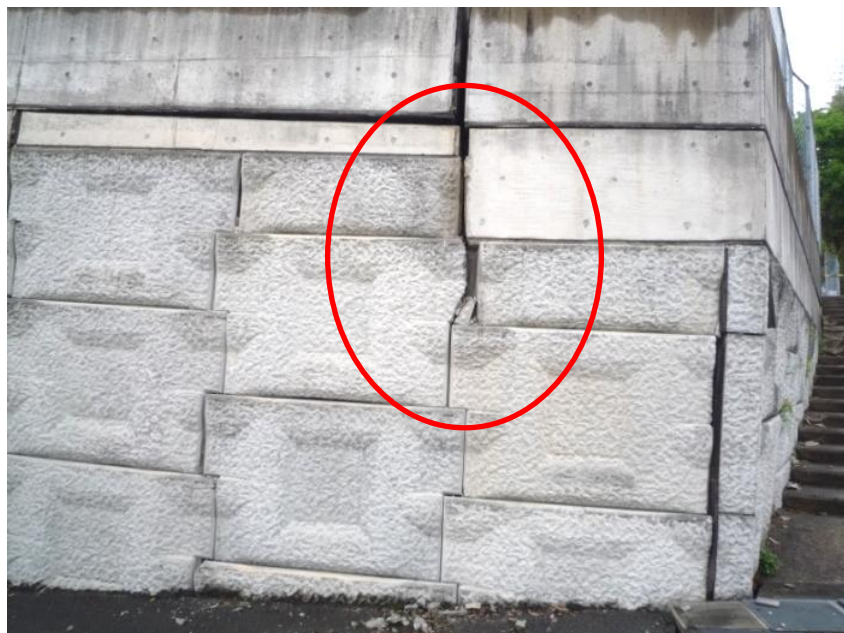
Figures 2–4 show the opening or gap separating two panels. All this damage was detected on MARWs that have a bend section. The greatest distance between two panels was approximately 7 cm. Typically, the initial distance is 1.5 cm. This damage does not cause soil leakage from the MARW immediately because there is non-woven fabric (30 cm width) between and behind the two panels.

Figure 2. Gap separating two panels

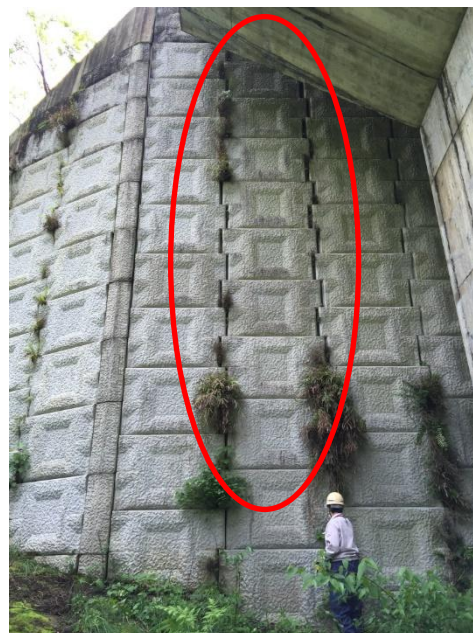
Figure 3. Opening two panels (1)

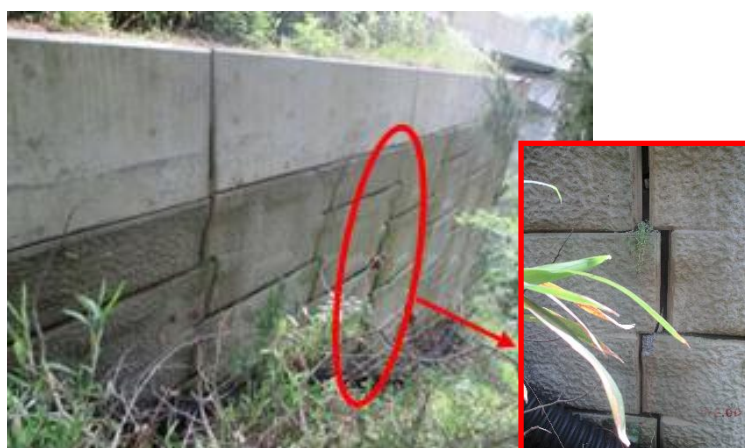
Figure 4. Opening two panels (2)

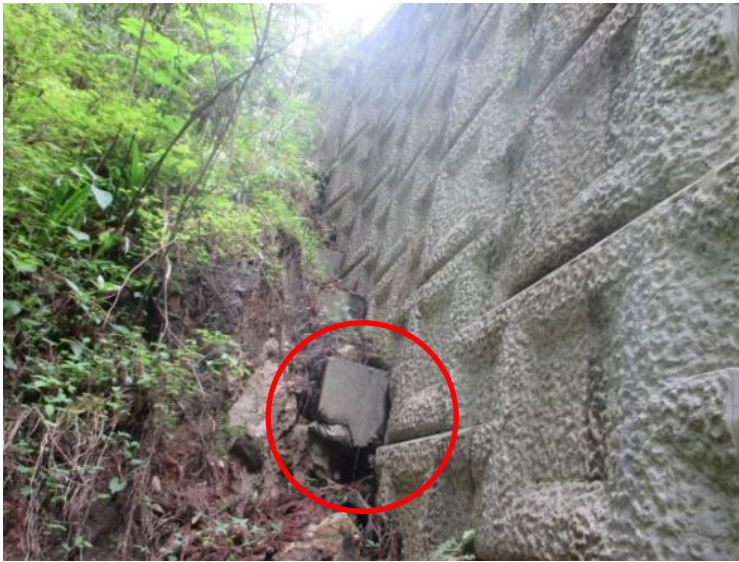
Figure 5 shows scouring of the soil under the foundation of the panels. In this case, the cavity was found at the bottom of the foundation on the slope. This damage probably occurred because of flowing water when it rained, and not from the earthquake.

Figure 5 Scouring under foundation

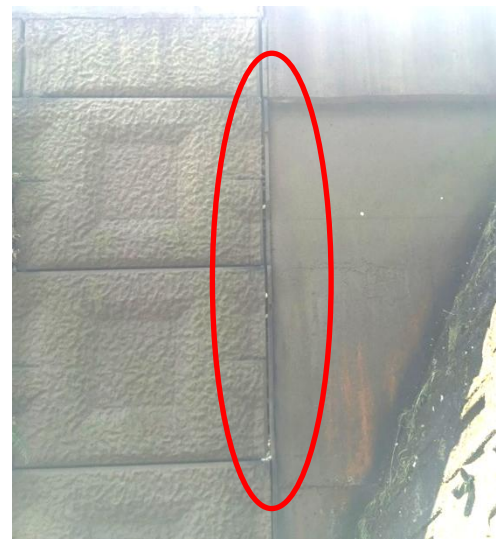
Figure 6 shows an opening between the panel and the adjacent structure. The width of this opening was 3 cm. It is unlikely that the soil leakage occurs constantly as long as the width of this opening does not increase.

Figure 6. Elongation between panels and adjacent structure
