Reinforcement of an old retaining structure using soil containing fine particles and multifunctional geocomposite

Alain Nancey & Anna Le Faouder

TenCate Geosynthetics France, France

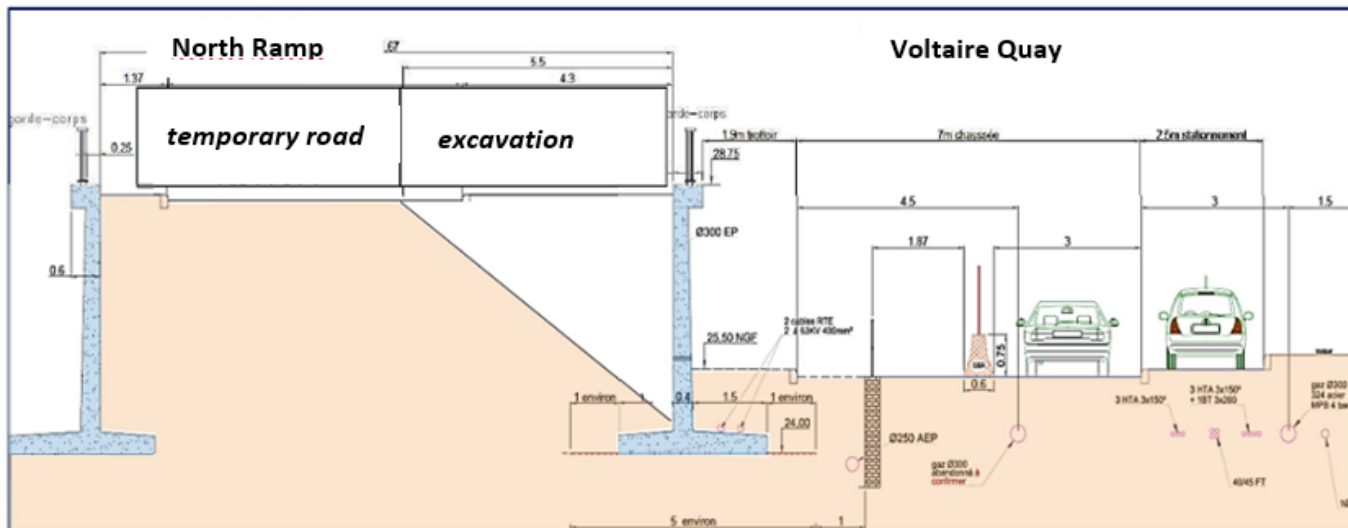
Figure 1. Typical cross section during the temporary phase before reinforcement.

The access ramp is a road embankment 100 m long, confined between two concrete walls (Figure 1) based on a shallow foundation. The maximal height of the embankment reaches 5.4m at the bridge level. The ramp is separated from the bridge by an expansion joint.

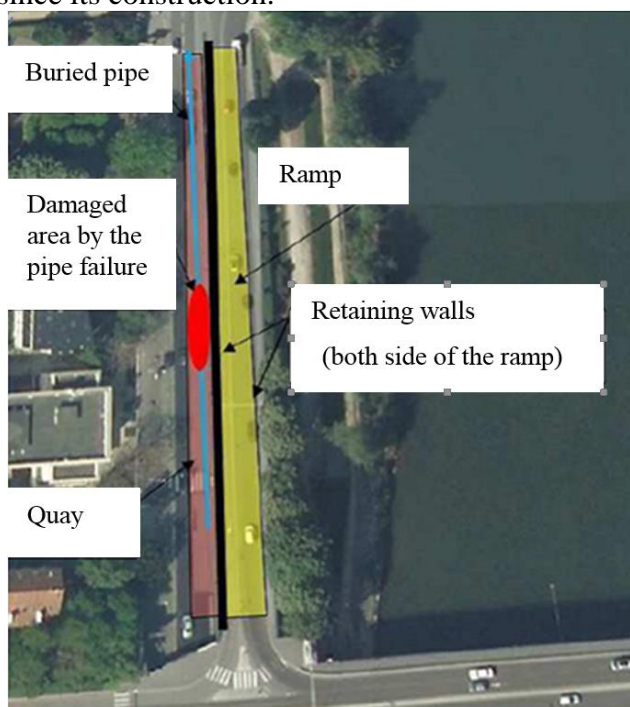
Figure 2. top view from the ramp and the bridge.

The first sign of damage was a pavement subsidence, subsequently revealing a leak of a buried water pipe beneath the “Voltaire” quay, situated along the ramp on the side opposite to the river (Figure 2). Further investigations show disorders partly hidden by the facings of the wall of the reinforced concrete wall. Alignment breaks have also been noticed on the equipment along the access ramp (guardrail, cornices ...), cracks in roadways, transverse and horizontal offsets on the facing of the retaining walls.

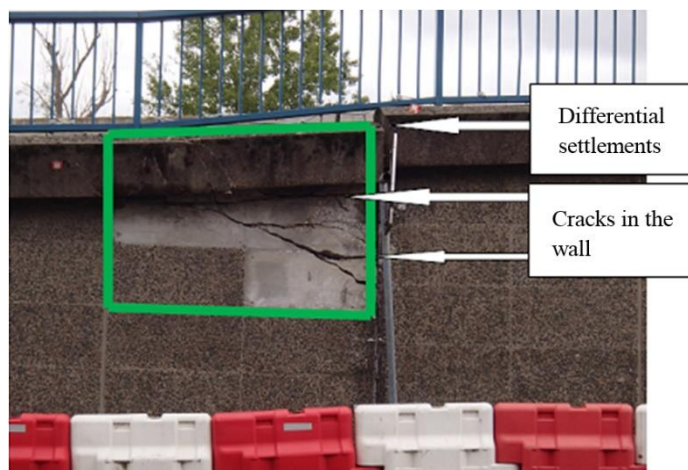
Figure 3. damages on the wall.

Due to the damages (Figure 3) seen on the retaining wall separating the ramp from the quay, it was decided to remove the earth pressure applied on the wall by an excavation. Consequently, the traffic was limited on one part of the ramp until the full reinforcement of the structure.

The water leakage contributed to settlements by washing the fine particles from the ground and reducing the bearing capacity of the wall foundations. This provoked the tilting of the wall against the adjacent wall section that shall support loads normally carried out by the foundation. This overloading may disturb the general equilibrium of the wall and induce further displacements and deformation.

To limit the load carried out by the concrete retaining wall, the solution chosen was to rebuild a self-standing reinforced embankment overall the 100m length ramp. A geosynthetic layer is installed at the base of each 50-cm fill layer on a vertical profile and are oriented in the perpendicular direction of the road. It covers all the width of the embankment. On each side the geosynthetic layers are wrapped around, confining totally the fill material and avoiding any earth pressure on the existing and remaining masonry. By consequence, the concrete walls are not a retaining structure any more but become just a component of the facing.

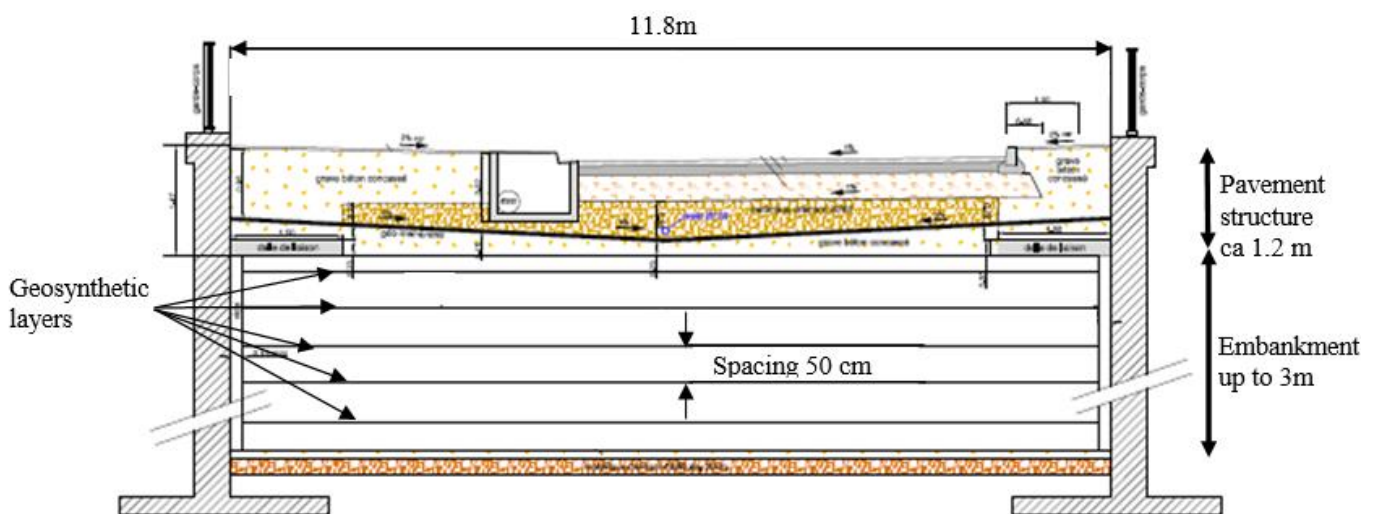
Figure 4. Typical reinforced cross section.

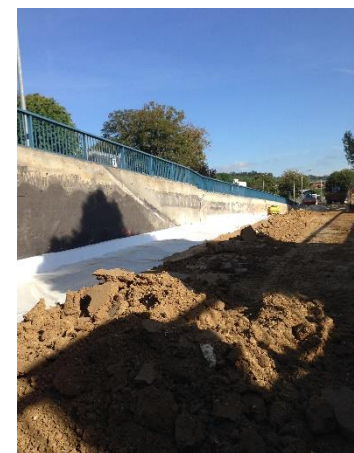
Grain size distribution of the different samples are reported on Figure 5 showing also limits defining frictional fills and fine-grained fills (Lawson 2005). This light brown clayey gravel seen on figure 6 and taken from the old embankment, is exactly in the overlap zone between frictional and fine-grained fills confirming that this material could be frictional and moisture sensitive. That means that it was possible to use it as a fill material on this site but taking care of the water content during installation and compaction of the material.

Figure 6. fill material on site.

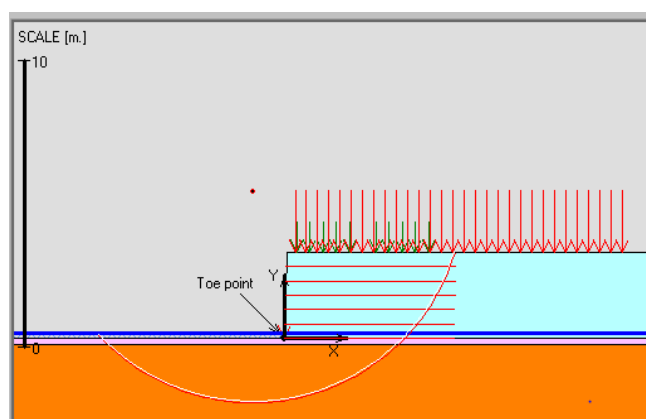
The structure checked in the design, consists of a 3m thick reinforced fill in the critical cross section with 6 layers of geosynthetic. The 1.5m of material on top is taken as a permanent load of 30 kPa and a traffic load of 13 kPa was considered. A friction angle of 25° was taken for the fill material. The study was carried out with ReSSA(3.0) software following a calculation at failure. The compound stability, including deep seated failure is checked for slip circle using the Bishop method, as shown on figure 9. following the Eurocode 7 approach 3, partial factors seen on table 2, are taken on actions and materials. An overall safety coefficient of $F_s > 1$ is required to insure the stability.

Figure 9. critical slip circle showing the minimum required factor of safety.

Considering all these partial factors, a geosynthetic reinforcement having an ultimate tensile strength of 125kN/m provides the justification of the stability.

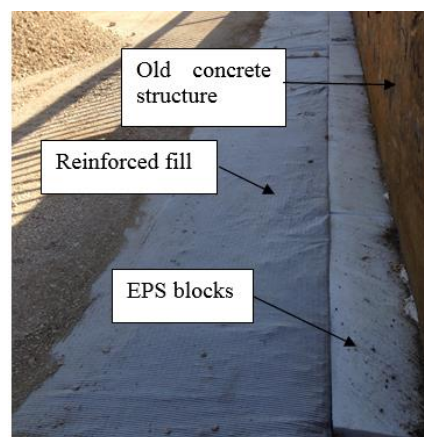
Figure 10. Junction between old concrete structure and reinforced fill

The reinforcement was installed with a classical wrap around method (figure 9) and a vertical spacing of 50 cm. EPS blocks have been used as a formwork between the reinforced embankment and the concrete structure, as shown on figure 10. This allows a good compaction of the fill (figure 11) on the whole area. The EPS blocks were removed after the completion of each compacted layer and placed upward for the following layer, creating a space between reinforced soil and the old retaining wall. The old masonry was then protected from any horizontal pressure coming from the embankment.

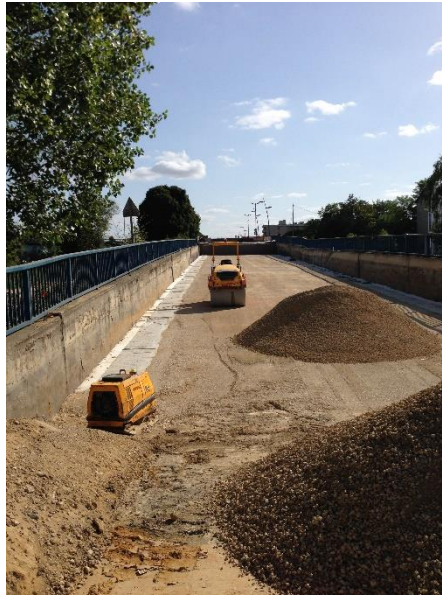
Figure 11. compacted layer before paved structure installation.
