Long term behavior and life expectancy of EPDM geomembranes installed in water reservoirs

ABSTRACT

This paper presents the long term behavior of EPDM geomembranes installed in 5 water reservoirs as well as in one experimental field in Spain.

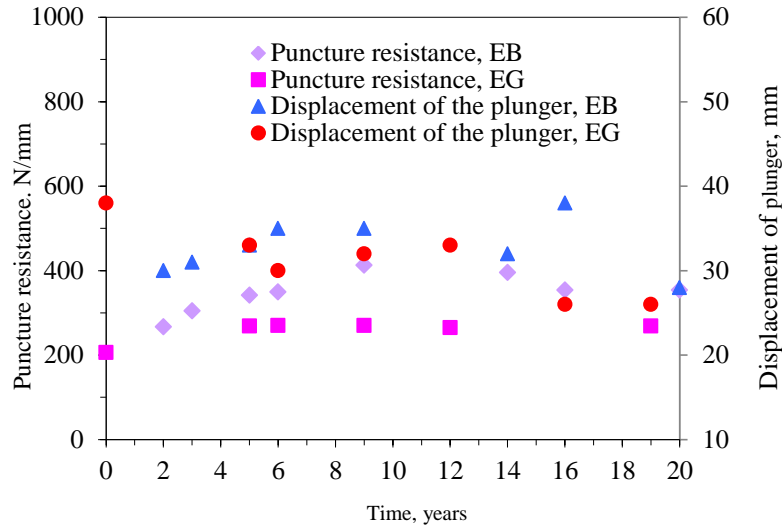
Over time, dynamic puncture resistance of exposed geomembranes increases. After only a few years of installation, the puncturing tool can be thrown from a height of 500 mm (required limit for thermoplastic materials) without damaging the samples, no cracks are observed in the impact area. This fact can be related to the increase over time of the reticulation of the macromolecules that is typical for this elastomeric material.

For this same reason, the static puncture resistance of the EPDM geomembrane samples tends to increase over time while the distance made by the plunger before break tends to decrease. The Figure 2 presents the evolution of the puncture resistance and the distance travelled by the plunger during the 19 and 20 years of the El Golfo and El Boqueron water reservoirs.

Figure 2. Evolution over time of the puncture resistance and displacement of the plunger before perforation of the El Boquerón and El Golfo water reservoirs

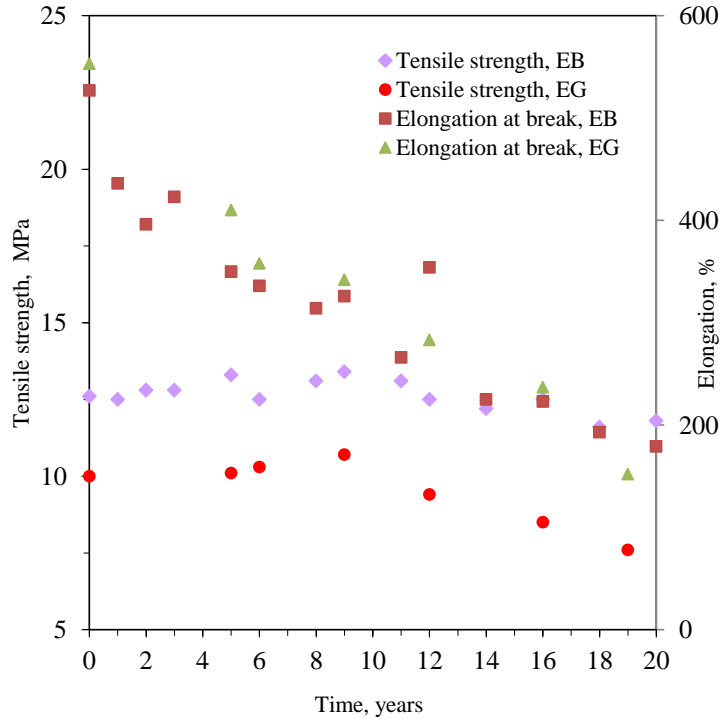
Figure 3 shows the evolution in tensile strength and elongation at break over the 19 and 20 years of the EPDM geomembranes installed in the El Golfo and El Boqueron water reservoirs.

It can be seen that in both reservoirs that the elongation at break decreases significantly over time. The decrease in elongation can be explained by the fact that, in the case of EPDM, during the oxidation phenomenon (induced by the temperature and UV exposure), the combination reactions of the carbon chains (cross-linking) prevails upon the cleavage reaction of the principal carbon chain (Kumar et al., 2004). Consequently, a decrease in molecular mobility and an increase in molecular mass can be seen (Kumar et al., 2004). These reactions are similar to the process of curing used during EPDM geomembrane production.

The values of the tensile strength at break undergo a slight increase over time due to the continuation of the vulcanization process after the geomembrane production. Nevertheless, after some years, we can observe a decrease of those values. While this decrease is pretty low after 20 years in the El Boqueron water reservoir, it is more important in the El Golfo water reservoir. This decrease of tensile strength could be related to the degradation of the polymer that induces its fragmentation.

Figure 3. Evolution of tensile strength and elongation at break over time of EPDM geomembranes coming from El Boquerón and El Golfo water reservoirs.

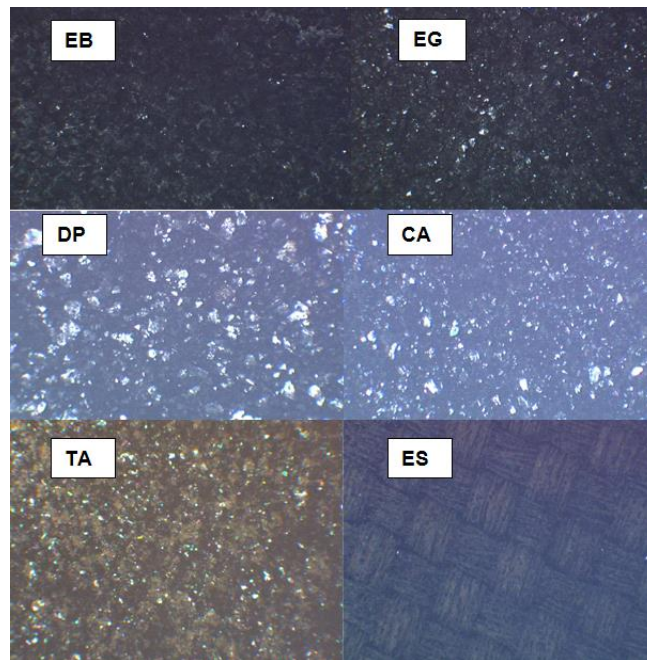
The optical reflection microscopy shows that the surface of the geomembranes is homogeneous and uniform. The samples extracted in the experimental field 'El Saltadero' show a grid path on the surface related to the separation fabric used in the vulcanization process during the production. The geomembrane itself is homogeneous.

Figure 4. Microphotography (40x) of the exposed face of the EPDM geomembranes after 11 years of installation by optical reflection microscopy.

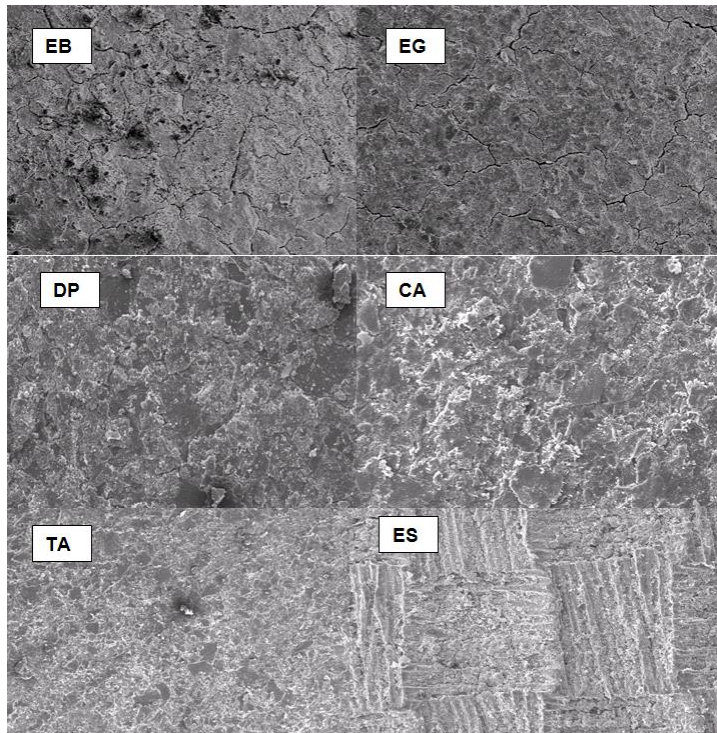
Scanning electron microscopy shows superficial aging of geomembranes being more pronounced in the samples coming from 'El Boqueron' and 'El Golfo' where micro cracks are detected.

Figure 5. Microphotography (90x) of exposed side of EPDM geomembranes after 11 years of installation by scanning electron microscope

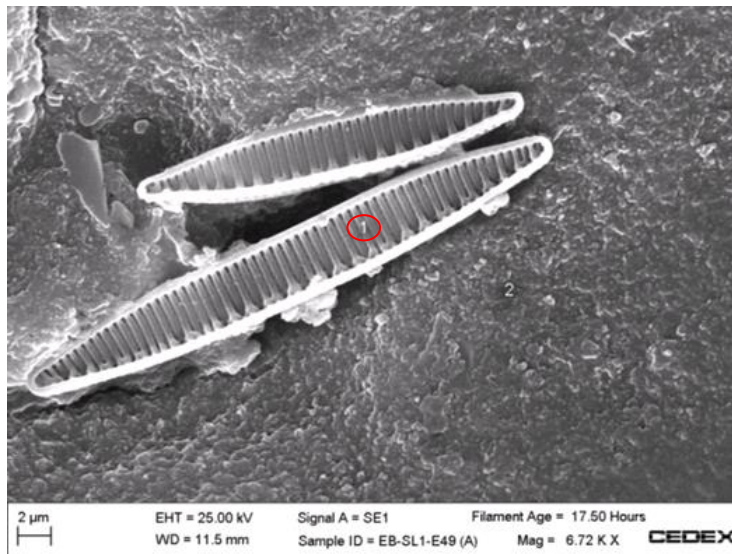
Microalgae identified as diatoms were observed by scanning electron microscopy. After the disappearance of the microalgae, its cellular walls are settled on the geomembrane, especially on its micro cracks. After an X-ray microanalysis it was confirmed that they consist of 100% silica (Point 1 of figure 6).

Figure 6. Silica walls of diatoms in the 'El Boquerón' water reservoir after 21 years of installation.

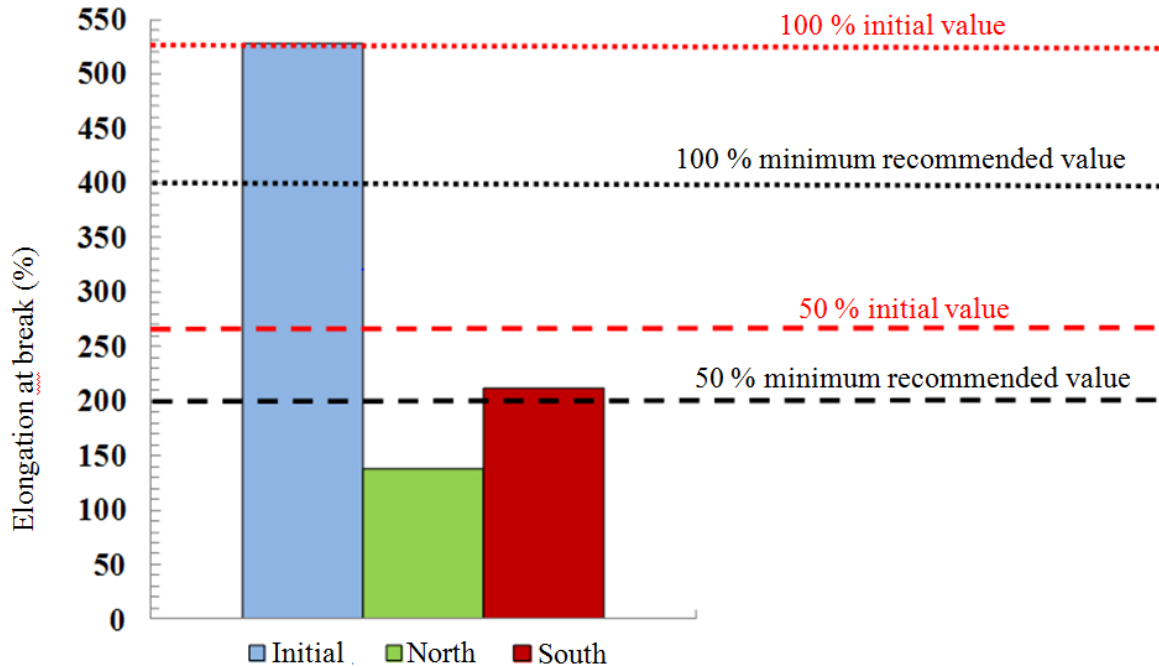
Following the previously mentioned criteria of 50%, a graphic has been done (Figure 7) for the water reservoir ‘El Boqueron’. The figure shows the values of elongation at break of the geomembranes at north and south embankments, 21 years after installation and the values corresponding to 100% and 50% of the initial elongation (527% and 263.5%) and the values corresponding to 100% and 50% of the minimum recommended elongation for new EPDM geomembranes described in the Manual of Water reservoirs (MARMA 2010), respectively 400% and 200%.

In this specific case, we can see that after 21 years of exposition, the elongation at break of all embankments is below the criteria of 50% of the initial elongation value.

If we consider the value of 50% of the minimum recommended elongation for a new EPDM geomembrane, the North embankment doesn't accomplish this criterion after 21 years of exposition and the South embankment is very close to this value of 200%.

Figure 7. Initial elongation at break and after 21 years of installation of the geomembrane at 'El Boqueron'
