Remediation and reinforcement of embankments for flood protection

ABSTRACT: Big floods in Croatia in 2014 induced the analysis of flood protection system and remediation measures of embankments after flooding. This extreme hydrological phenomenon was higher than design criteria for flood protection system. The result was many defects on embankments and the largest were two breaches. High water levels caused piping in foundation ground and hydraulic breakdown in the area between trench and embankment base. Optimal was proved an interactive design approach executed parallel with the construction. Bad weather conditions during the remediation and clay with high water content at the site required a modification of design. After analysis was selected solution with reinforced soil using clay as it is on site. Embankment remediation with using reinforced soil was quickly implemented and less sensitive to bad weather conditions. During construction monitoring equipment was installed to keep track of construction and for forecasting and warning about embankment behavior during flood defense. In this paper the behavior of reinforced embankment is analyzed. The aim is a better understanding

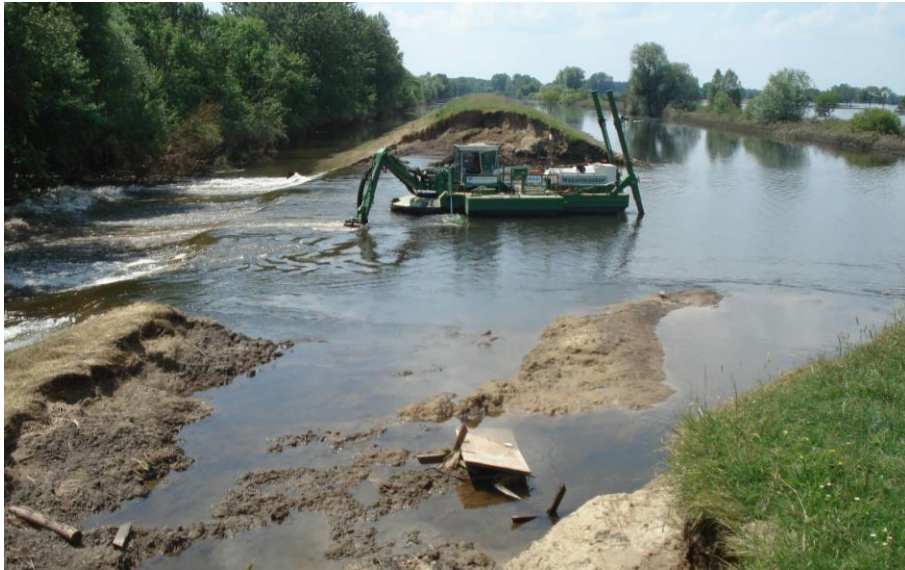
Figure 1: Levee breach in village Račinovci

Levee breach occurred in May 2014 when the water level of the Sava River was approximately 50 cm below the levee crest. During the period of April and May 2014 was an extremely rainy season (DHMZ, 2014), water was in inundation for a long period and the ground was saturated. High water levels caused the back erosion of sand in the foundation ground below the levee and hydraulic breakdown of soil in the area between landside canal and levee toe.

At the location of landslide on levee slope (Fig.2) fast intervention measures with line of thirty 8 m long wooden piles driven in an hour prevented levee breach. But by that time on the second location, few hundred meters away, levee started collapsing. Before the collapse on the levee two vertical cracks were formed and levee body began to sink. Lowering of levee

opened the way for overtopping. The water overtopped the crest and erosion of levee landside slope started.

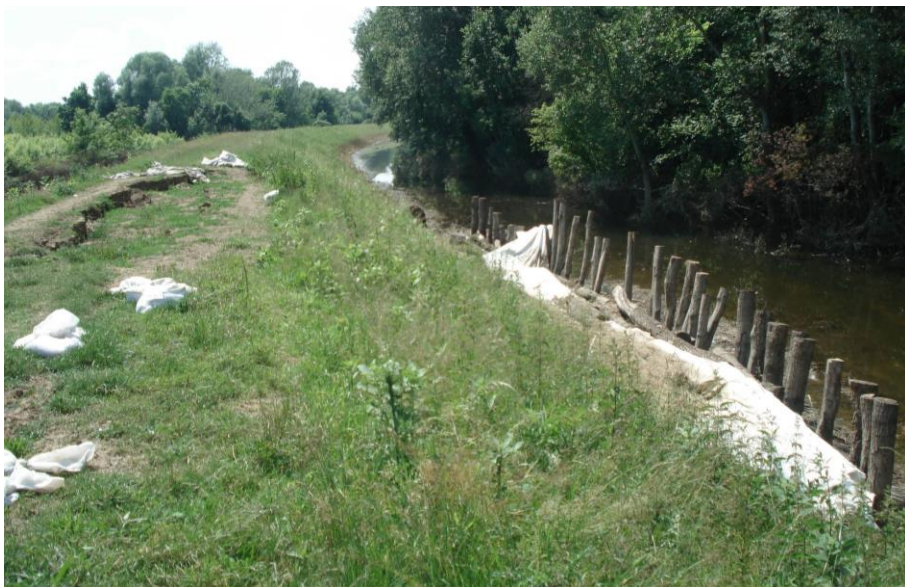
Figure 2: Levee landside slope sliding in village Račinovci

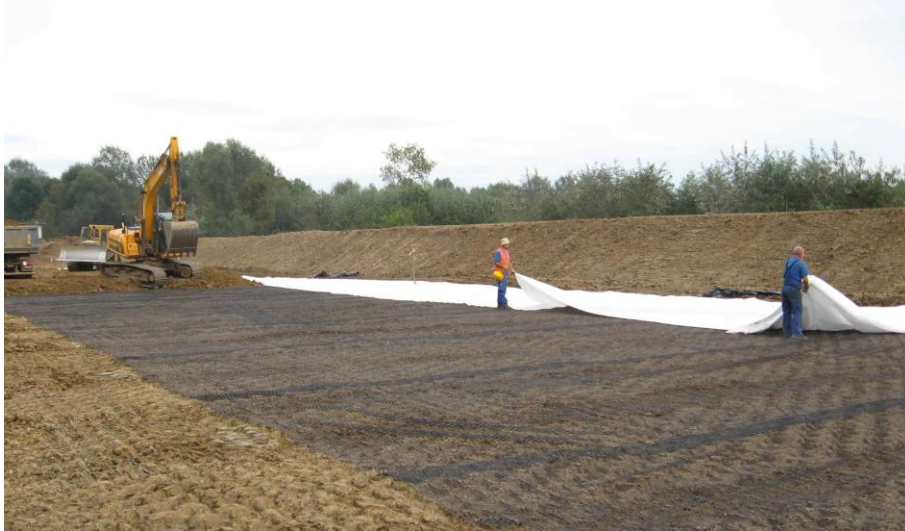
Figure 3: Second layer of reinforced soil and temporary levee in the background

This technical solution as an emergency measure proposed reinforced soil with geosynthetics. In this method, a levee or some other earth retaining structure is reinforced with geotextiles or geogrids.

Selected technical solution for the construction of earth structures reinforced with geosynthetics solved problem of reduced shear strength of clay with high water content installed in extremely rainy period with reinforcement by geosynthetics and problem of increased settlements was solved by overfilling design profile by some 50 cm. After the period of one year of levee consolidation, it was planned to make visual inspection, some in-situ investigation works and adjustments and if needed take off overfilled material and put a layer of humus and seed grass.

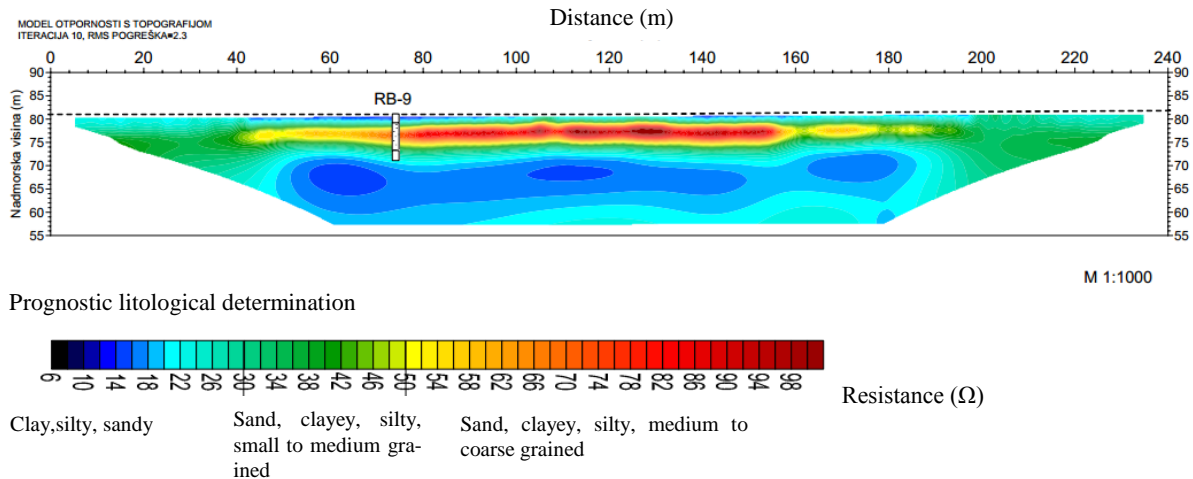
Geophysical methods consisted of seismic refraction, MASW and geoelectrical tomography. Geophysical profiles were drawn parallel and perpendicular to the levee at location of damage. Very useful in the interpretation of events during the collapse of the levee showed geoelectrical tomography (Fig.5). On selected profile, which was set parallel to the levee toe, was very clear to see anomalies on the location of levee breach. There was near surface layer of coarse sand with a minimum cover of top clay layer, which served for piping below the levee to canal on landside.

Figure 5: Geoelectrical tomography profile at levee breach

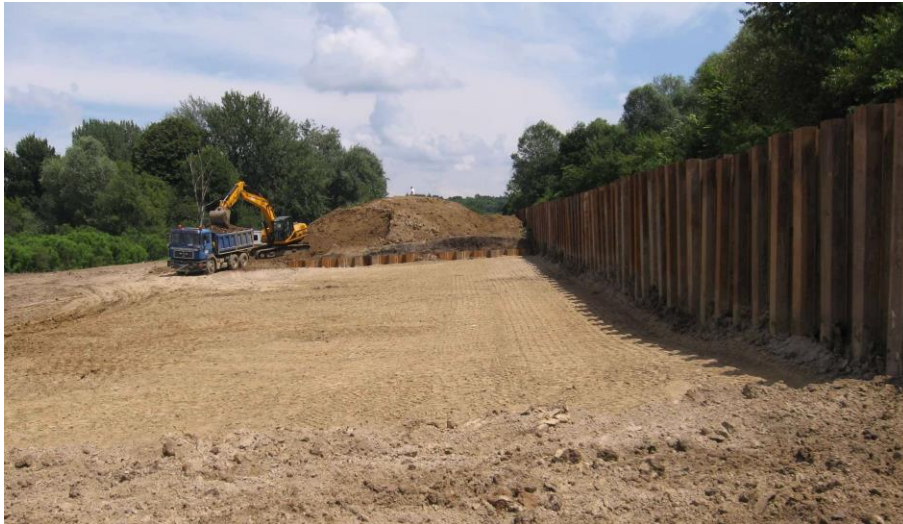
Figure 6: Sheet pile coffer dam at beginning of remediation

On location of the levee breach it was needed urgently to close opening in the levee and the ground was saturated and partly under water. It was waited to flood withdraw to river bed and immediately temporary sheet pile wall was made (Fig.6). The length of wall was about 120 m and 12 m long sheet piles were installed. It was used steel profile Larssen 604 and it was placed near to waterside toe of former levee. Temporary cofferdam had the function of protection against high water level up to same elevation of 84.15 m.a.s.l. Steel sheet pile wall was left in place after the levee remediation at the levee toe and has a watertight function in the foundation ground in the area of breach, as additional security.

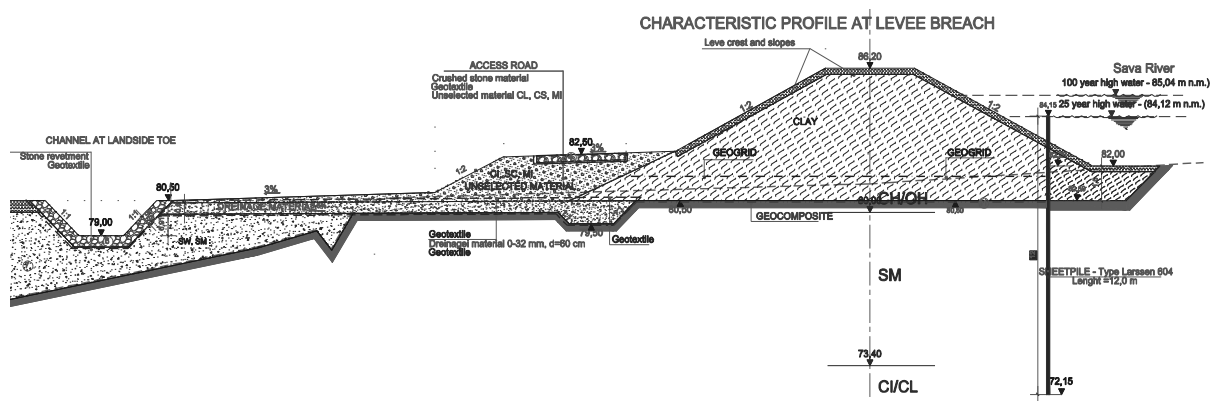
Figure 7: Characteristic profile of remediation at levee breach

On the location of levee landslides and breach levee was reconstructed in full profiles by filling clay materials in thin layers. On landside of levee first was formed toe drain from gravel material wrapped in geotextile and over the drainage berm is constructed from unselected material which functions as an additional load on landside levee toe (Fig.7). At a distance of approximately 10 meters from the new berm is existing channel Stružac. During remediation channel was again profiled, reconstructed and covered with layer of geotextile and crushed stone. In the section between two damaged locations waterside slope and crest of levee was reconstructed. Slope was cut in 1m high steps and filled back in thin layers with clay material. The new levee crest after remediation was designed on elevation 86.2 m.a.s.l., which is about 20 cm higher and is fitted with a smooth transition to the existing levee outside the remediation area.

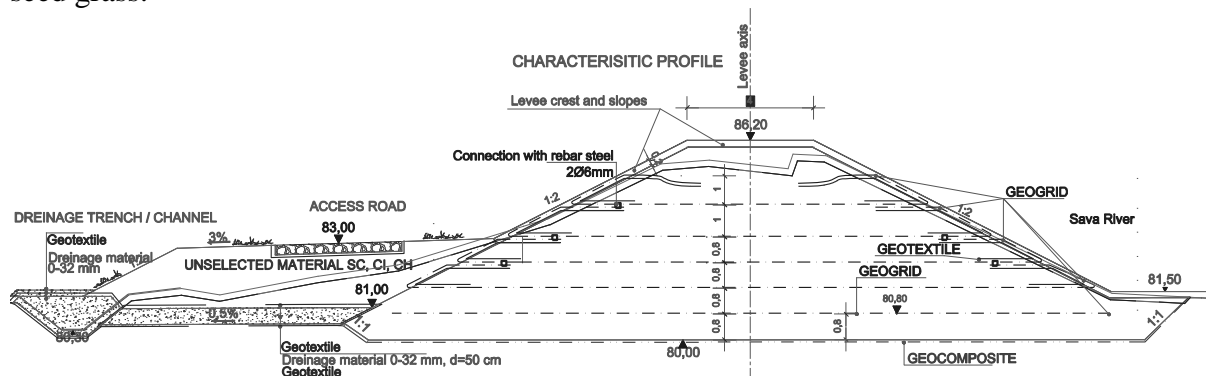
Due to high water content in clay material, as a result, during the construction of levees with such materials settlements are expected to be higher than designed and shear strength of clay is significantly smaller. It was not possible to rebuild levee to be fully functioned in flood defence system without additional measures. We analysed a number of different solutions that are needed to enable a simple as possible construction and to restore the flood protection system to its full functionality. After analysis it was chosen solution of levee reinforced with geogrids.

Figure 8: Characteristic profile of alternative solution

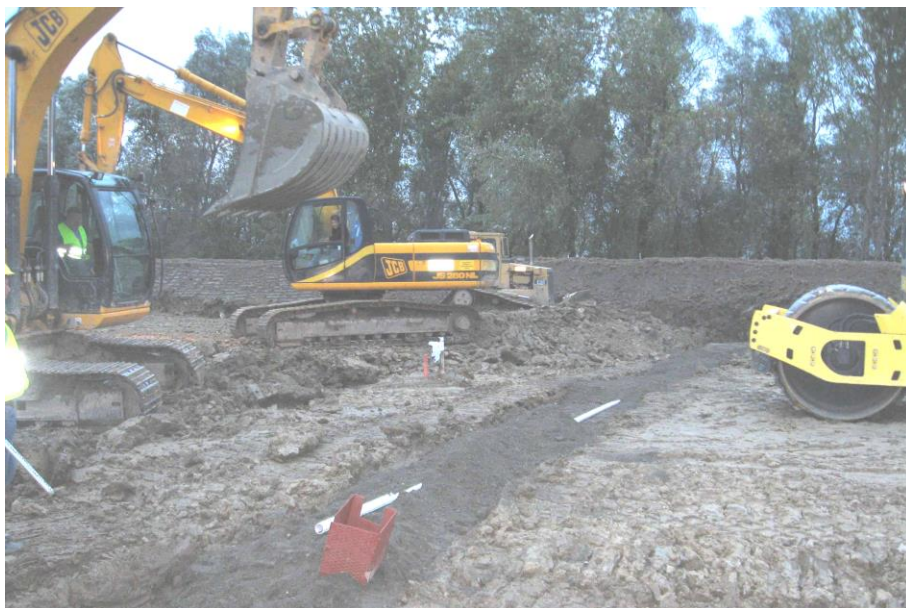
Monitoring involved using a system of horizontal inclinometer (Fig. 9), placed on the foundation soil before first layer, four piezometers and permanent geodetic points. A series of 10 measurements were carried out from September 2014 until December 2015, during which period of time high water level didn't occurred and only settlement after remediation were measured. Measured values corresponded to design calculations. It is planned to carry out detailed analysis and publish results as part of PhD thesis.

Figure 9: Installation of horizontal inclinometer
