# Evolution over time of PVC-P geomembrane used at Barlovento Reservoir

M. Blanco & A. M. Noval

This paper shows the evolution over time of the polymeric synthetic geomembrane (GBR-P) of plasticized polyvinyl chloride (PVC-P) installed in one of the reservoirs cited before, La Laguna de Barlovento reservoir.

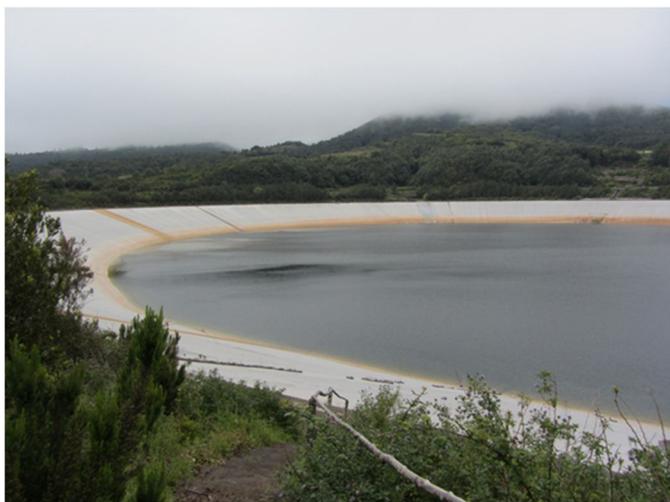
Figure 1. View of the PVC-P geomembrane of the La Laguna de Barlovento reservoir.

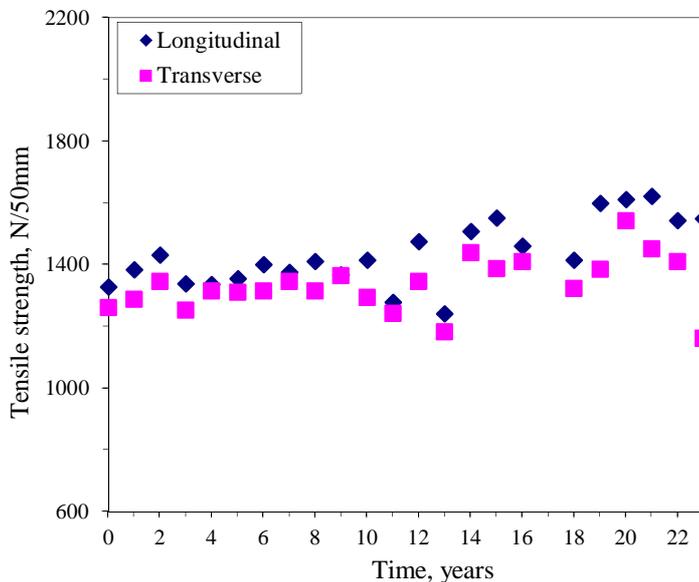
Tensile strength and elongation at maximum load values of the specimens collected in the north of the crest area are showed in Figures 2 and 3 respectively. Neither the elongation at break nor the tensile strength results did present significant changes over the 23 years of service. The good mechanical performance is due to the protection given by the PVC-P resin to the polyester scrim that is the responsible of the mechanical response in this reinforced geomembrane.

Figure 2. Tensile strength evolution over time.

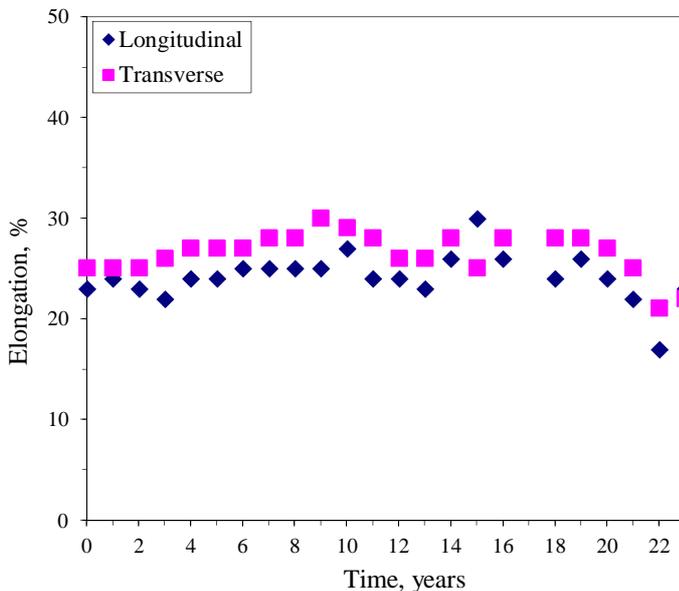
Figure 3. Elongation at maximum load evolution over time.

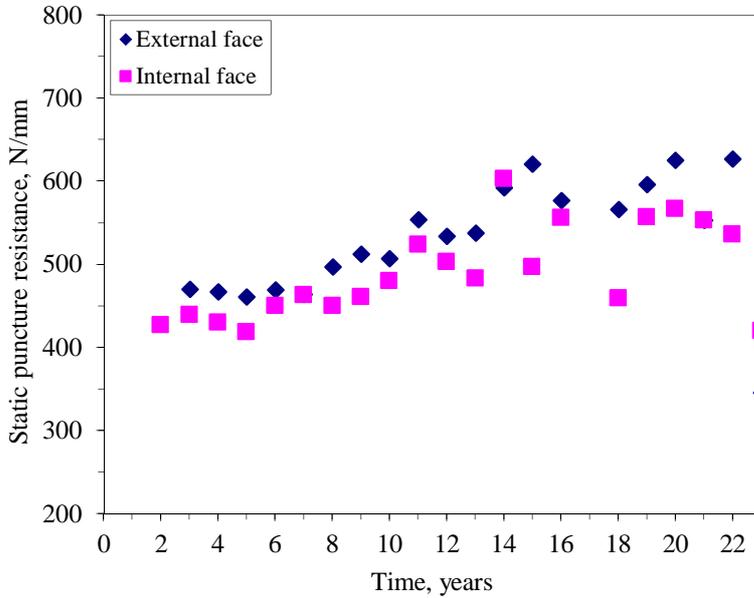
The performance in the static impact test is presented in Figures 4 and 5 where are showed the variation of the puncture resistance and the displacement of the plunger before perforation, respectively. Samples were collected in the norther slope of the crest area. Puncture resistance values are observed to increase over time, while displacement of the plunger before perforation decrease. These displacement values are comparatively small because of the polyester reinforcement. Nevertheless, in the last sampling, at 23 years, both characteristics decrease their values.

Figure 4. Puncture resistance evolution over time.

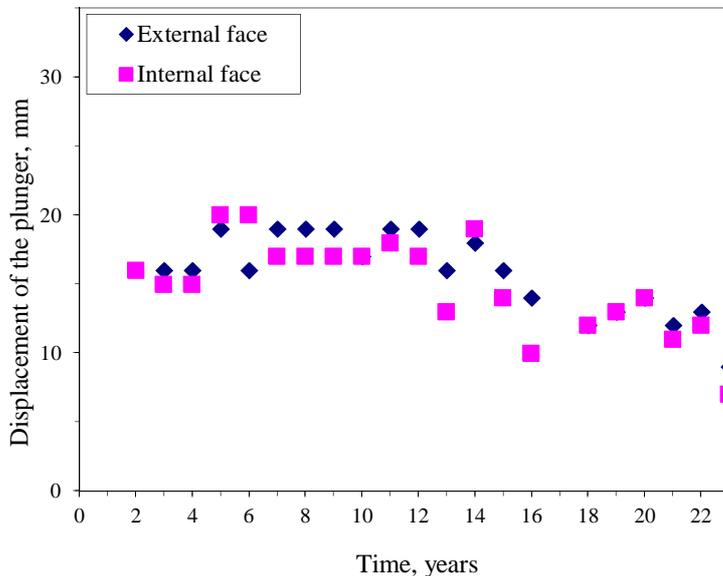
Figure 5. Displacement of the plunger before perforation evolution over time.

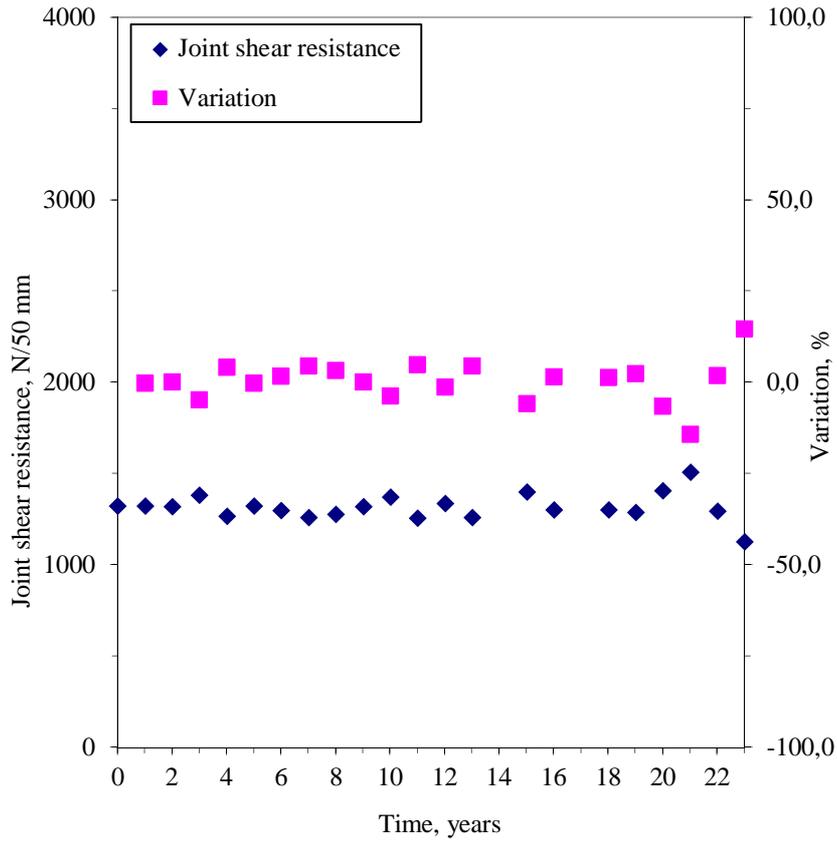
The results of the welding strength resistance test are correct, as all the specimens broke in the edge or close to the seam, but never through the seam itself. Test values of samples collected in the north of the crest area, are presented in Figure 6. In Figure 7 are presented the results of the peeling test of same samples. The high values obtained in this test, as a quantitative test, indicate the good execution of the seams.

Figure 6. Welding strength resistance evolution over time.

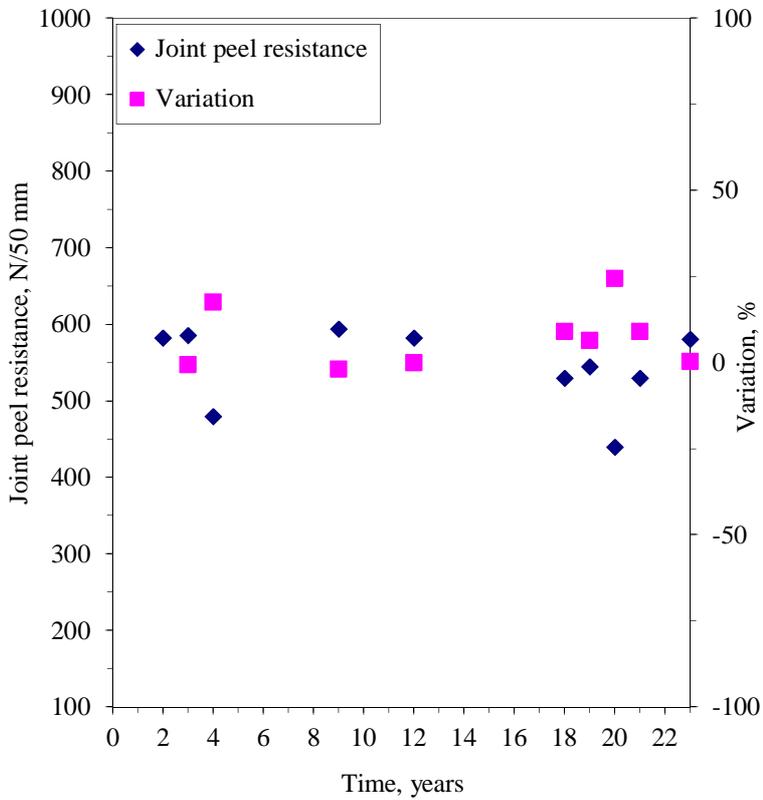
Figure 7. Welding peeling resistance evolution over time.

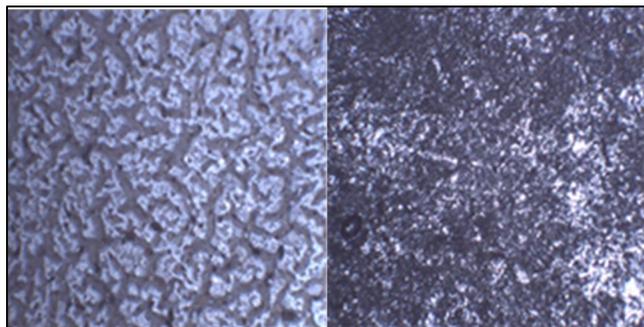
Reflection optical microscopy showed an external face with a high superficial cracking while the internal was in good state of preservation. The results obtained using scanning electron microscopy confirmed these observations.

Figure 8. Microphotographs obtained using MOR (x 40) of PVC-P geomembrane after 23 years of installation. External and internal face.

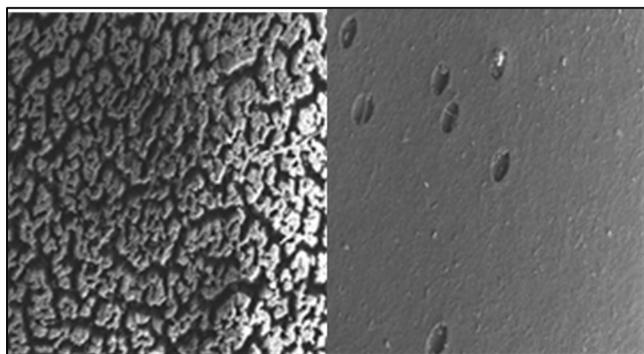
Figure 9. Microphotographs obtained using SEM (x 90) of PVC-P geomembrane after 23 years of installation. External and internal face.

Reflection optical microscopy same as scanning electron microscopy showed, after 23 years of service life, an external face with a noticeable cracking while the internal face showed a surface in good conditions with only some small craters.

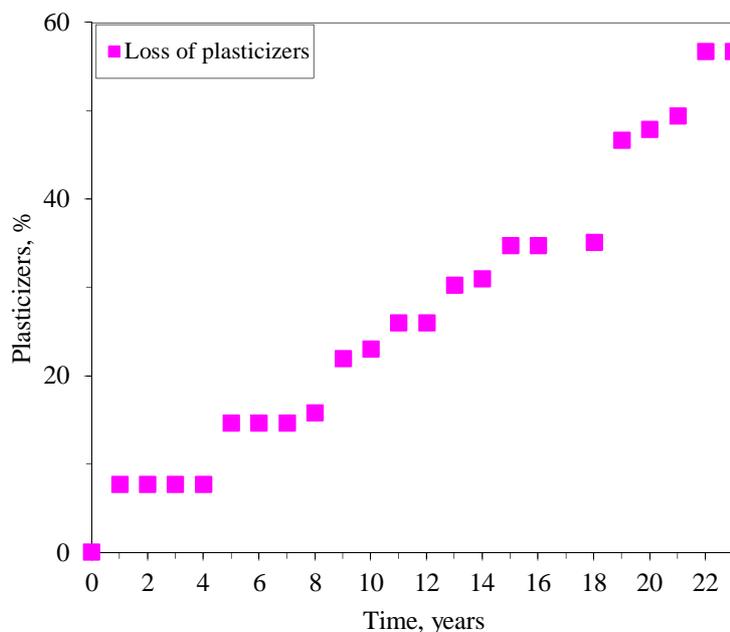
Plasticizers content determination of the initial geomembrane lead to a value of 35.1%. In Figure 10 can be observed the decrease of this value and the plasticizer loss in relation with the original value over the 23 years after its installation in samples collected in the north of the crest area. During the plasticizer extraction test, ethyl ether extract all the organic products with low molecular weight, so, not only plasticizers are extracted, but also other organic additives like UV absorbers, antioxidants and stabilizers among others. This fact has been taken into account in plasticizers content and plasticizers loss calculations (Giroud 1995, Giroud & Tisinger 1993).

Figure 10. Plasticizers loss evolution over time.
