Geosynthetic reinforced soil structure - problems faced and lessons learned. Case studies from Romania

2 BACK-TO-BACK GEOGRID REINFORCED WALL WITH CONCRETE BLOCK FACING

3 GEOGRID REINFORCED FLOOD PROTECTION DIKE

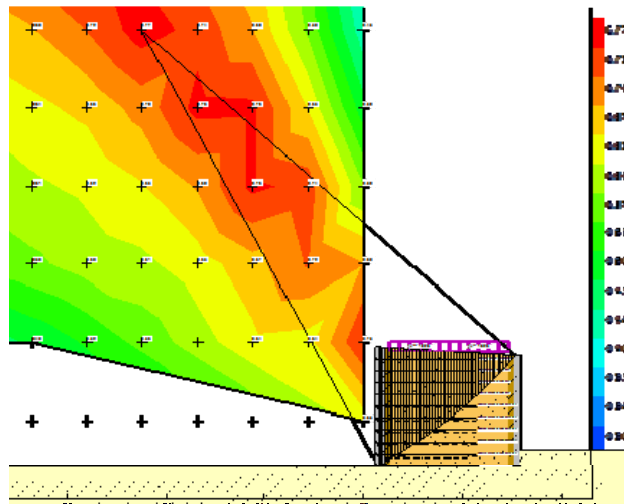
Figure 2 presents the results of the overall analysis (global stability) (Comment: the slip circle shown in Figure 2 doesn't show an overall failure, but much more an internal-type failure as it is only going through the reinforced fill and not through the backfill and subgrade soil), while figure 3 shows the results for the internal stability check using the two-part-wedge method.

Figure 2: Bishop's overall analysis - critical sliding circle, maximum utilization degree $\mu=0.77$ - calculation according to EN 1997-1 in design approach 1 combination 2 = design approach 3

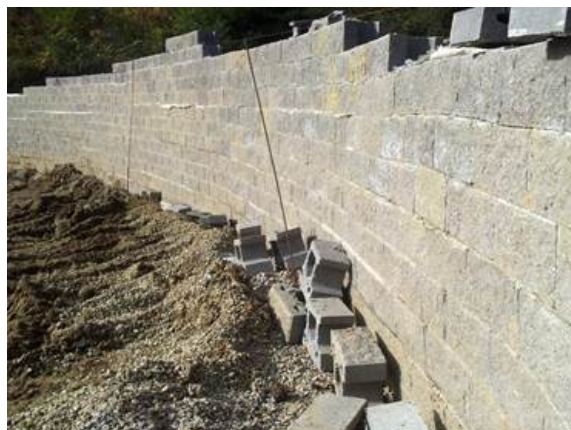
Once the construction was started (by a company without experience in this type of construction), the engineer who verified the project was informed that, as the ramp increased in height, bulging of the block wall facing appeared and some blocks were even falling (figure 4).

Figure 4. View of the structure during execution, showing fallen facing blocks

The non-conformities were so severe that could endanger the whole structure, which would have not been stable even to support its own weight, without any traffic loading on top, therefore the verifier recommended the demolition and a complete reconstruction of the ramp. The

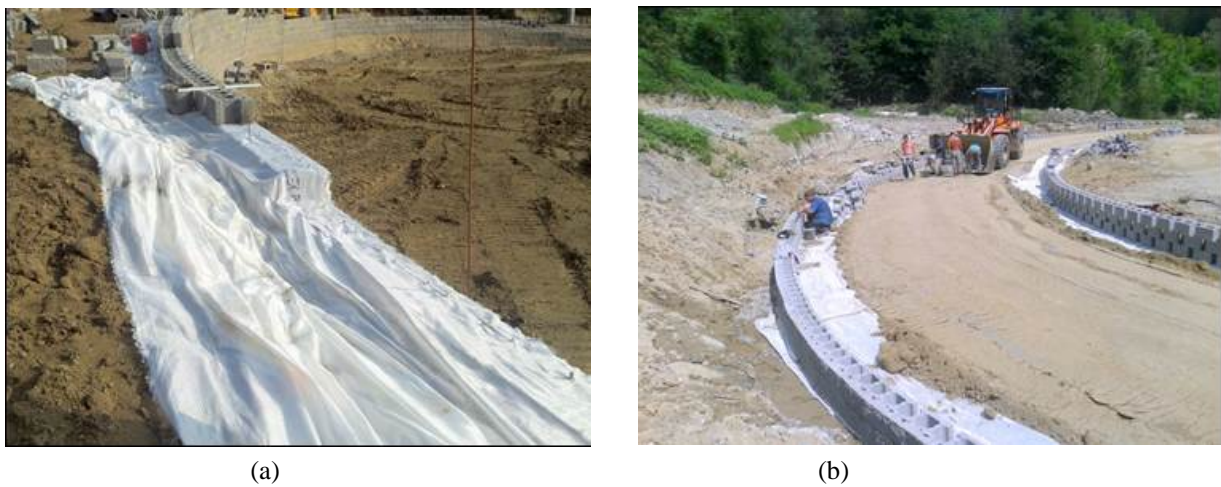
A woven geotextile was supplied and installed instead of the proposed geogrid (figure 5a). The geotextile provided a nominal tensile strength higher than required, but due to its structure without openings it couldn't interact with the fill material by interlocking; due to this reason there was also no sufficient connection with the facing blocks.

The fill material that had been used was a clayey soil, different from the one considered in the design (figure 5b).

Figure 5. Execution of the back-to-back wall (a) reinforcement material (geotextile); (b) fill material (clayey)

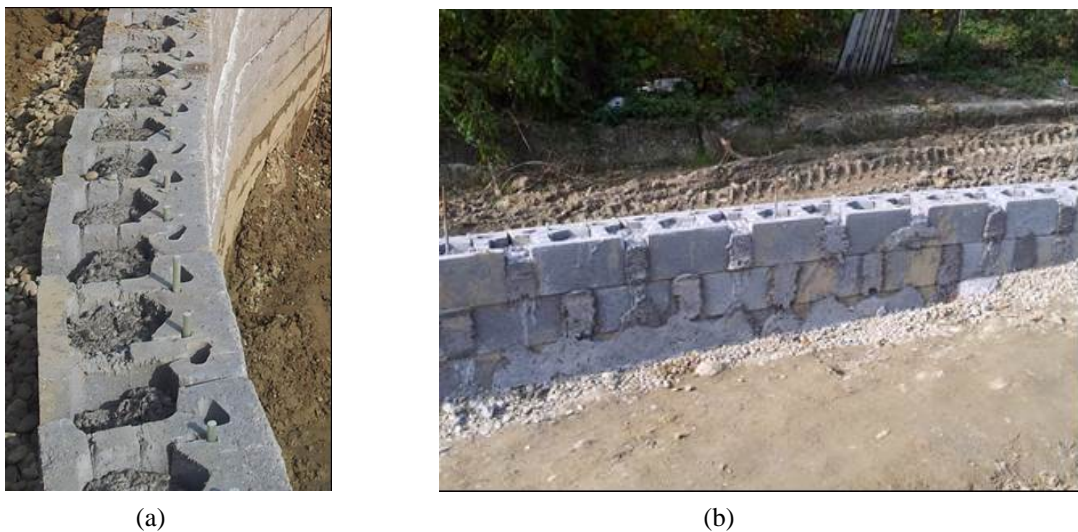
The drainage layer installed behind the block facing was not enough permeable (figure 6a). Proper drainage of the fill material is essential in order to avoid saturation with water and buildup of hydraulic pressure behind the facing.

The facing blocks were partially filled with mortar instead of gravel (figure 6b) (the gravel was meant to provide the connection between the reinforcement and the facing in case the proper geogrid would have been used).

Figure 6. Execution of the back-to-back wall – improper treatment of the facing (a) improper and insufficient drainage material behind the facing; (b) mortar filling between and partially inside the blocks

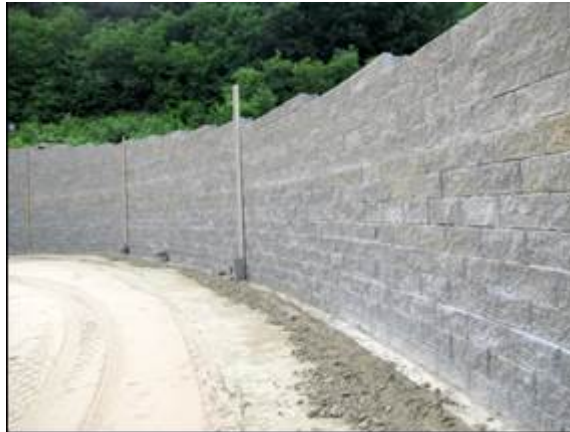
Figure 7. Rebuilt back-to-back reinforced wall with proper materials

ramp was demolished and rebuilt with proper materials under close technical supervision (see figure 7).

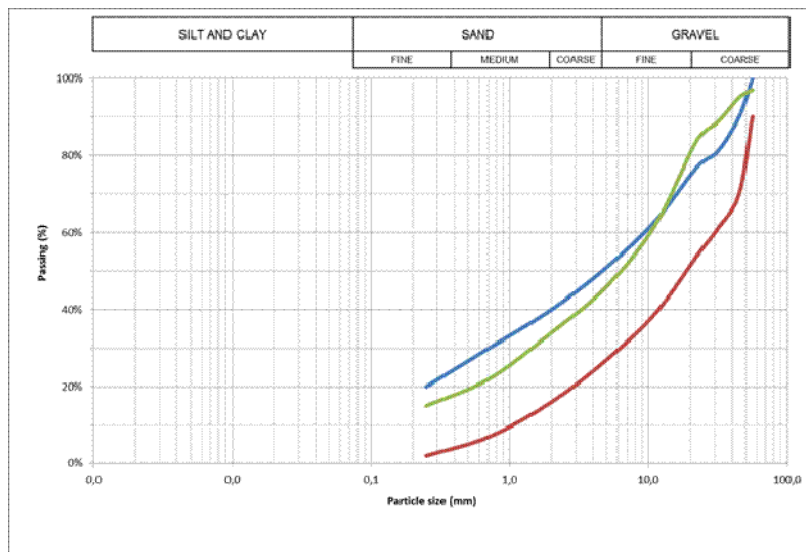
The granular fill material being used was well-graded aggregate, with a grain size distribution curve (represented in green on figure 11) fitting in the range recommended by the designer (red and blue curves in figure 11). As the fill material was supposed to have a higher friction angle than required by design, no stability issues were to be expected. But, the fill material also had more than 88% of the particles smaller than 31.5 mm, which is close to the width of the geogrid openings (73 mm x 30 mm), meaning that it was very easy for the small particles to erode through the openings of the geogrid in the absence of a geotextile installed behind the geogrid in the wrap around area (figure 12).

Figure 11. Fill material: recommended granular domain (between the limits represented by red and blue curve) and grain size distribution curve of the fill (green curve)

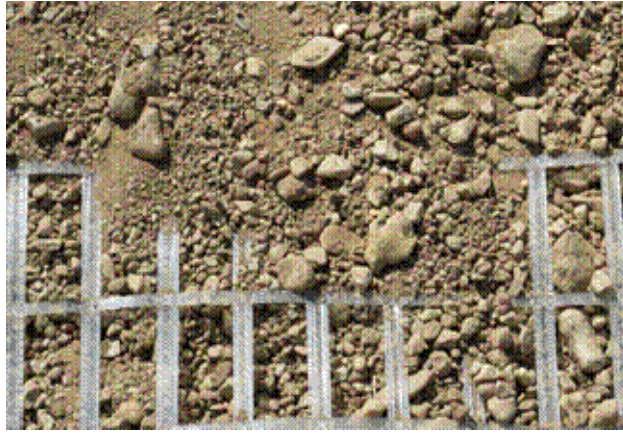
Figure 12. Fill material: more than 88% of the fill material is passing through the openings of the geogrid in absence of a geotextile

No geotextile or erosion control mat with very small openings was used behind the geogrid in order to prevent the migration of the small particles through the apertures of the geogrid.

All those problems were addressed by the designer who required the proper compaction on the last meter towards the edge of the dike using a manually operated vibro-compaction plate, the use of a thin non-woven geotextile behind the wrap around area of the geogrid on all the areas still to be constructed. It was also recommended that in the areas where the fine grained

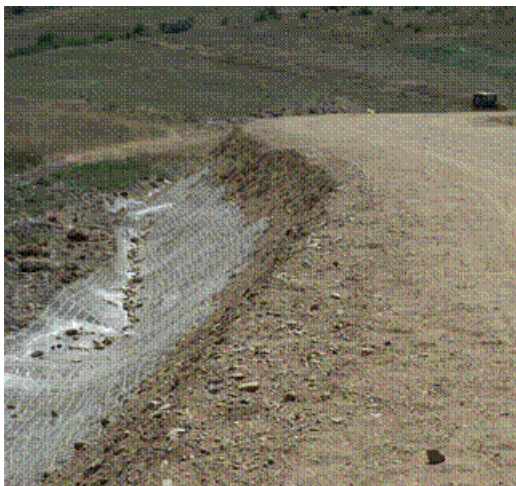
The compaction of the last meter towards the edge of the dike was not properly performed. In some cases the granular material near the edge was not compacted at all (figure 13a), while in other cases a heavy vibro-compactor was driven over the edge which is completely against the working procedures recommended for such structures (figure 13b). According to these procedures, the last meter of the fill material towards the edge must not be compacted with anything else but a hand operated vibro-compaction plate.

Figure 13. Execution: (a) improper compaction on the edge; (b) use of heavy vibro-compactor at the edge

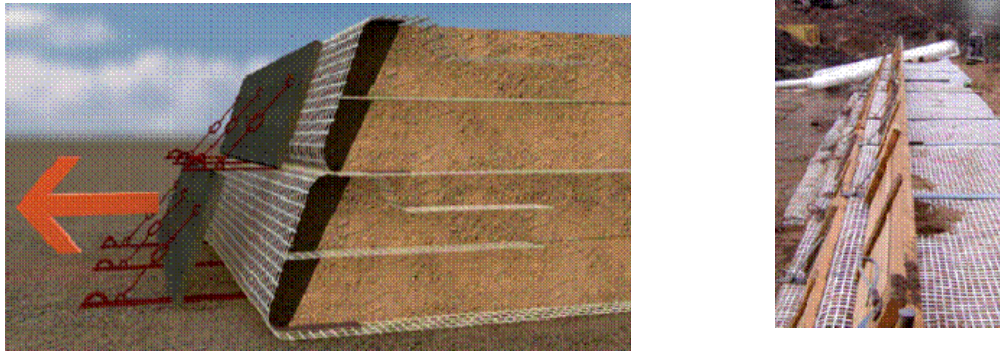
Another execution problem was that no temporary frame (as the one shown figure 14) was used for the wrap-around facing, therefore the compaction quality at the edge of the dike was affected. As well, the visual aspect of the reinforced soil in the wrapped - around area was negatively affected.
