Designing, execution and using stage of highway A4 (E40) based on active geological fault

Jan Zych, Marek Tondera and Maciej Machowski

Abstract

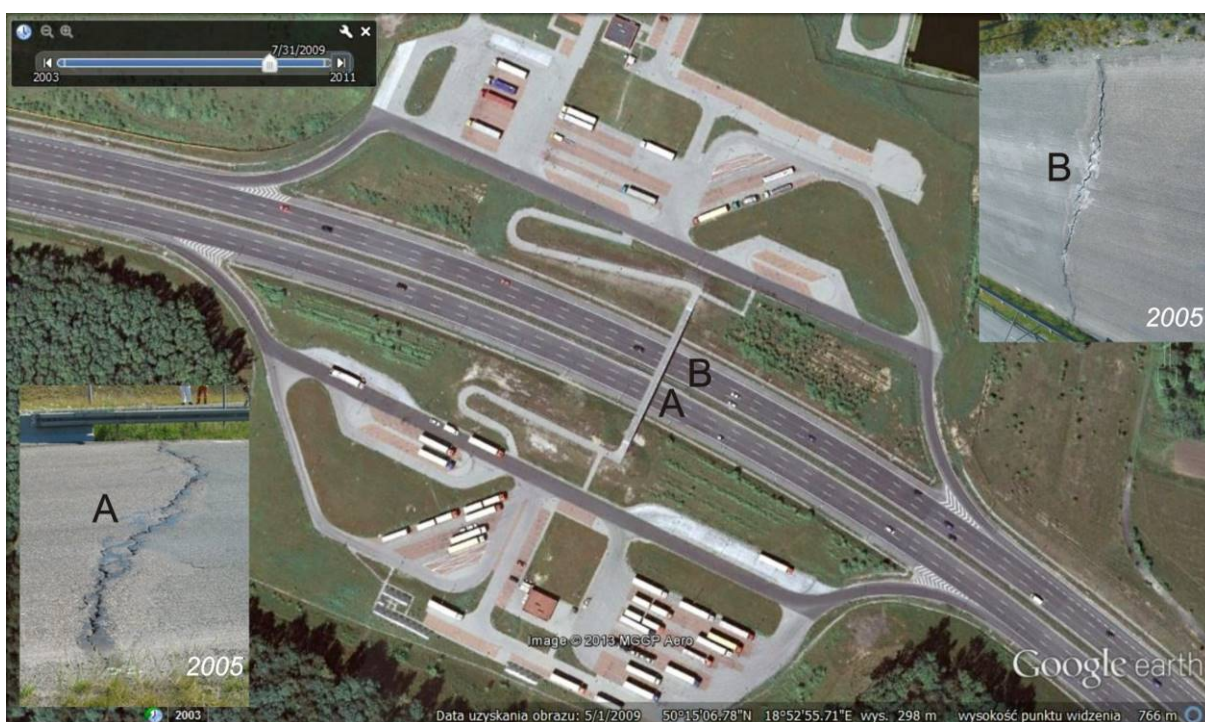
The issue could be considered to be closed if the highway surface hadn't been seriously damaged which occurred in the first year of its use. A crack, on both sides of the road, appeared in 2005 near "Halemba-Wirek" service areas (figure 1). Soon after, the crack transformed into vertical displacement (fault) which become a serious danger for highway users.

Figure 1. Cracks on the highway surface 2005.

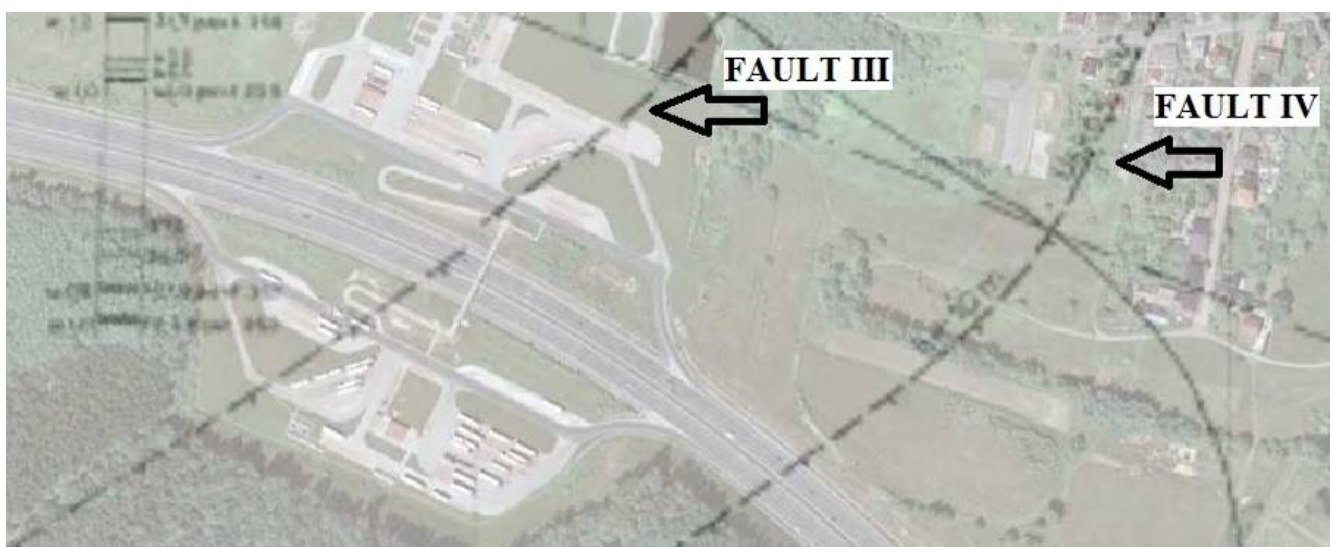
Figure 3. Estimated localization of the faults III and IV

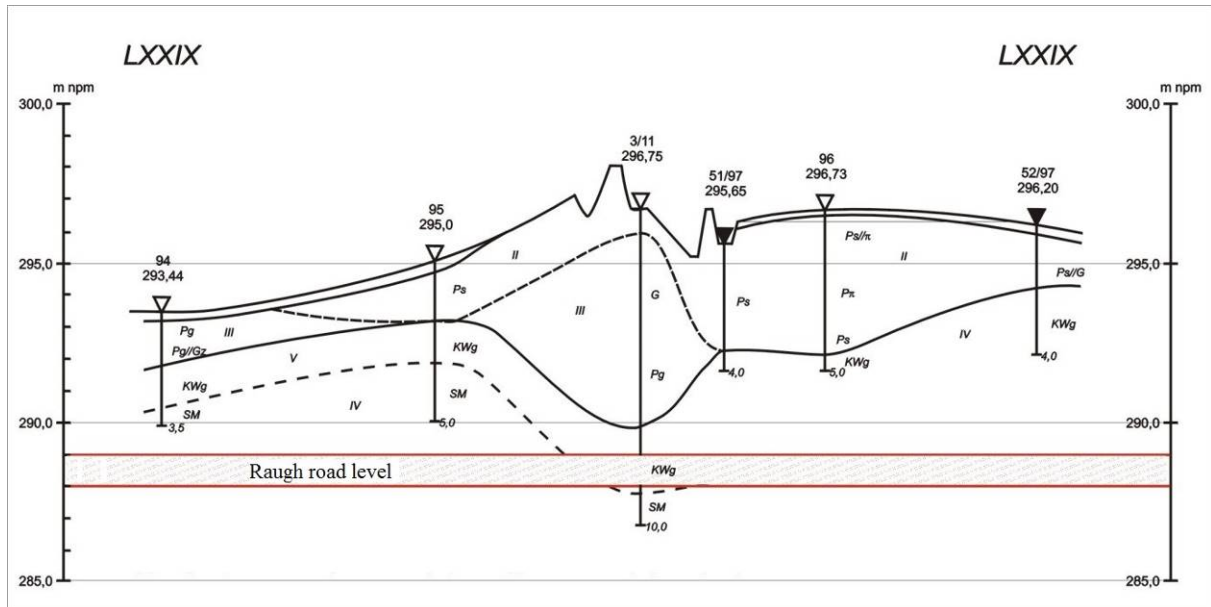
Designing process was based on the Geotechnical Documentation from 1999. The authors of the article concentrate only on the motorway subsection, where the cracks appeared. The subsection is between 327+350,00 km and 328+000,00km, where the road goes in deep excavation. Unfortunately the subsoil recognition process didn't take this fact into account. The geological boreholes were made too shallow (figure 4).

Figure 4. Geological cross section based on the geotechnical documentation from 1999.

This issue had not been resolved at the designing process and the highway construction had been designed on unrecognized subsoil.

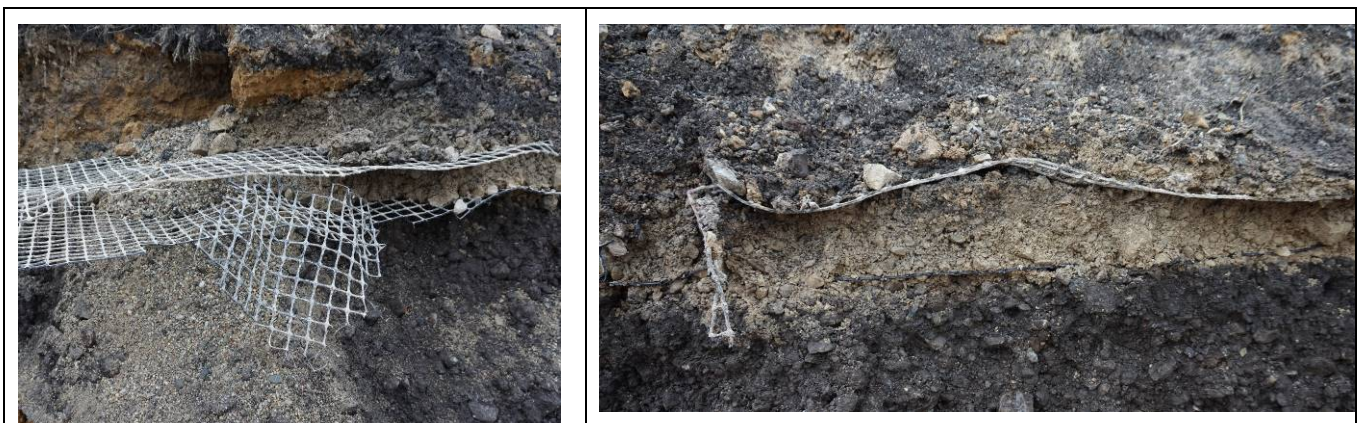
According to the authors of this paper also the problem of mining activity was downplayed. The project involves unified geosynthetical reinforcement on the whole section. The reinforcement was applied regardless of ground conditions or the scale of mining activities influence on the subsoil. Designers suggested the reinforcement should be in a form of two layers of stiff monolithic geogrids with integral junctions (figure 5).

Figure 5. Original reinforcement provided for mining influence at the A4 highway (section Ruda Śląska – Chorzów).

Photo made in 2015 during the renovation.

Designers decided to change the reinforcement only just above the suggested localization of the fault III. The modification covered only 5,0m width of the highway. Two extra layers of low-tension stiff monolithic geogrids were added (altogether there were 4 layers of geogrids). According to the authors, these changes were insignificant in comparison to the occurred situation.

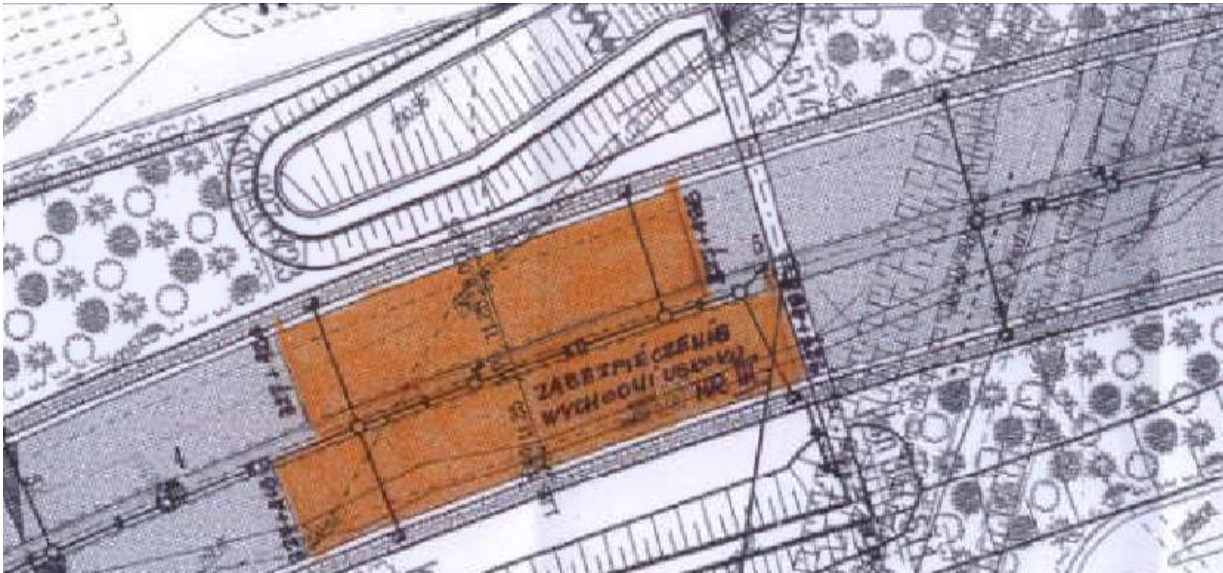
In October 2003 the excavation works were advanced. As a result of observed variability of the ground, the contractor commissioned an additional ground investigation. Geophysical works were made, and they become a base for reinforcement expansion. The expansion in the area of suggested fault III localization, included the modification of ground layers thickness and the modification of the range for designed two additional layers of geogrids (enlargement from 5,0 m to 54 m on the north roadway and from 5,0 m to 78 m on the southern roadway). Geogrids material - polymer and its strength were not changed.

Figure 6. Range of additional reinforcement in estimated fault III area.

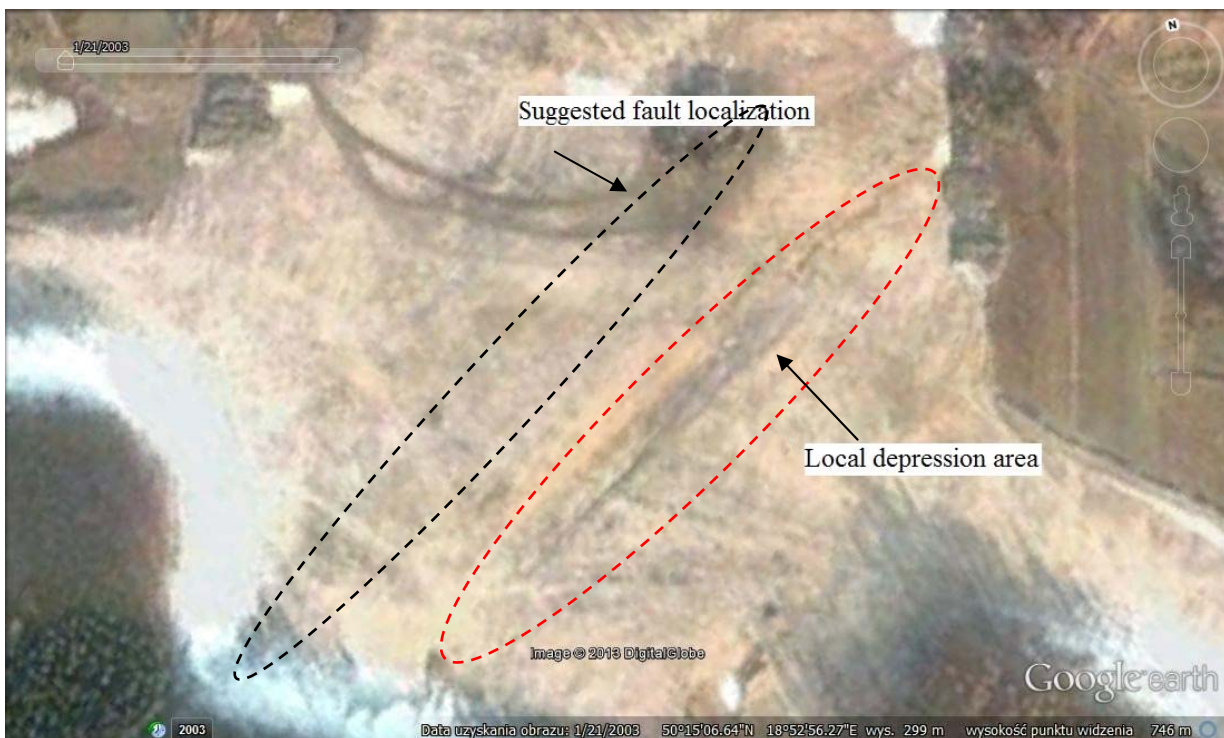
Contractor and designers noticed another disturbing signals when excavation works were done. Sinkholes and local depression appeared on the highway base ground, as a result of heavy rainfalls in May 2004. The depression location did not correspond with the estimated fault III localization. The comparison can be seen on satellite image (figure 7). This image dates May 2004 - depression outline can be seen.

Figure 7. The local depression area on building site after heavy rainfalls.

Unfortunately this situation was neglected, and the cause of the problem had not been found. Sinkholes and local depression had been buried, the reinforcement type and even the range of it had not been changed.

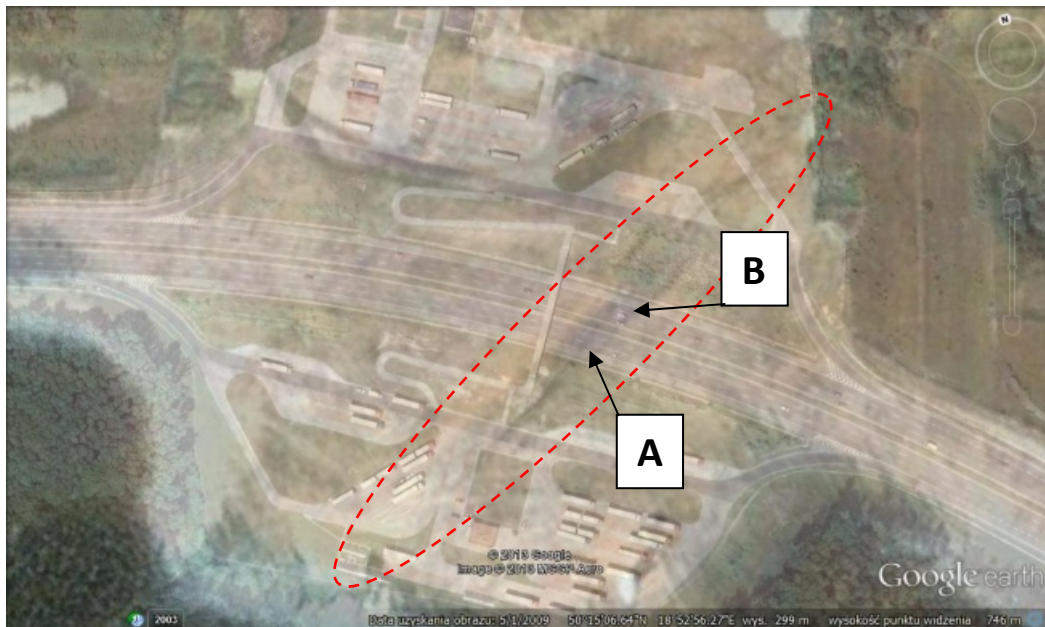
In 2005, right after the highway was given to use, the crack on both sides of the road appeared. Shortly after the crack transformed into gaps and next in a little vertical displacement. As it can be seen by comparison figure 1 and 7, the crack occurred exactly at the place where the local depression occurred during construction stage.

Figure 8. Location of the local depression plotted on the highway satellite photograph.

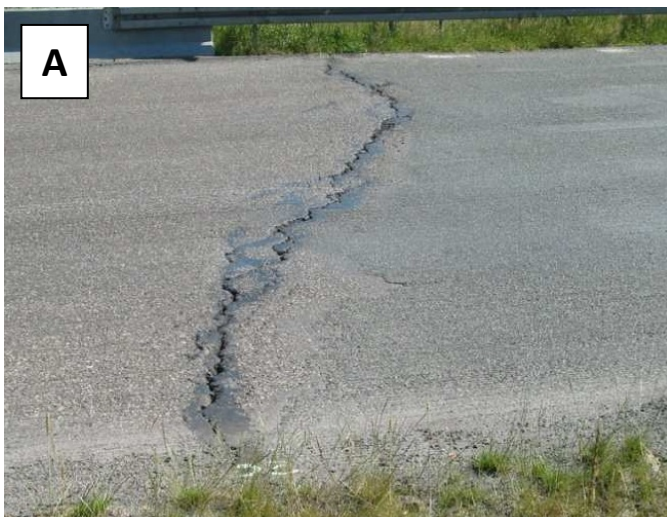
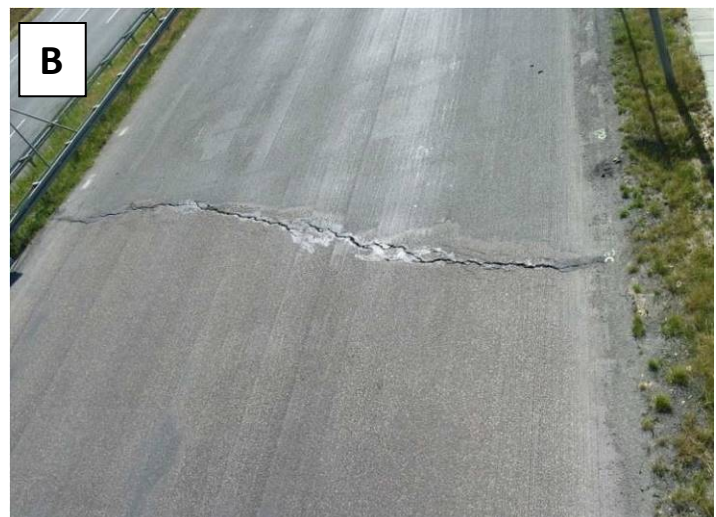
Figure 9. The crack which occurred in 2005.

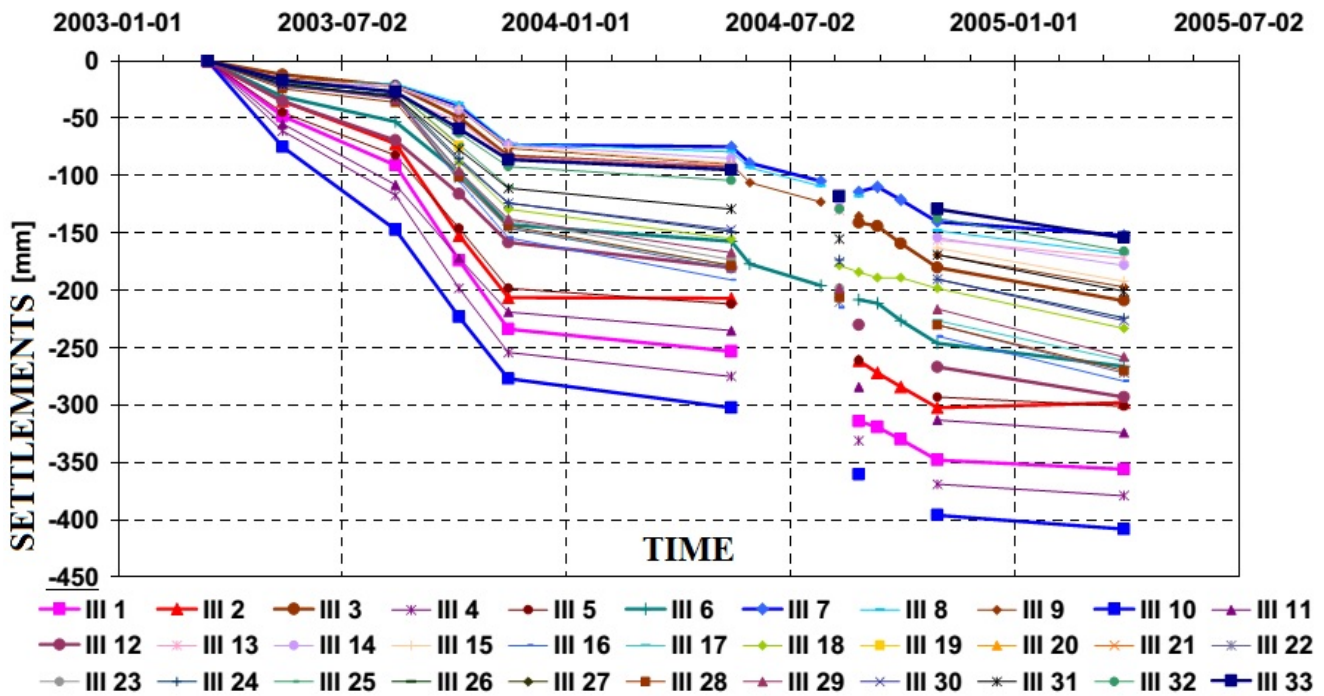
Figure 10. The geodesic monitoring measurements in fault III area.

As it can be observed, settlements increase significantly in period 2004-2005, exactly at the time when crack occurred.

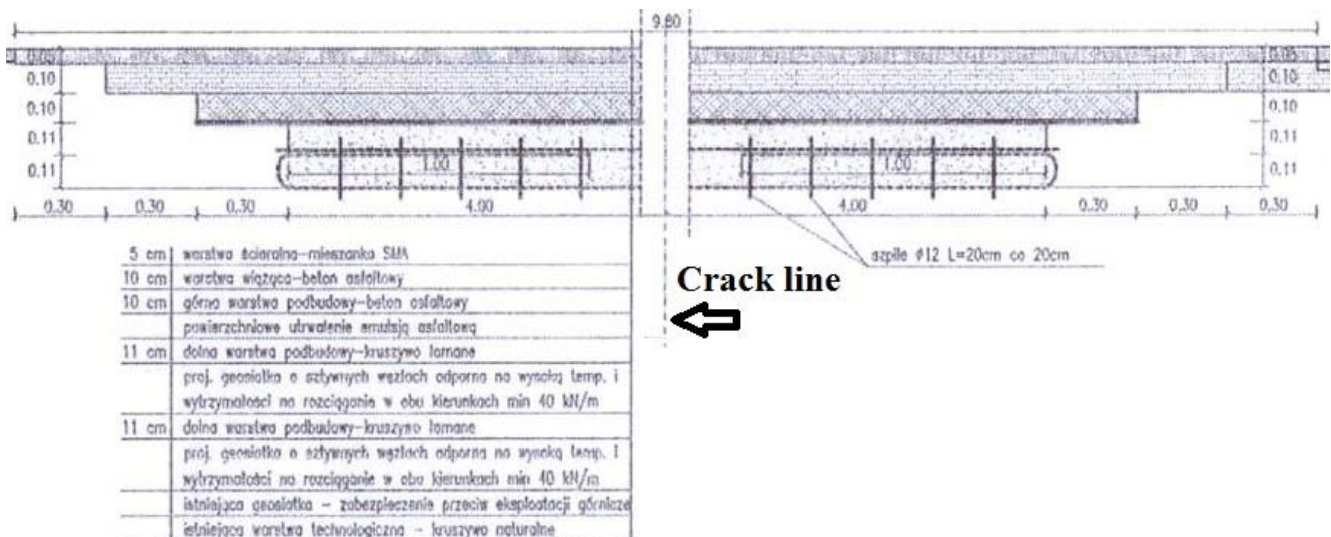
Figure 11. Repair project from 2007.

The repair action included removal of asphalt layers (2 meters width on each side of the crack) and removal aggregate layers to 0,44m depth. Designers provided reinforcement as a two layers of stiff monolithic geogrids (ultimate tensile strength 40 kN/m), tied together with still pins (figure 11).

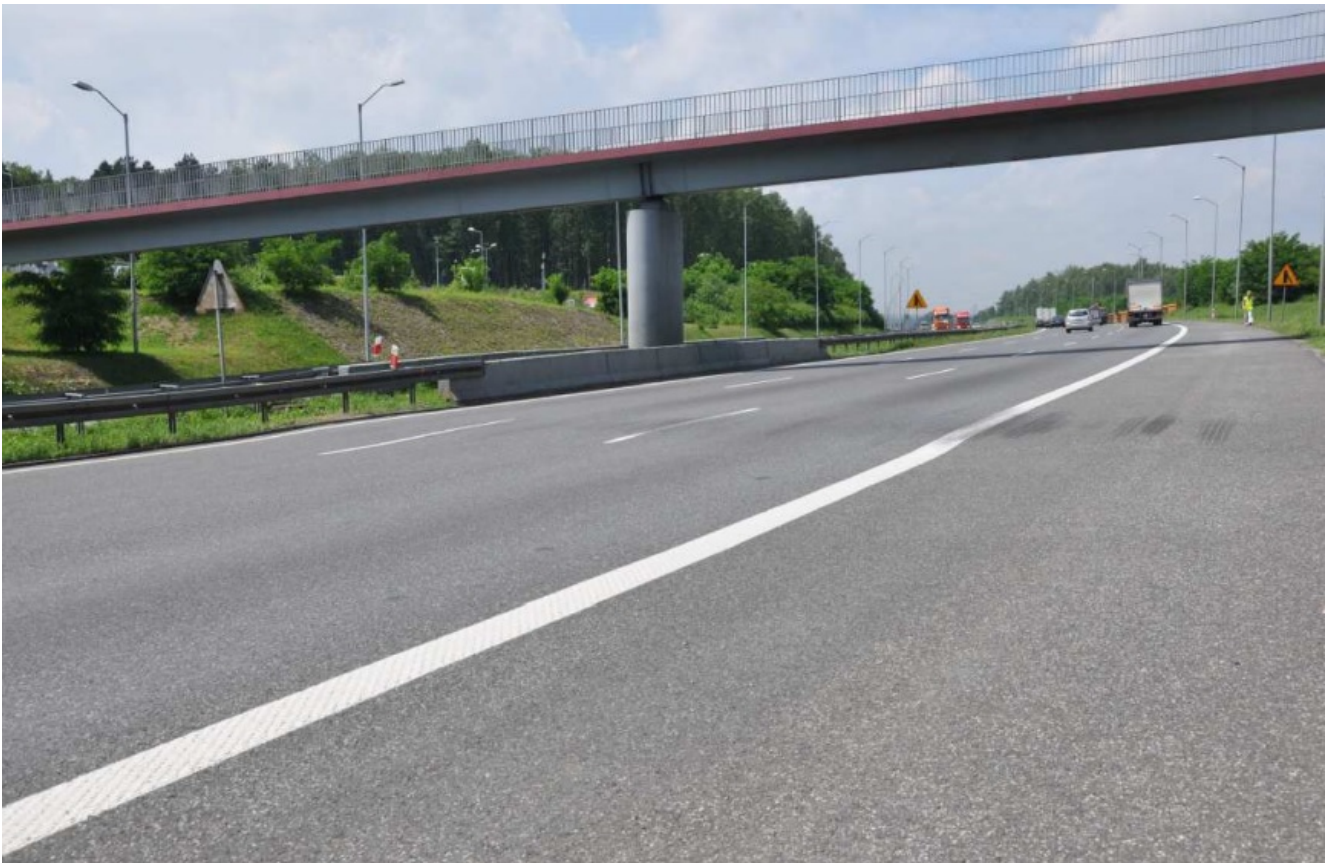
Less than two years after renovation, in May 2009 discontinues deformation occurred again. A place of occurrence was corresponding with damage from 2005.

Figure 12. Discontinuous deformation raised in first half of 2009.

Worth to noticed is highway surface behaviour. This time discontinuous deformation did not cause crack or gap in asphalt layers (figure 12).

At the beginning the deformation has been downplayed. The highway administrator did not take any repair action, only the travelling speed has been limited. The vertical deformation increased over the time. This state lasted up to end of 2011, when the administrator took the decision about reparation. In 2012 geological surveys and Falling Weight Deflectometer examinations were started. In that time vertical difference between both sites of the deformation amounted about 9 cm (the volume was not equal on highway width, 9 cm was the highest difference). In 2012 layers of asphalt still were not broken.

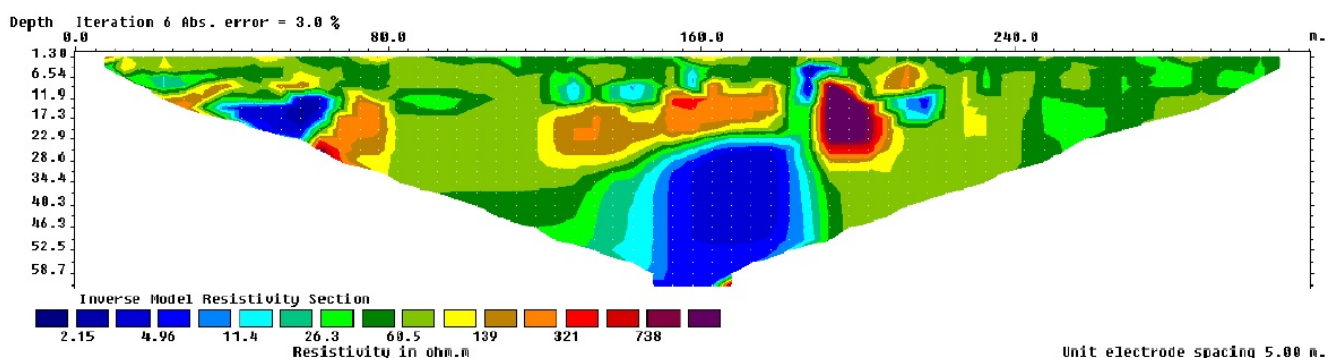
The executed geophysics recognition allowed to predict that discontinuity under the highway had developed. At figure 13 resistance differences can be seen.

Figure 13. Resistance differences in the highway subsoil.

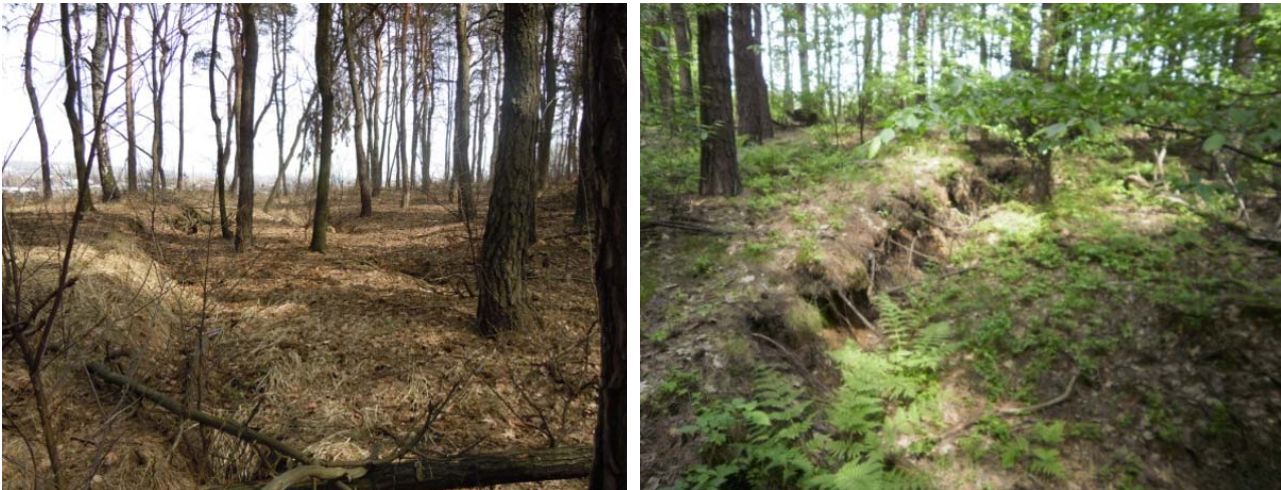
Landform in the area around highway, can confirm the hypothesis. Figures 14 and 15 were taken in 2012, and illustrated discontinuous deformations caused by mining activities.

Figure 14 and 15. The landform caused by mining activities. Localization in a forest near to highway.
