DEATHERAGE, J. D., BECKWITH, G. H. and HANSEN, L. A.

Sergent, Hauskins and Beckwith Consulting Geotechnical Engineers, USA

RESTORATION OF McMICKEN DAM

After being declared unsafe, and then breached, McMicken Dam was restored through the use of a geotextile-geomembrane cutoff and drainage system. Constructed in 1955, the 15 km-long flood control structure was breached in 1972, when extensive cracking was discovered. The use of a polypropylene-coated and uncoated woven geotextile lined rock-fill drain through the center of the existing structure proved the optimum economic solution. Design considerations required high-strength elastic geotextiles and geomembranes which could withstand future cracking, as well as intercept seepage through existing cracks during infrequent flood flow events. Tests were conducted in the laboratory to determine the ability of various materials to span a 25.4 mm simulated crack. McMicken Dam was restored to service after completion of construction in 1984. A total of 227,000 m² of polypropylene geomembrane and woven geotextile were used with a savings of over 1.5 million dollars from the next most economical alternative.

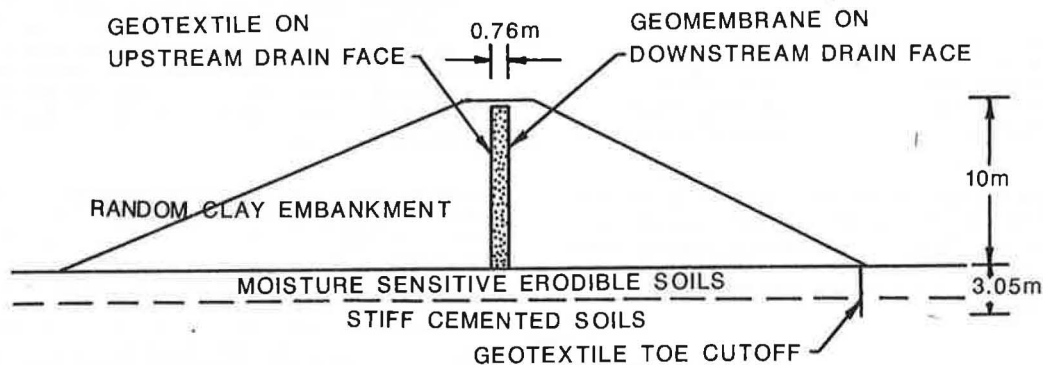
Figure 1: McMicken Dam Restoration Design Details.

Design details of the central drain are presented in Figure 1. The granular drain was excavated through the center of the existing dam. The drain material is a coarse gravel and is separated from the embankment soils on the downstream side with a geomembrane, and on the upstream side with a geotextile.

The upstream geotextile intercepts erosion through cracks and is intended to promote plugging of cracks. The high degree of internal drainage provided will transmit flow from the geotextile. The downstream geomembrane is intended to prevent flow into cracks downstream from the center drain. Outlet finger drains spaced laterally at 60 to 300 m are intended to transmit seepage from the center drain safely out the downstream toe of the dam.

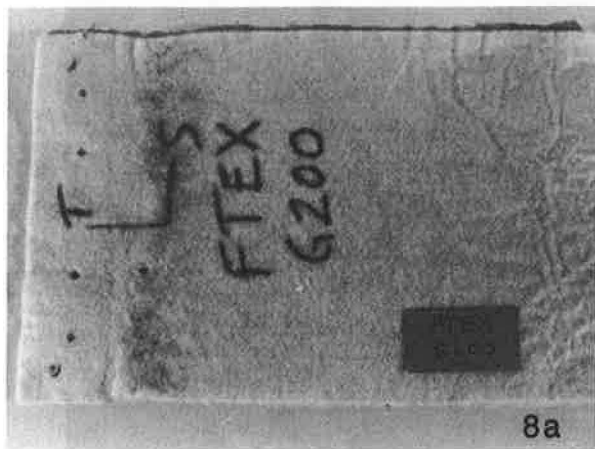
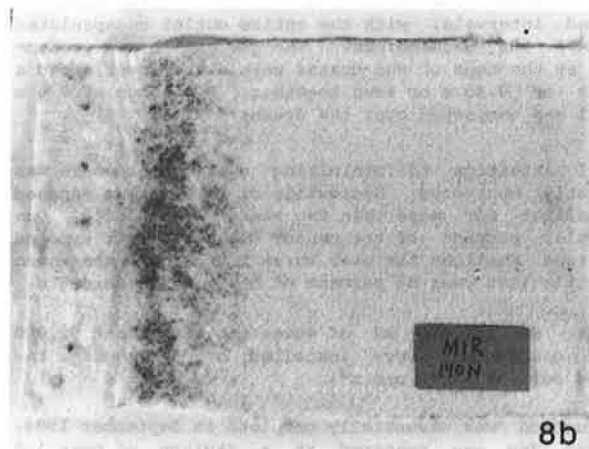
The results of the pullout testing are shown in Figures 4 through 7. It was observed during testing that the portion of the geotextile sheet which elongated would become smeared with the clay underlying it. This smearing allowed the effective length of geotextile which strained to be approximated. Photos of the soil smear on the geotextiles after testing are shown in Figures 8 and 9. The approximate length of smear is listed with the pullout test results in Table 2.

Figure 8: Tested Geotextiles - Note Soil Smear.

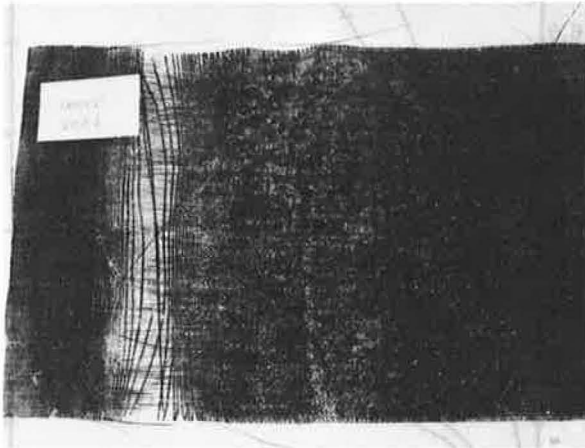
Figure 9: Tested Geotextile and Geomembranes - Note Soil Smear and Failures of Geotextile

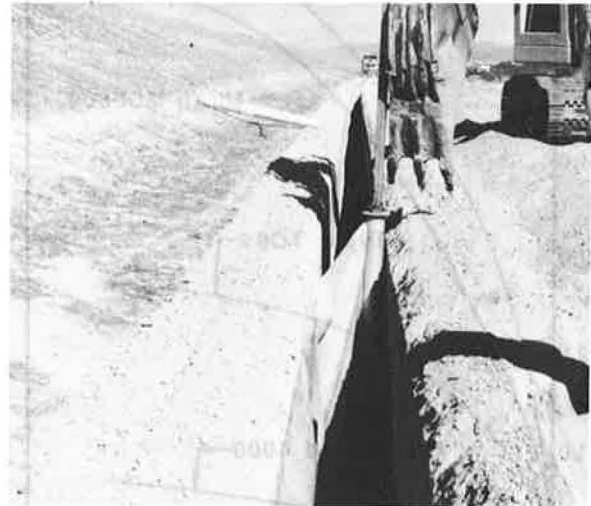
Figure 10: Installation of Downstream Geotextile Cutoff.

Installation of the downstream geotextile cutoff was accomplished as the first phase of the work. The geotextile rolls were attached to a large spool connected to a backhoe, and the material was unrolled inside the trench as the excavation progressed. Figure 10 shows this portion of the construction.

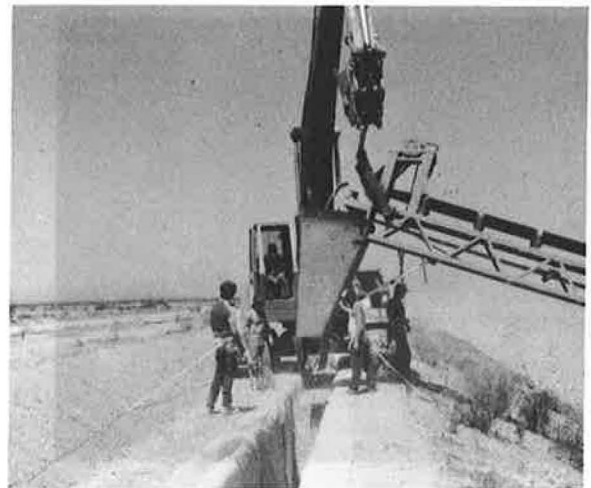
The second phase of construction involved prefabricating 30.5-metre long panels of geotextile sewn to geomembrane for the center drain. The prefabricated panels were dropped into the maximum 10-metre deep center drain excavation immediately following the trencher. Coarse gravel was promptly placed into the geotextile-geomembrane-lined excavation by conveyor or truck. Figure 11 shows this portion of the construction.

Figure 11: Installation of Center Drain. Geotextile is on Left Side of Trench, Geomembrane on Right Side of Trench.
