Major slope stability problems in dam constructions in Thailand

N. Deeswasmongkol, P. Noppadol & C. Areepitak
EGAT, Nonthaburi, Thailand

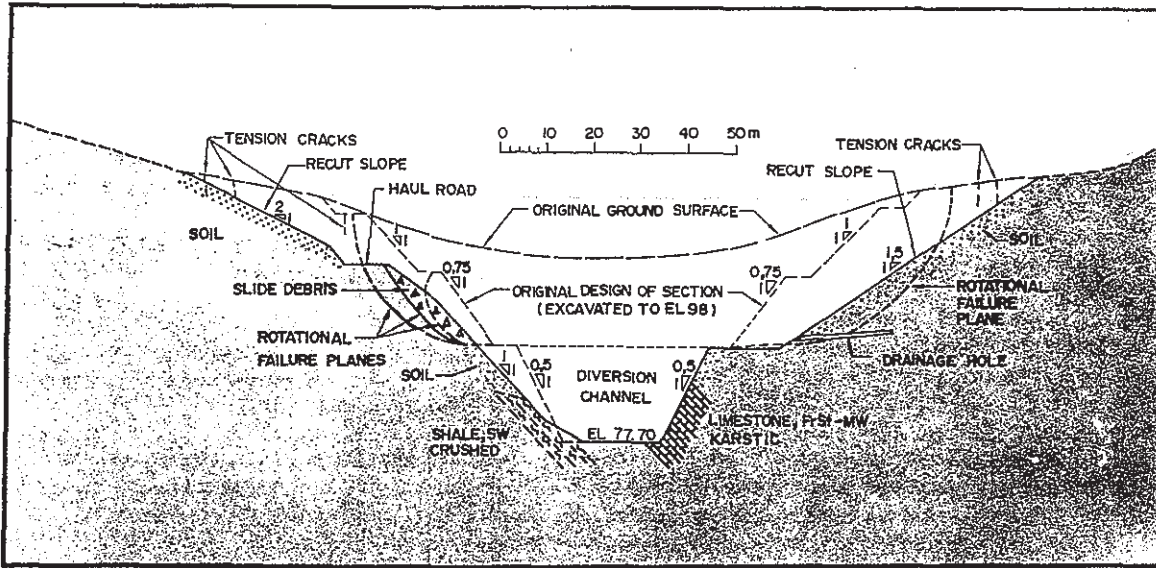
The diversion channel was excavated across the Three Pagoda Fault which the rocks comprise mainly of thin bedded black shale, siltstone and some sandstone: From design criteria, the slope gradient varies from 0.5:1 to 1:1 (h:v) regardless the geological conditions. Some small wedge and plane failures occurred especially where the black shale exposed. Consequently, the slope was re-excavated which the gradient varied from 1.5:1 to 2.1 from the bottom to the top of slope.

Fig. 2 A case study of slope design failure at the diversion channel of Khao Laem Dam, Western Thailand.

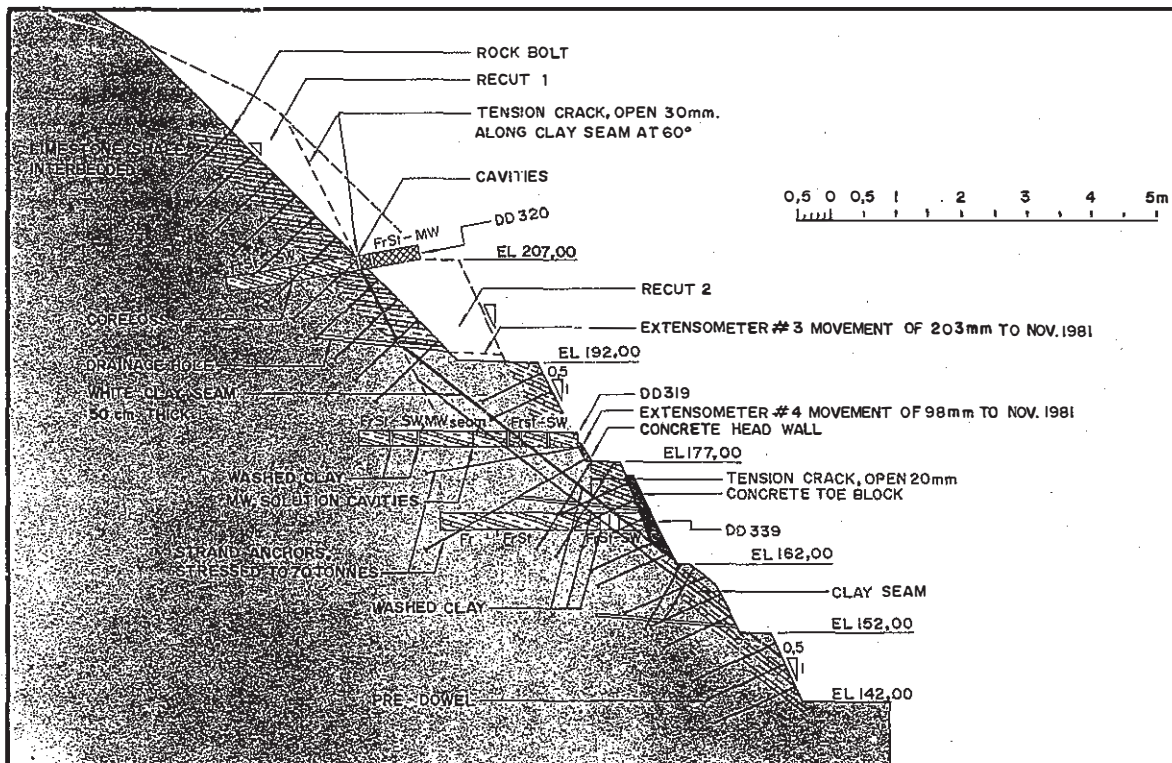
During excavation of left abutment slope, single point extensometers revealed the movement of slope along the clay seam 10 cm thick which daylighted at elevation 207.0 m (MSL). The result of direct shear test revealed the cohesion and friction angle of clay seam about 8-10 t/sq.m and 25-30° respectively. From stability analysis after HOEK, & BRAY (1981), stabilization of slope was extremely necessary. Hence, 91 sets of 70 tons strand anchors have been installed to stop the movement.

Fig. 3 A case study of spillway crest excavation and support system of Khao Laem Dam, Western Thailand.
