Long-term behavior of geodrain composites in landfill capping - results of exhumations

J. Müller-Rochholz

Z. Bronstein

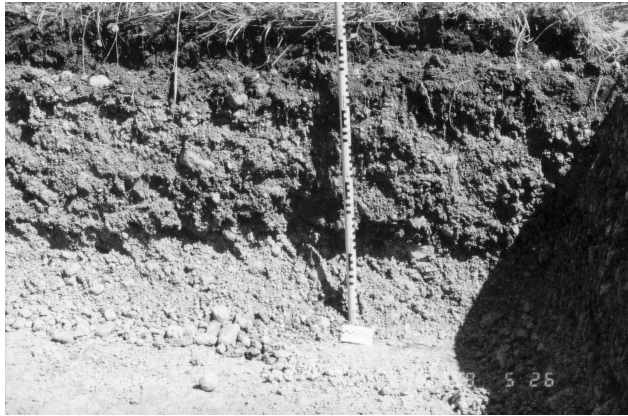
Fig. 4: sideview of the vegetation and coarse soil

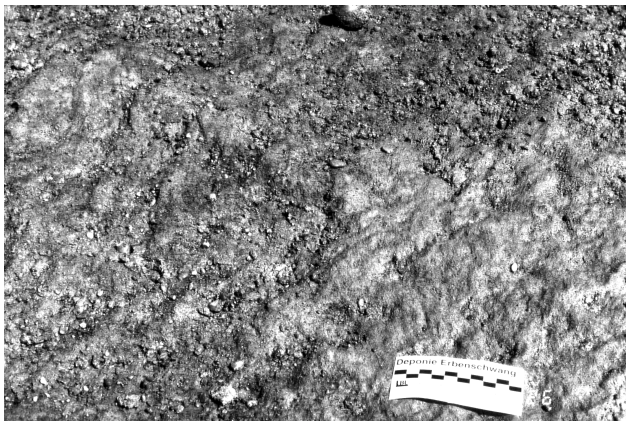
Fig. 5: upper side of drain composite after contact with topsoil.

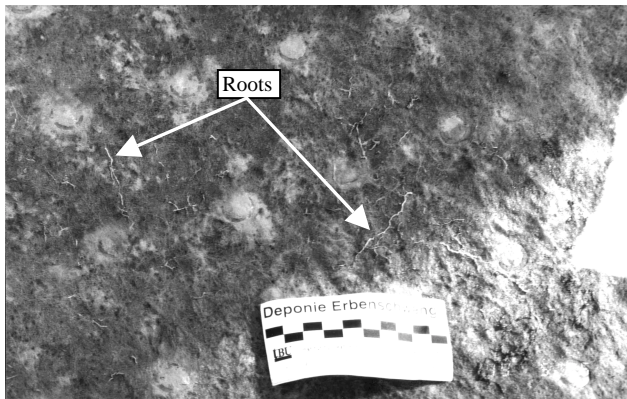
Fig. 6: lower contact side to clay liner (small roots visible).

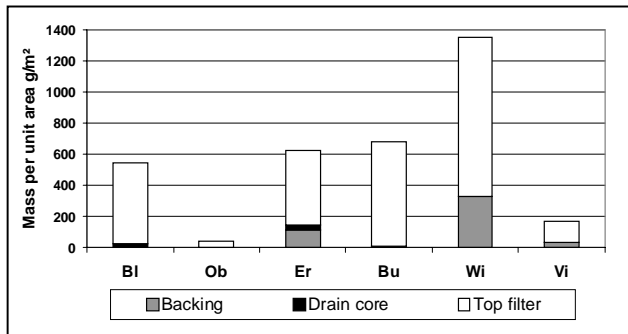
and expected a waterfilled drain. We found some humidity in the nonwoven filter, but no signs of extreme flow. The drain composite was washed to find soil intrusion. The result is shown in Fig. 8, which shows some soil in the upper filter, no soil in the core, sometimes some clay from the underlying clay liner in the bottom geotextile.

Fig. 8: Soil embedment in the elements of geocomposites.

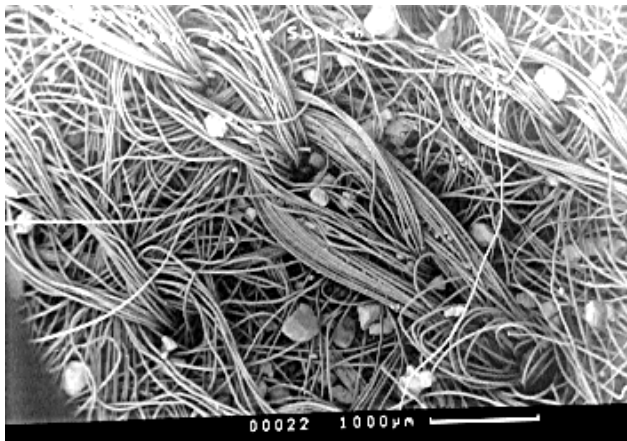
As there was very little soil in the geotextiles, we found only some deposits of grains in the filters. The Fig. 9 and Fig. 10 show nonwoven knit bonded filters (Malivlies) with granular embedments

Fig. 9: granular intrusions in the nonwoven filter

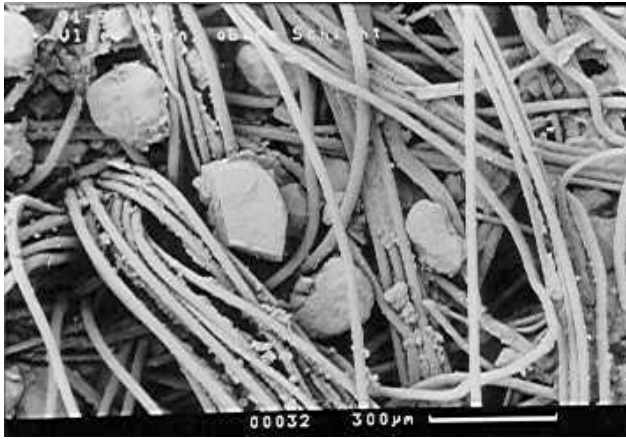
Fig. 10: grains and fine soil particles in the nonwoven filter

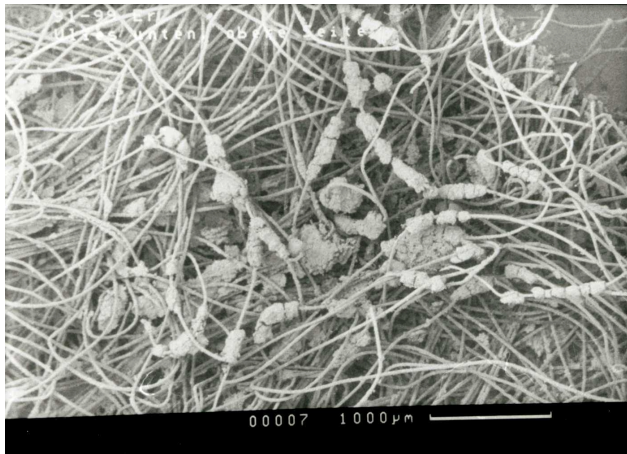
and Fig. 11,12,13 very curious attachments of fine particles on a fibre. The fine soil particles seem to have grown in concentric layers; the pearl chain structure may be caused by drying shrinkage.

Fig. 11: soil attachments to fibres

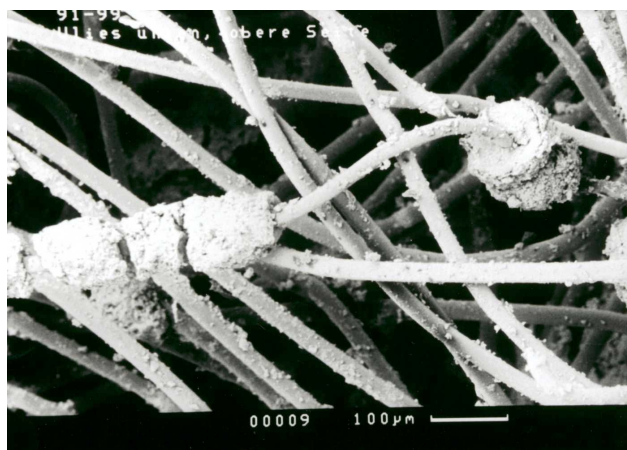
Fig. 12: closeup to particle attachments

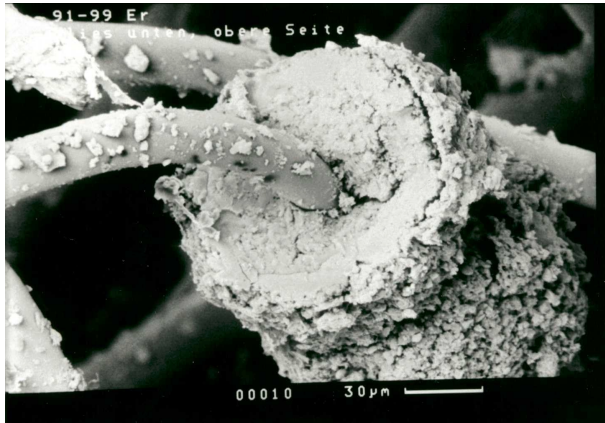
Fig. 13: concentric layers of fine soilparticles

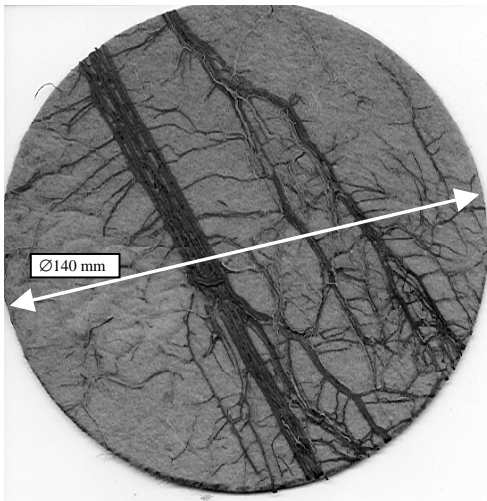
Roots were found macroscopically only between nonwoven joints (Fig. 14); some very fine could be discovered in the drain core (Fig. 15).

Fig. 14: roots in a double layer of nonwoven (joint)

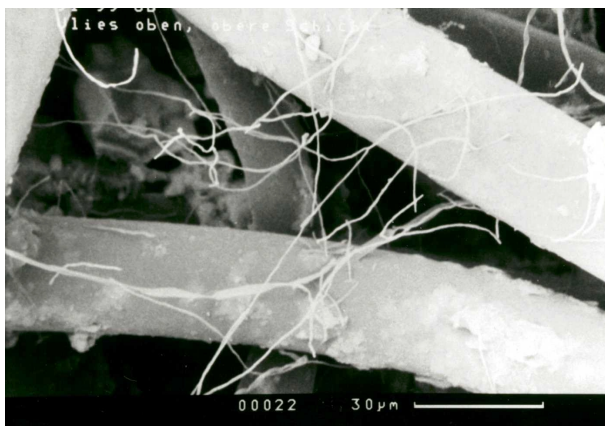
Fig. 15: very fine root fragments in the topfilter
