# Post-installation assessment of the quality of a novel heap leach pad liner

I. D. Peggs

B. Loeffler

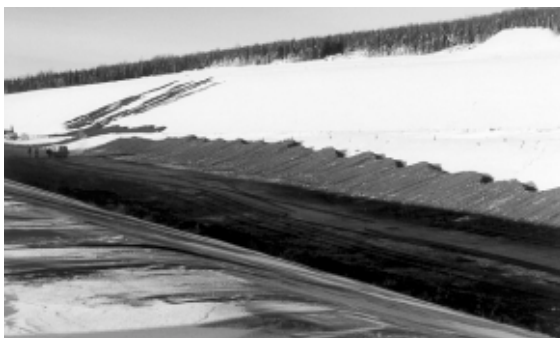
The central feature of the gold mine was an approximately 16 ha heap leach facility, built into the side of a hill, using the hill as the foundation for the upland embankment with engineered embankment to form a downhill side of the facility. What made the leach pad novel was a deep solution trough (Figure 1) across the lower end of the pad that would store the leachate.

Figure 1. Solution trough at low end of leach pad.

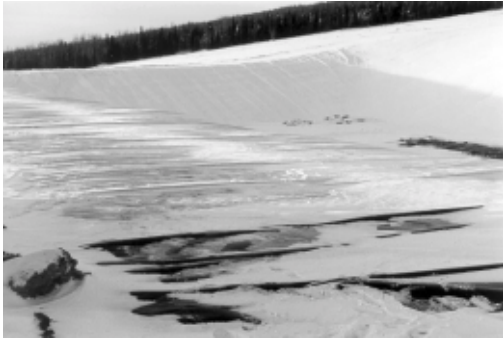
A one-day site visit was made in November 1996. As shown in Figure 1 the floor of the cell had been covered with soil and there was a great deal of snow on the side slopes limiting access and examination. Even at the moderately low temperature of  $-1^{\circ}\text{C}$ , Figure 2 shows there to be no excessive tension in the geomembrane. Reinforced PP has a very low coefficient of linear thermal expansion, thus minimizing concerns of extreme tension at low temperatures and excessive wrinkling at high temperatures.

Figure 2 also shows sections of geomembrane with the beige side uppermost and with the black side uppermost. The only difference between these materials is that the black layer contains carbon black for UV radiation protection while the beige side contains a hindered amine light stabilizer (HALS) UV protection package. The performance differences of these two additive packages is of no significance in this project since the geomembrane will be covered and protected from exposure to UV radiation within a few months. Interestingly it was found that as ambient temperature decreased, the black material would flash-over suddenly with ice, while the beige material did not.

Figure 2. East end of Cell. Black uppermost in foreground. Beige on top in background. Liner is not under tension.

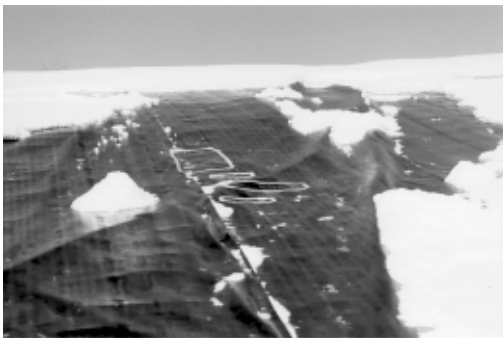
Figure 3. No tension and only small wrinkles in liner.
