# Effects of large differential settlements on embankments on soft soils

E.M. Palmeira & A.R.S. Fahel  
*University of Brasilia, Brasilia, Brazil*

**ABSTRACT:** This paper presents the performances of four geosynthetic reinforcement abutments built on soft foundations. The embankments are part of highway developments in the north-east and south regions of Brazil. The first embankment is a geogrid reinforced bridge abutment constructed as part of the BR-101 highway-widening programme. In this case the new embankment was built with part of its width resting on the existing embankment. The other three reinforced embankments were built in the Linha Verde highway to allow the crossing of rivers in the region. One of these embankments was built on a concrete slab and on piles with caps, another on a group of piles with caps and the last one directly on a top sand layer overlying a compressible clay layer. The designers of these works heavily reinforced the abutment, but little concern was put on the effects of differential settlements caused by foundation consolidation and erosion. This paper shows that, in spite of the large deformations imposed to the structures, the overall performa

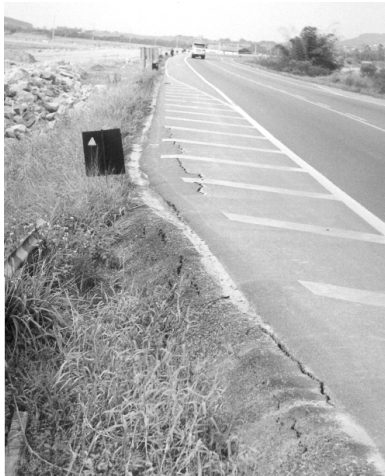
The consolidation of the soft foundation soil, accelerated by the vertical drains, caused some cracks on the existing embankment, as can be seen in Figures 8 (a) and (b). The fact that part of the new embankment rested on the old one pulled the latter down during consolidation, causing the cracks. However, these cracks occurred outside the traffic lanes and were of minor consequences to the existing embankment. The presence of the reinforcement in the new embankment is likely to have been beneficial in minimising damages to the existing embankment. This aspect is under investigation using numerical analyses (Fahel, 2000).

(a) Cracks along the edge of the pavement.

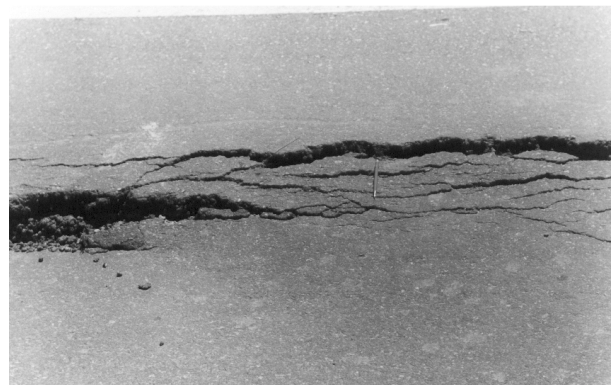
(b) Detailed view of the cracks.

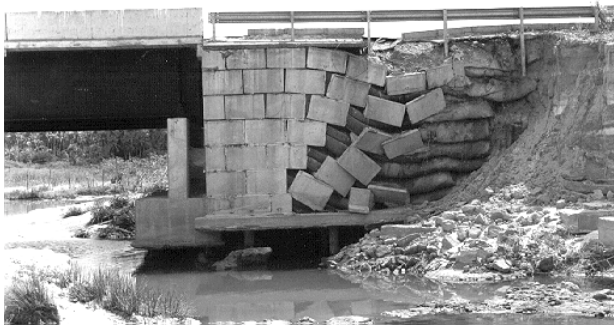
The reinforced abutment in Case History 2 was not affected by foundation settlements because most of the reinforced mass rested on a piled slab (Fig. 3). However, significant damage was caused to one of the lateral wall faces because of erosion of the fill material underneath the rear part of the reinforced mass, as shown in Figure 9. A river flood caused the removal of the soil below the base of the reinforced mass adjacent to the concrete slab, causing a severe differential settlement in that region and the collapse of some facing units. In spite of the large distortion of the reinforced mass, only some rather minor repairs were needed along the pavement surface. This behaviour of the geosynthetic reinforced mass emphasises the benefits of having a flexible retaining structure in this type of work, capable of accommodating large settlements with relatively minor damages.

Figure 9. Facing units collapse in Case History 2.

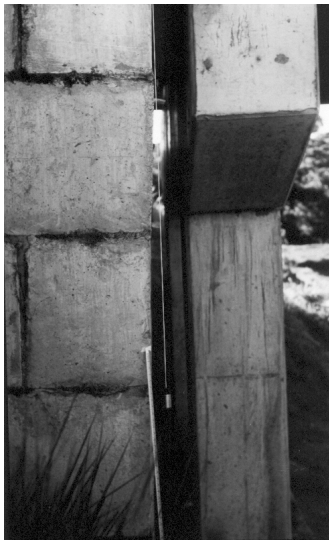
No significant settlements were observed in Case History 3, which was the one having the highest reinforced structure (7.3 m). This was certainly due to the efficiency of the piles along the embankment base. However, horizontal displacements of the wall crest of the order of 40 mm (approximately 0.55% of the wall height) were measured, as shown in Figure 10. Bearing in mind that the wall was heavily reinforced, that value of displacement and the pattern a wall face deformation

must be associated with the reduction of reinforcement length in the upper region of the wall.

Figure 10. Wall face displacement in Case History 3.

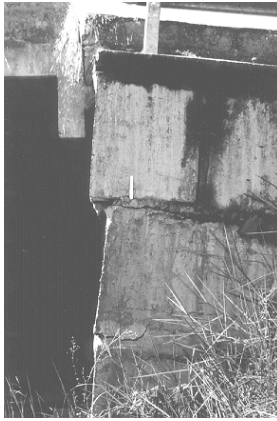
The reinforced abutment in Case History 4 was the one that presented the largest overall deformations, because of the lack of measures to minimise surface settlement, such as the use of piles. For this abutment the measured settlement at the wall face was equal to 290 mm. Settlement were not noticeable beyond a distance of 21 m from the wall face. The maximum horizontal displacement of the wall crest was equal to 55 mm (2.8% of the wall height) and the wall face rotated with respect of its crest, as can be visualised in Figure 11. Similar mechanisms of reinforced walls on soft sub-grade have been identified in model scale testing and in numerical analyses (Monte, 1996, Dellabianca, 1999).

The displacements and rotation of the wall face caused relative displacements of the wall facing units of 90 mm, as well as some cracks (Fig. 11). The differential settlement also required a rather heavy maintenance work of the pavement surface, as shown in Figure 12 (note bent guard-rails along the sides of the highway).

Figure 11. Rotation of wall face and facing units in Case History 4.

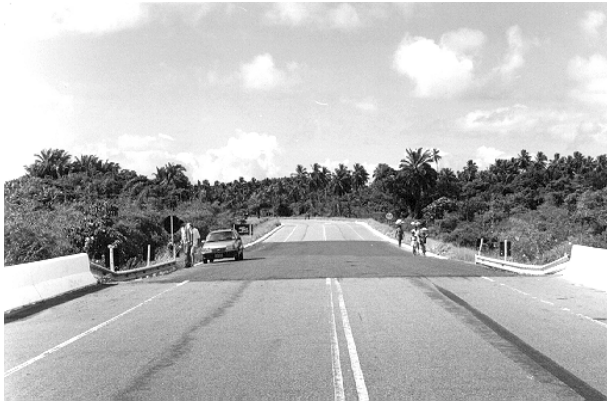
Figure 12. Repairs in the pavement of Case History 4.
