Durability of PVC-P geomembranes

Assessment after very long UV exposure

D. Fayoux

D. Van Der Sype

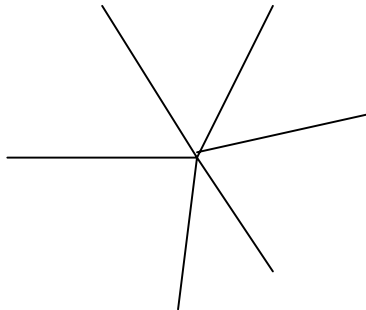
During the same time, low temperature brittleness increase, from about – 35°C to 0°C or more. In case of shock, "star" failures are visible on the geomembrane, at each important impact.

Figure 1: Star failure of PVC geomembrane, indicating brittle behavior.

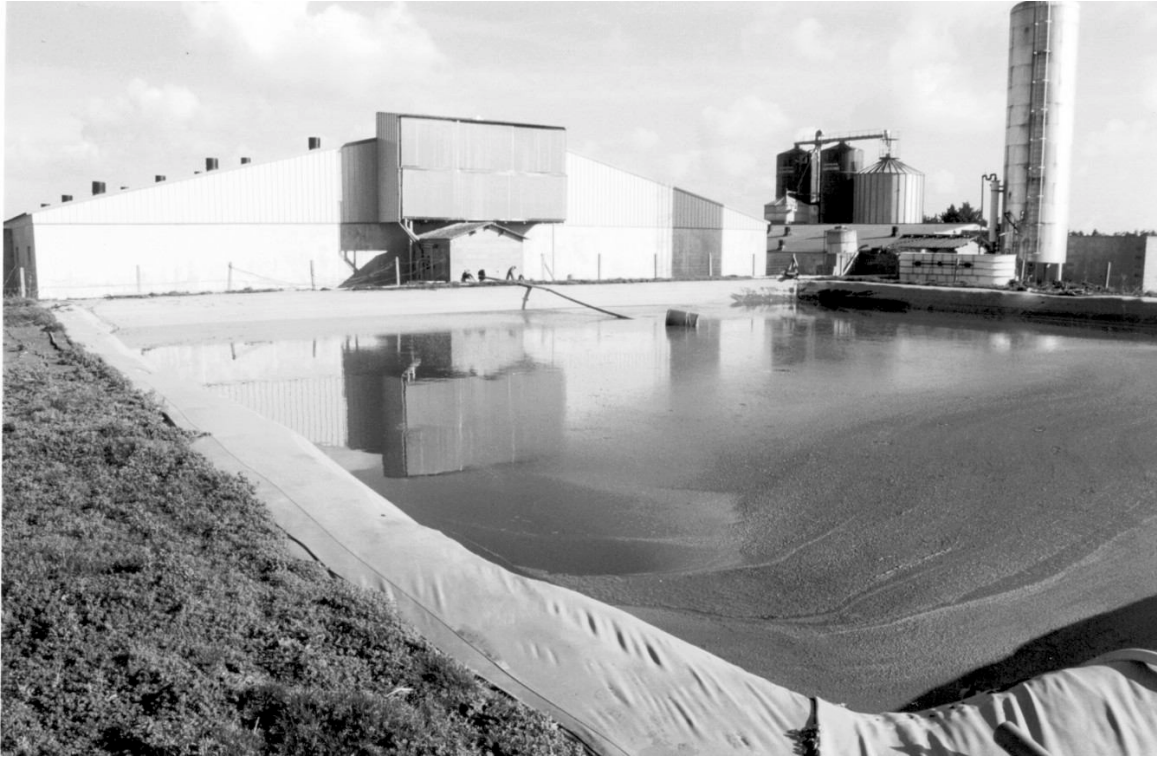
Figure 2: Mar cay manure pig pond; view after 18 years

The figure 2 shows a general view of the site, horizontal welding on slopes (we see the welding on the top of slope) and the fold in the corner. The figure 3 shows the pond in the opposite direction and irregularities of supporting layer, without damage for the geomembrane

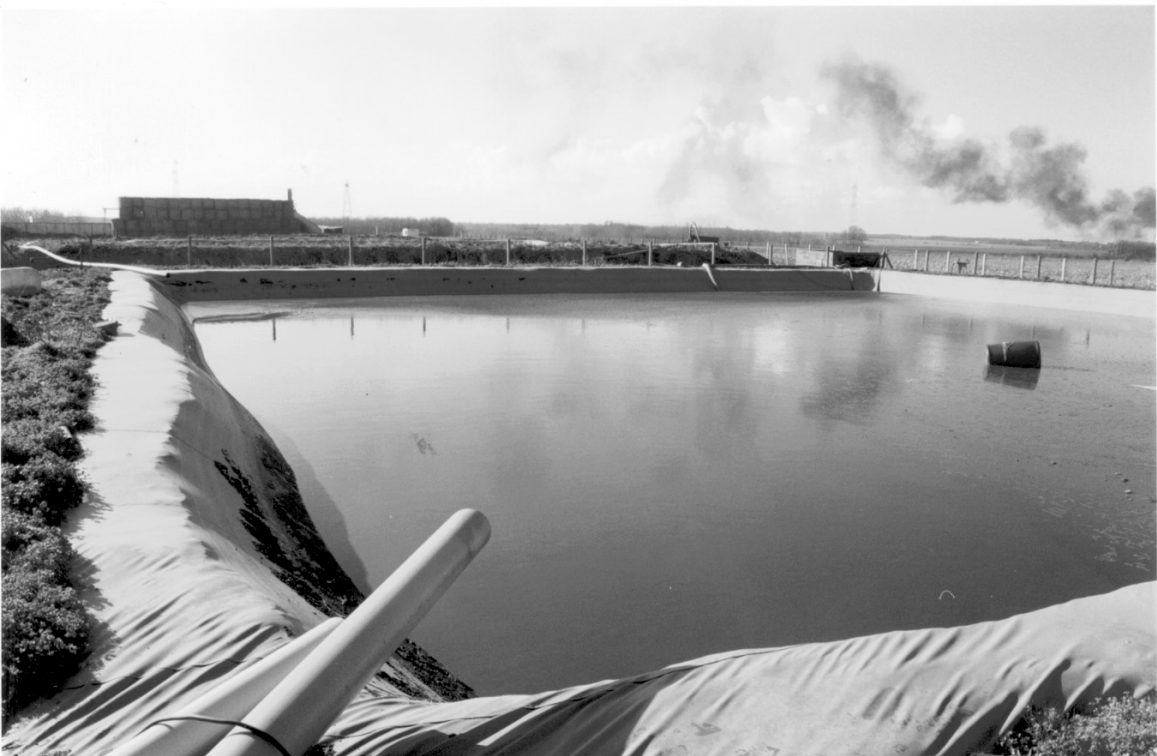
Figure 3: Mar cay Pond (1981/1982); irregularities of supporting layer

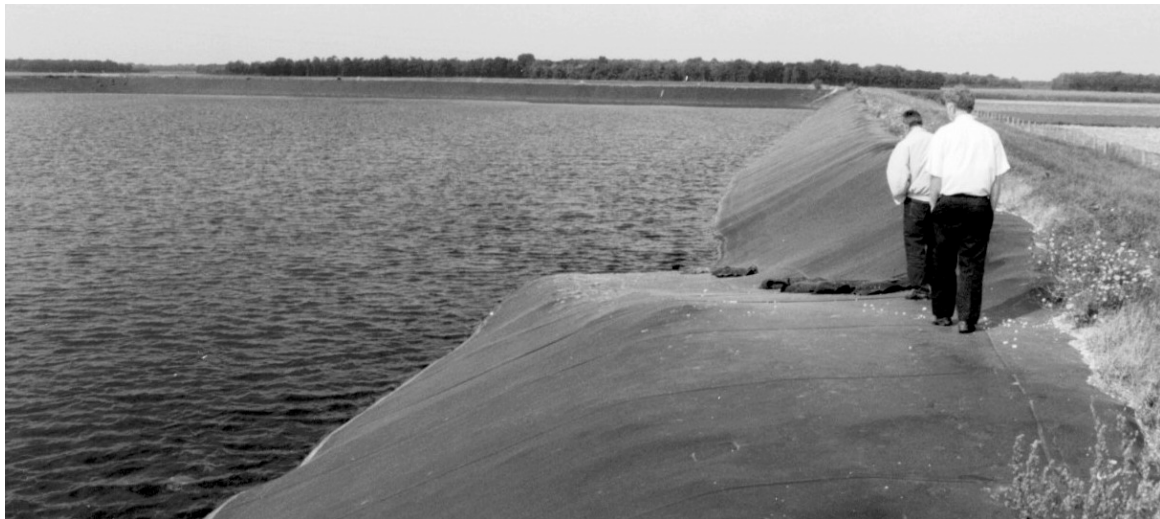
Figure 4 Préfontaine PVC 1mm thick 40000 m² 1982; view after 18 years

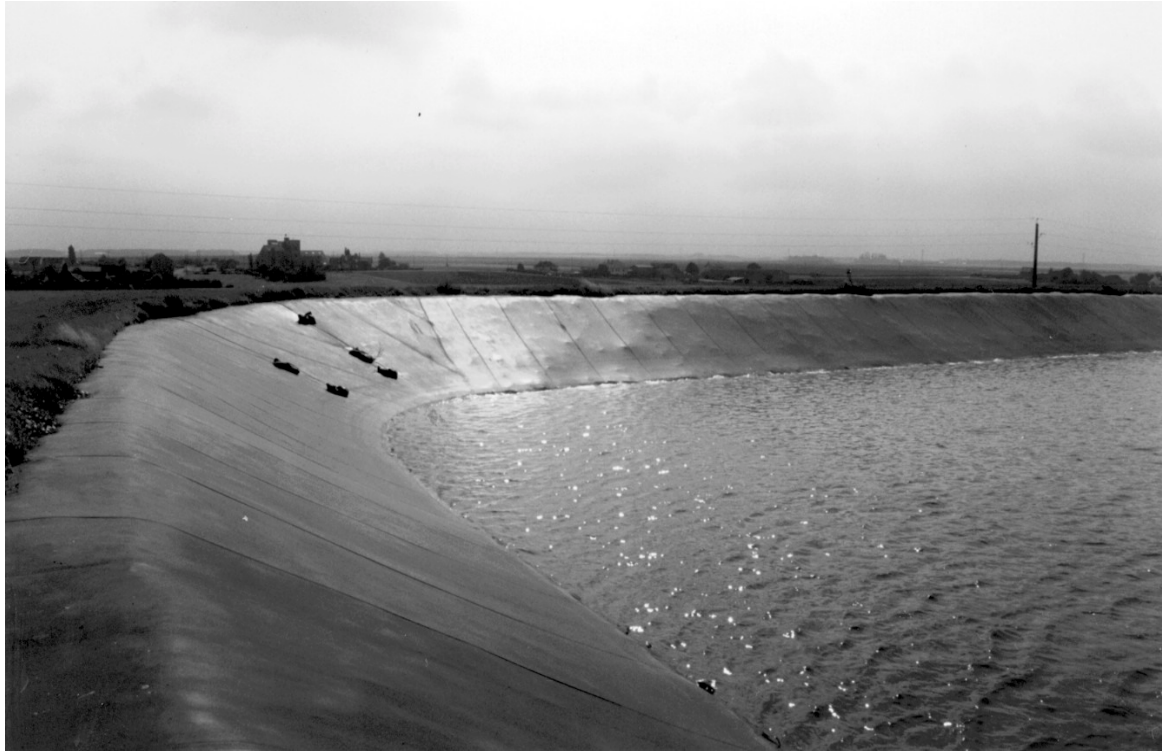
Figure 5: Préfontaine 1982 general view; note the irregular support

We note on the figure 5 some irregularities of the supporting layer, due to stones through the sand layer. Horizontal welding is visible on figure 6. And figure 7 shows heavy puncturing due to stones below the geomembrane and the very good resistance of the PVC geomembrane for this kind of stress.

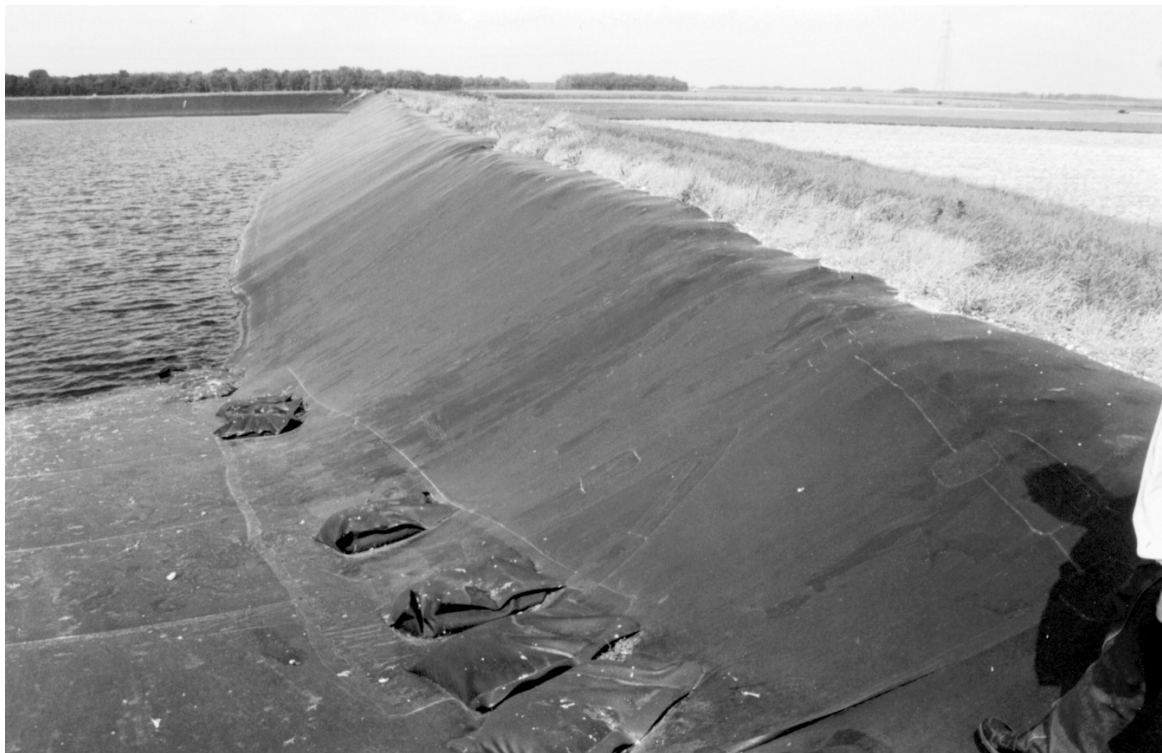
Figure 6: Préfontaines, detail of access ramp; note horizontal welding (right)

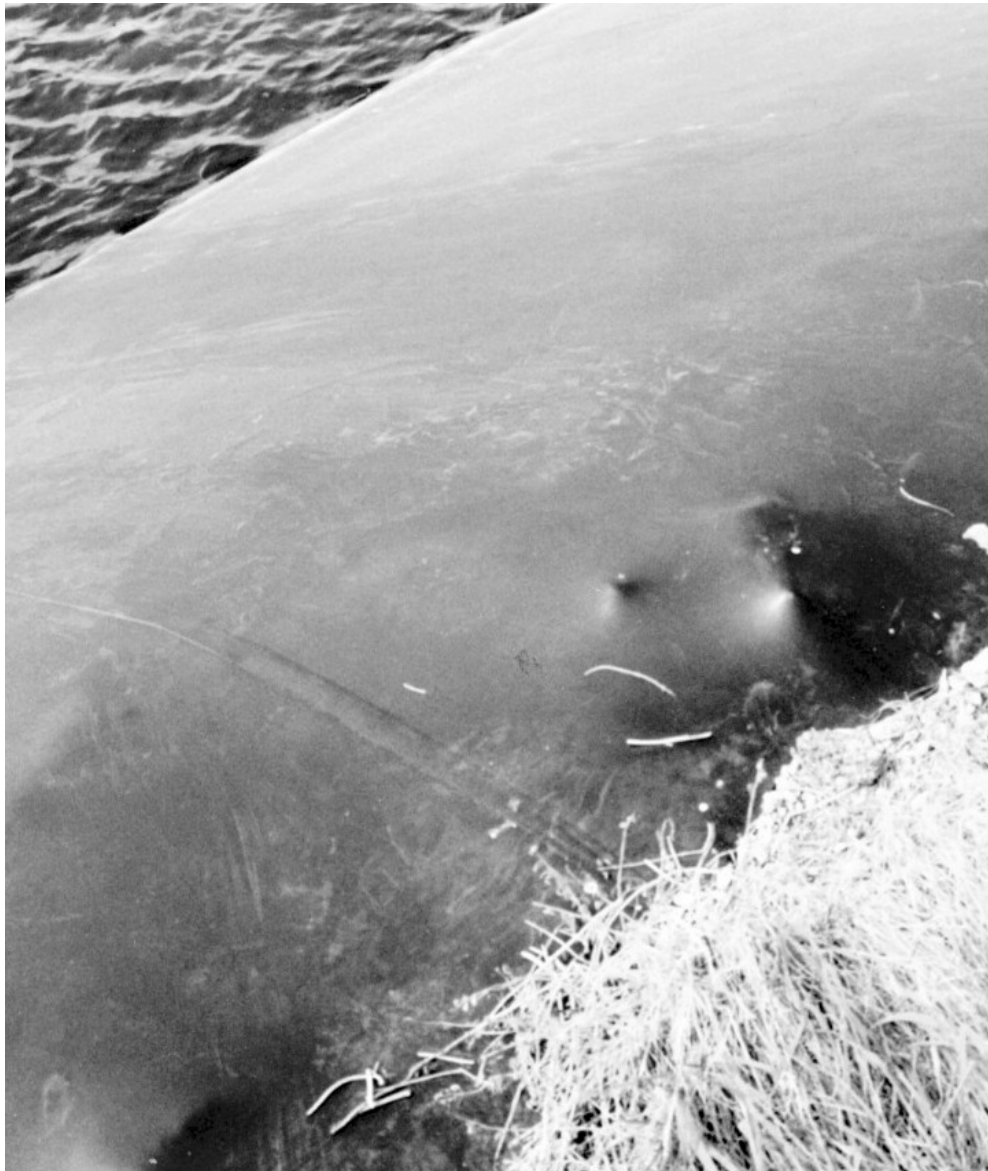
Figure 7: Préfontaine: note heavy puncturing due to stones below the geomembrane, without failure after 18 years.

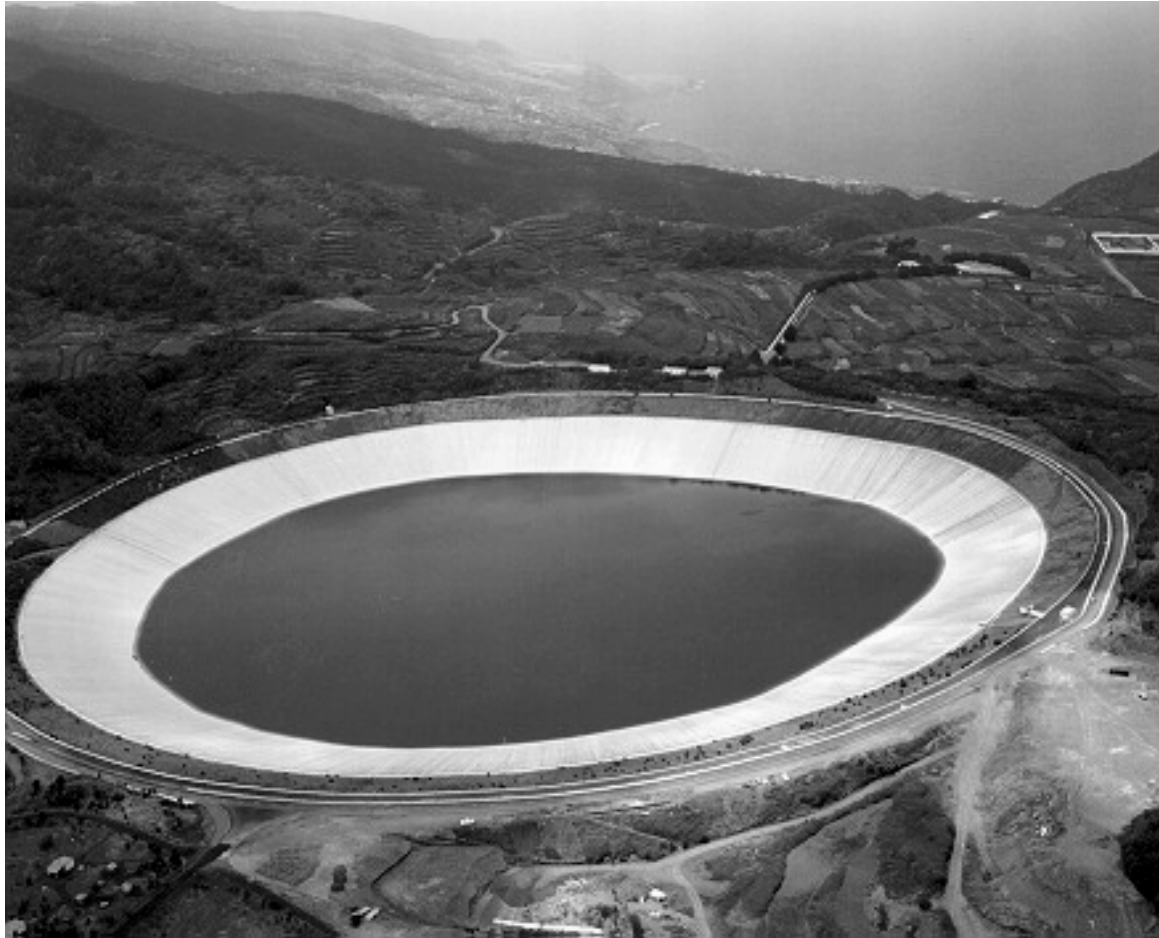
Figure 8: Barlovento Reservoir; Canaries Island PVC geomembrane 1.5 mm, 1991
