Landslide stabilization using an MSE buttress at a U.S. Superfund remediation site

Beech, J.F., Monteleone, M. J., & Bonaparte, R.
GeoSyntec Consultants Atlanta, Georgia, USA 30144-3694

Keywords: MSE buttress, landslide, stabilization, geogrid

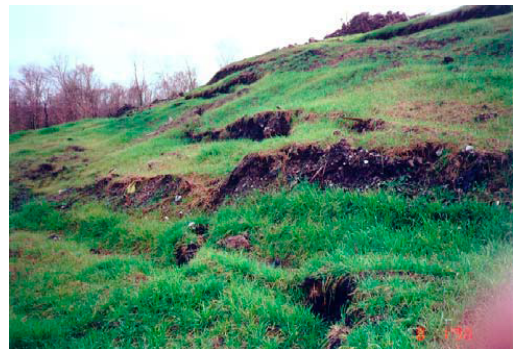
In 1986, USEPA placed the site on its Superfund National Priorities List, meaning the site was a priority for clean-up. The site sits on a 50-m high sloping hillside underlain by colluvium and bedrock. A remedial design involving large debris removal (i.e., cars, metal drums, etc.), reduction in the size of the SWR footprint by consolidation of material onto one portion of the slope, and final capping of the consolidated SWR, was developed by others and in 1997 remedial construction began. Only after the start of construction was it discovered that the slope was geologically unstable and the surficial SWR and colluvial soil was actively creeping downslope. Construction on the project was halted and the authors were retained to investigate the instability and develop a slope stabilization plan. The condition of the site when construction was halted is

Figure 1. Site conditions in 1997 showing slide scarps at multiple locations

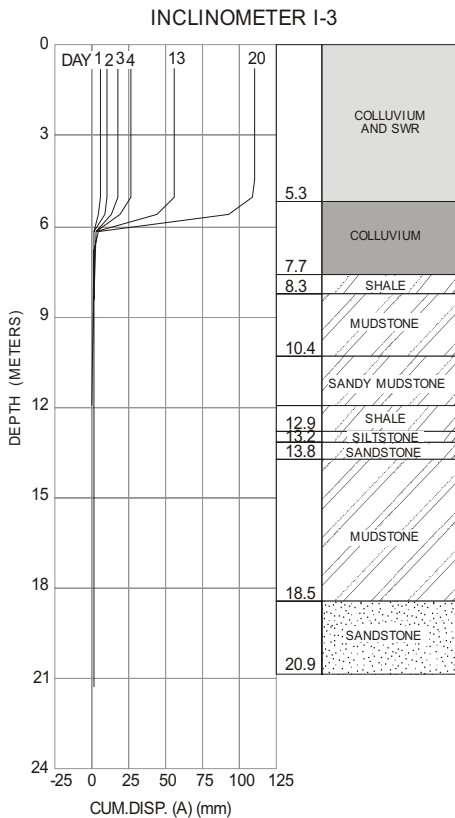
the inclinometers are shown in Figure 2. The displaced shape of this inclinometer is typical of movements observed in other inclinometers at the site. The inclinometer results revealed that slope movements were limited to the SWR and colluvial soil that overlies interbedded sandstone and mudstone bedrock. The locus of slope movement was found to be in the colluvium near the bedrock interface.

Figure 2. Typical slope inclinometer results

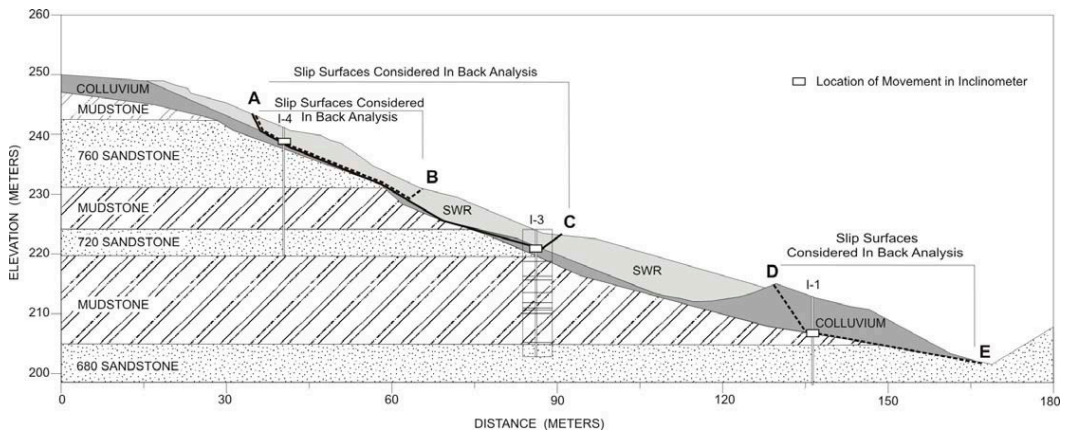
A back-analysis of existing slope conditions was performed using a 2-D limit equilibrium slope stability model, colluvium residual strengths obtained as described above, and varying piezometric levels above the bedrock interface. Typical slip surfaces considered in the back-analyses are depicted in Figure 3.

Figure 3. Slip surfaces considered in back analysis

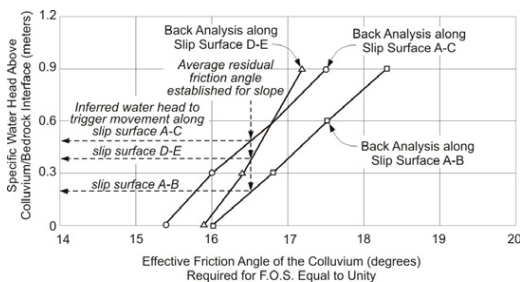
The variation of specific water head above the colluvium/bedrock interface versus residual friction angle of the colluvium producing a calculated factor of safety of unity is plotted in Figure 4. Also shown on this figure is the average residual friction angle established from the laboratory testing program and the corresponding water head required for a calculated factor of safety of 1. The predicted water levels are within the range of water heads measured in the piezometers installed as part of the geotechnical investigation. The results of the field program, laboratory testing program, and back-analyses plotted in Figure 4 for the slip surfaces shown in Figure 3 led the authors to the conclusion that the slope was marginally stable under zero water head conditions, but continuing downslope movement of SWR and colluvium would occur in response to significant precipitation. This prediction is consistent with observations in the field. Based on this conclusion, any revised environmental remedy for the site would need to also stabilize the slope to prevent continued movement. The approach to stabilization is discussed in the next section.

Figure 4. Relationship between water head and effective friction angle for a factor of safety of unity

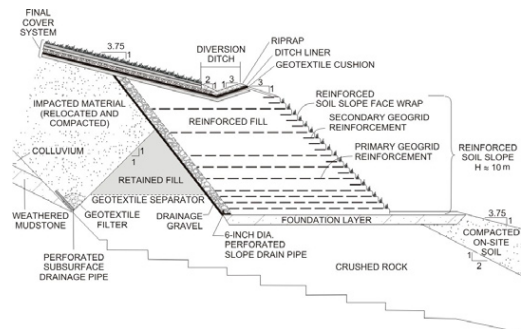
Figure 5. MSE/CR buttress cross-section

A slope stabilization plan was developed incorporating a geosynthetic-reinforced, mechanically stabilized earth and crushed rock buttress (MSE/CR buttress) keyed into bedrock near the toe of slope. A cross-section drawing of the MSE/CR buttress is presented in Figure 5. Compacted crushed rock having a high angle of internal friction comprises the lower portion of the buttress. The crushed rock portion of the buttress disrupts and intersects the zone of critical potential slip surfaces within the colluvium. The overlying MSE portion of the buttress was constructed on top of the crushed rock to both increase the normal stress in, and hence frictional strength of, the crushed rock and also to retain the SWR and colluvium consolidated from other areas of the site.

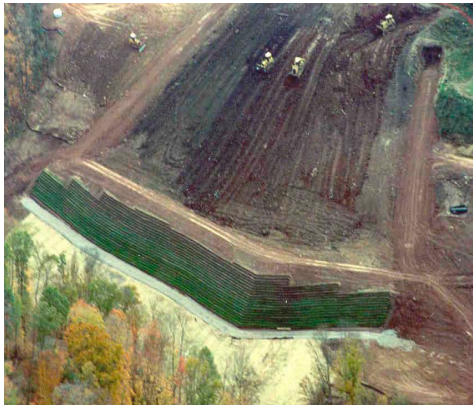
Figure 7. Placing impacted material behind MSE/CR buttress

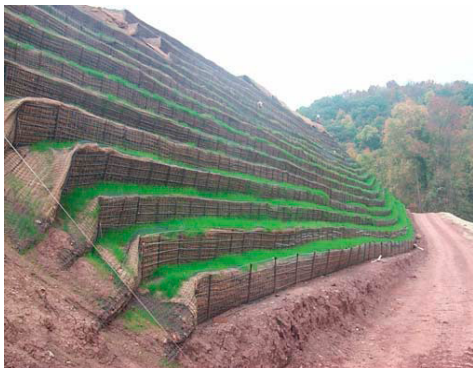
Figure 8. Front of MSE/CR buttress

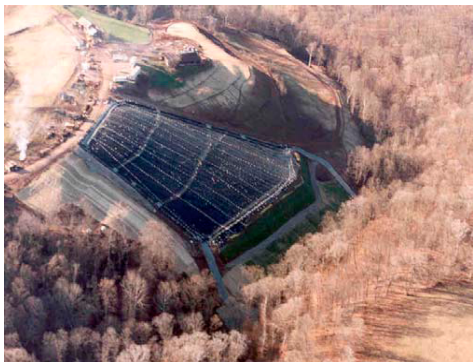
Figure 9. Site after installation of geomembrane

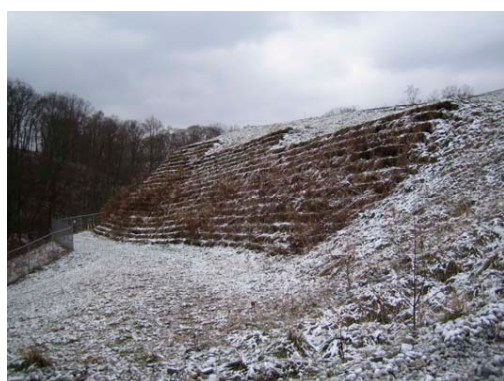
A site visit was conducted in November 2005 as part of scheduled monitoring. The MSE/CR buttress (Figure 10) and surface of final cover system were observed to be in good condition (Figure 11).

Figure 10. MSE/CR buttress in November 2005

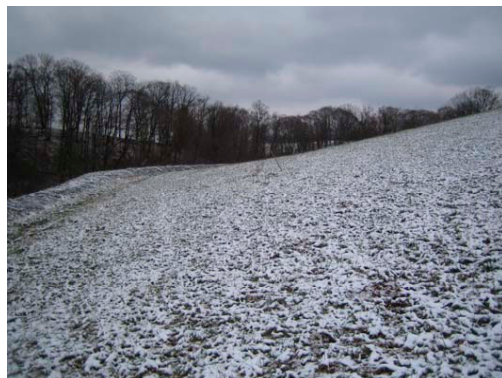
Figure 11. Top of MSE/CR buttress and storm water controls (left side) and RCRA final cover system (right side) five years after construction
