# DIAGNOSIS OF A LANDFILL COVER FAILURE. THE RELEVANCE OF PROPER INSTALLATION PROCEDURES.

The case study that will be presented is fully described in Lopes *et al.* (2003) and refers to a USW landfill located in the North of Portugal, serving an area where shoe industry is of the utmost relevance.

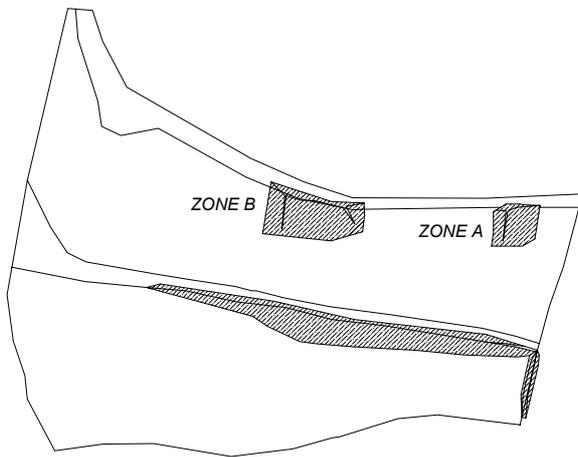
In the beginning of 2003, during an abnormal rainy winter, several localized failures were identified in the lower slope of the landfill cover system (Figure 1).

Figure 1 Cover system failures location.

As shown in Figure 1 failures took place on the lower slope of the landfill cover, and the presence of leachate was observed nearby. In fact, the percolation of this solution along the geocomposite drain (GCD) is, probably, the major reason for the ruptures, as its chemical aggressiveness can change the mechanical properties of the geosynthetics and prone them to failure.

- Zone A (see Figure 1), which was the failure area where heavy concentration of leachate was found;
- A stable area of the cover, without the presence of leachate.

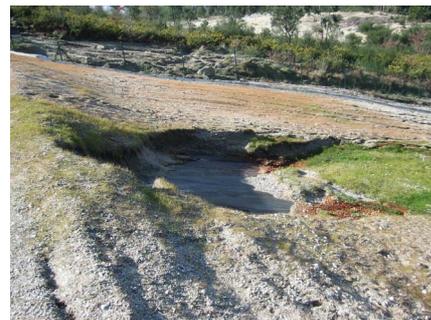
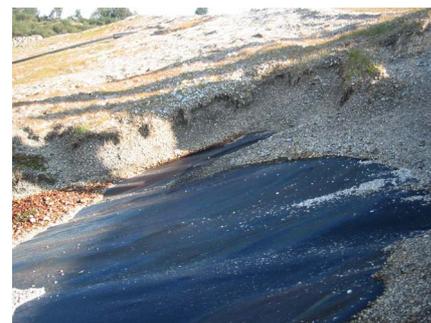
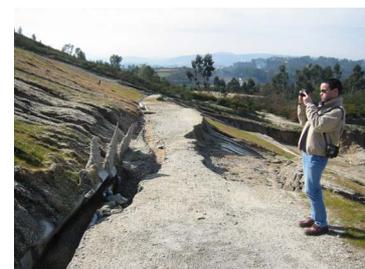
In the site it was observed, not only the slippage of the cover soil, but also the rupture of geocomposite drain constituents of the cover system. Moreover, it was confirmed the presence of leachate nearby the failure areas.

Figure 2 Failure overview.

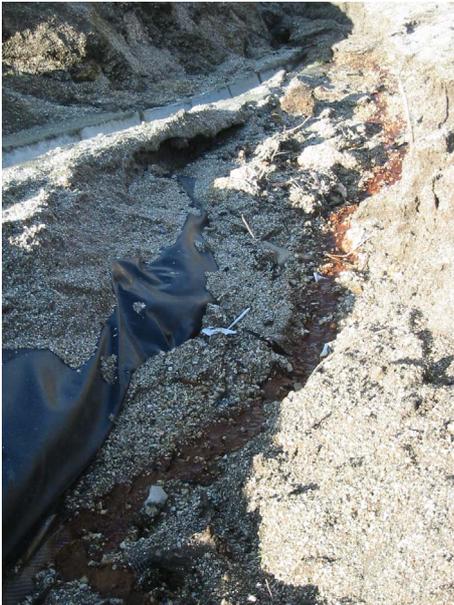
Figure 3 Leachate percolation along the landfill cover.

However, as the oxygen content of the leachate is low, the oxidative effect of the solution is not related with the dissolved oxygen, but with another oxidant chemical species, which was identified as chromium VI (Cr (VI)).

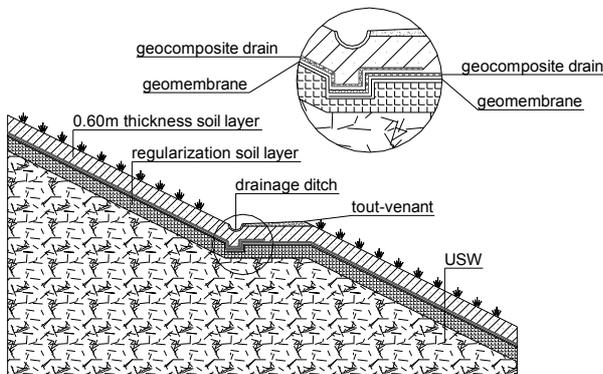
Figure 4 Landfill cover system detail.

Mainly because the sealing requirements between the upper and the lower slope's geomembranes were not assured. In fact, as shown in Figure 4, geomembranes are overlapped, but not welded.

The landfill cover failures could have been avoided if the geomembrane junctions were welded and if the tightness of system, both against rainwater and leachate was effective.

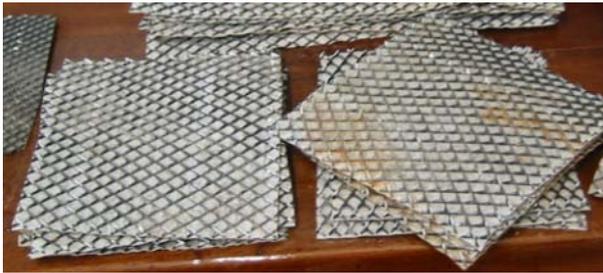
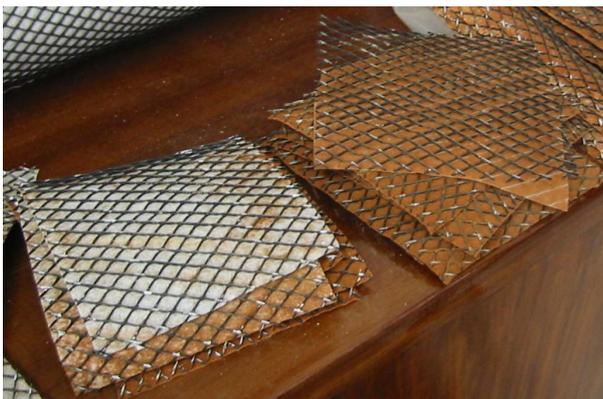
Figure 5 Specimens of the exhumed material: a) GCD<sub>DRY</sub> ;b) GCD<sub>WET</sub>.

In fact, tensile strength in the machine direction reduces about 47% when the geocomposite drain had been in contact with the landfill leachate.

Probably, the heavy oxidant leachate, due to its high chromium content, partially oxidizes the main polymer constituent of the geocomposite drain (polyethylene), leading to reduction on the mechanical resistance of the geosynthetic.

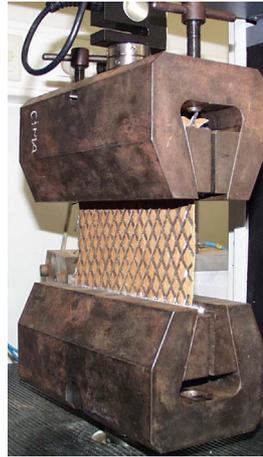
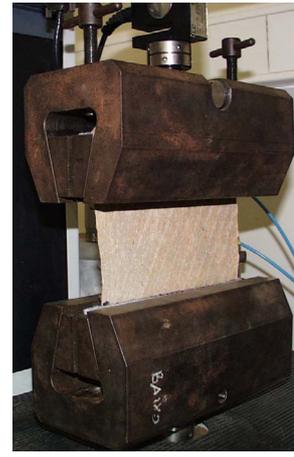
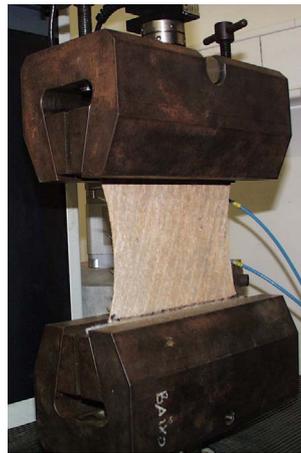
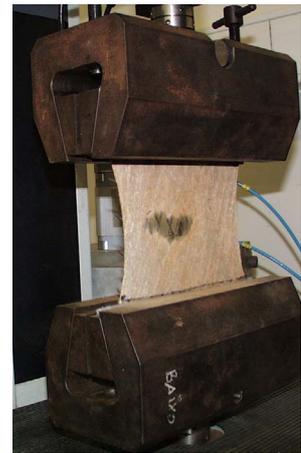
Figure 6 Tensile test of GCD<sub>WET</sub>.
