# LANDSLIDE AT THE JAKUSEVEC LANDFILL

A. Vukelic

Civil Engineering Institute of Croatia, Zagreb, Croatia

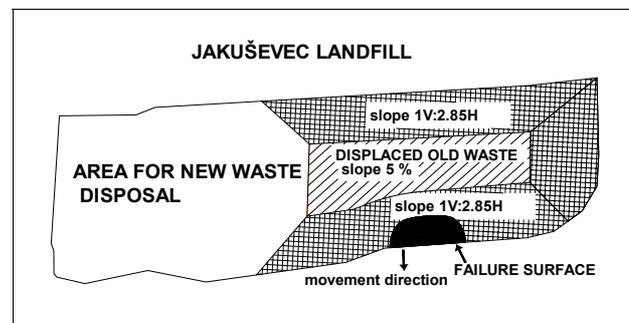
Figure 5. Position of the slide at the landfill

In August 2002 a locally contained slide was noticed at the south side of cell 3 at the bottom of the deposited waste slope. A slide position scheme on the landfill layout plan is shown in Figure 5. Old waste was deposited at this location after it had been relocated onto the rehabilitated cell in a very short period of time of approx. one year. At the moment the slide appeared, waste had been deposited up to the elevation of approx. 150 m a.s.l., i.e. approx. 4 m below the designed elevation.

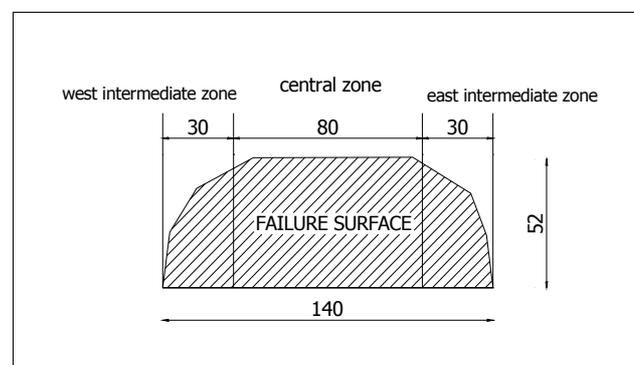
Figure 6. Slide zones

Clear edges of the slide were not fully pronounced due to high plastic properties of waste but it was possible to determine the slide-affected area with great accuracy based on fissures created in the zone of large displacements and based on the topographical survey. The slide is approx. 52 m long and 140 m wide (Figure 6). It has spread over estimated 100.000 m<sup>3</sup> of waste.

Considering the extent of deformations, the slide area may be divided into *peripheral (intermediate) zones*, where no significant waste displacements occurred and the bottom liner geosynthetics only wrinkled up (see Fig. 7), and the *central zone*, where all major displacements occurred, of both waste as well as of all bottom liner materials (see Fig. 8).

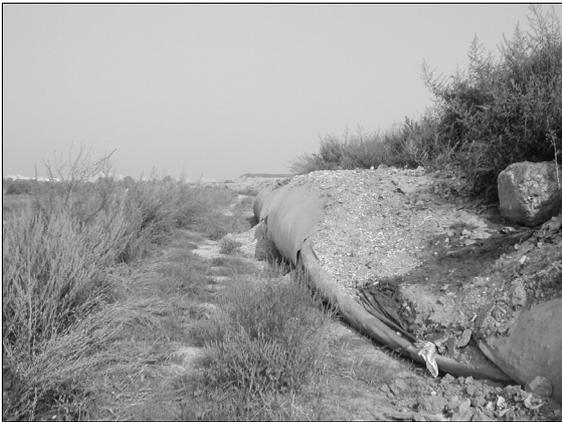
Figure 8. Deformations in the central zone

The detail of the perimeter berm constructed in accordance with the design is shown in Figure 9, whereas material deformations in the central zone of the slide are shown on the perimeter berm detail in Figure 10. Maximum horizontal waste displacement in the central slide zone is approx. 8 m.

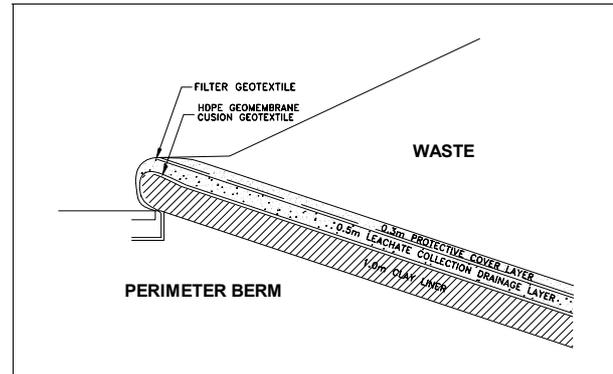
Figure 10. Perimeter berm scheme in the central zone of the slide

It was noticed by visual inspection at the bottom edge of the slide (perimeter berm crest) that the slide has developed at the interface between the clay liner and the berm.

In this section the geomembrane is deformed along with the drainage gravel, and filter and protective geotextile (Fig. 10). Furthermore, it has been assumed that the slip plane has affected the clay liner right underneath the geomembrane, except at the top of the perimeter berm (Fig. 10) where the slip plane has also affected the soil underneath the clay liner.

It should also be mentioned that, after the slide occurred, leachate from the slide-affected area was not noticed to drain outside the waste body, i.e. it was not reaching the leachate drainage system shaft located on the outer side of the perimeter berm. It has been concluded that the drainpipe connection with drainage at the inner toe of the perimeter berm has been damaged during the displacement of bottom liner materials.

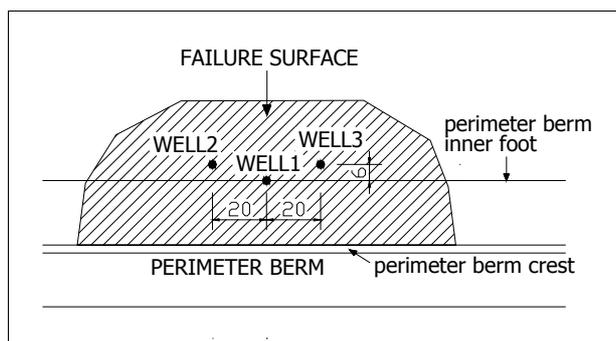
Figure 11. Location of wells

Three wells were constructed at the lowest position of the bottom liner (at the inner berm toe near the leachate drainpipe). The purpose of these investigations was to establish by visual inspection the waste content and properties; the level of leachate inside the waste; as well as the impact of water pumping inside one well on the level of leachate inside other two wells. Location of those wells is shown in Figure 11.

- According to content and properties, the waste deposited in the slide area does not differ from the waste deposited at other parts of the landfill. Larger quantities of old inert waste have been deposited, soil and construction materials, along with municipal waste.
- According to initial measurements carried out in September, the measured level of leachate from the top of the clay liner was as follows: 1.1 m for WELL1, 0.7 m for WELL2 and 11.5 m for WELL3.
- By pumping water from one well, the water level did not change in other wells.
- After water from the pumps had been pumped, further measurements were carried out up until December 2002, which have indicated that leachate remains inside the leachate drainage gravel layer.

Varying water levels measured in the wells, suggest that perched leachate (Koerner & Soong, 2000) may exist within the waste. This has also been confirmed by a test where pumping water from one well does not influence the water level in other wells. Leachate lenses have been created probably because, along with municipal waste, larger amounts of low-permeability earthen materials are also deposited at this section of the landfill.

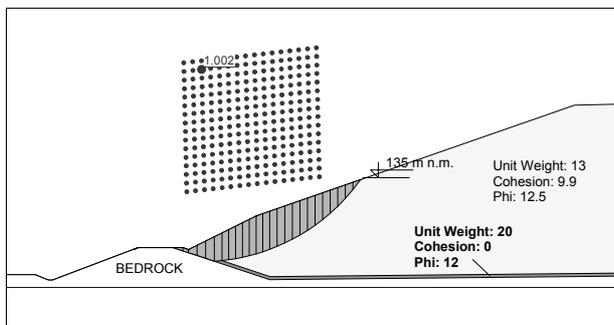
Figure 13. Back stability analysis where the slip plane does not spread over to the bottom liner

When the bottom liner shear strength parameters are selected according to laboratory results ( $c=0 \text{ kN/m}^2$ ,  $\phi=12^\circ$  and  $c=0 \text{ kN/m}^2$ ,  $\phi=9^\circ$ ), slip failure plane runs almost entirely through the waste and does not spread over to the bottom of the cell (Fig. 13).

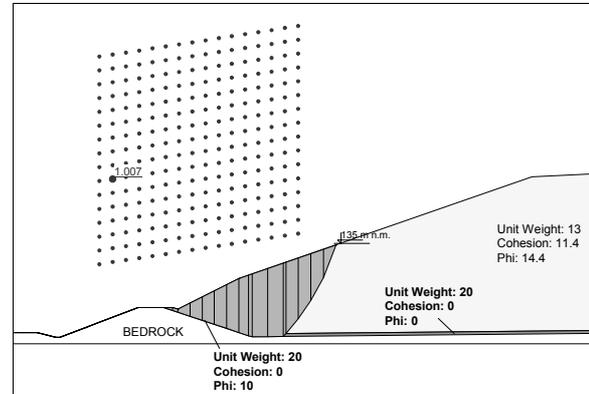
Figure 14. Back stability analysis where the slip plane spreads over to the bottom liner

Due to large displacements of the bottom liner materials but mostly due to the fact that the drainpipe connection with drainage at the inner perimeter berm toe was damaged, it may be concluded that the actual slip plane spread over to the bottom liner at the bottom of the cell. The same result has been obtained in back analyses where no bottom liner shear resistance at the cell bottom ( $c=0 \text{ kN/m}^2$ ,  $\phi=0^\circ$ ) was applied, whereas bottom liner parameters at the perimeter berm were in keeping with prior laboratory testing or were just slightly lower ( $c=0 \text{ kN/m}^2$ ,  $\phi=12^\circ$  or  $\phi=10^\circ$ ).

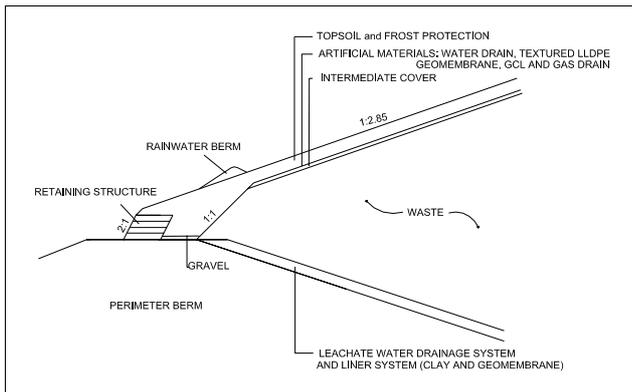
Figure 14. Cross-section of the rehabilitated landfill section

It is assumed that the displacements created during sliding caused damage to the bottom liner geomembrane. Since a 1.0 m thick clay liner has been placed underneath the geomembrane, and under the clay liner a clay material fill 3.0 to 4.0 m thick, it has been concluded that these layers provide adequate protection barrier with regards to the leachate inflow to the underground, and that there is no need to repair the damage made to the geomembrane. Furthermore, it has been decided that a 1 mm thick textured LLDPE geomembrane will be placed along the GCL as an additional liner inside the landfill cover system, not proposed at other landfill slopes, in order to bring infiltration of the rainfall water into the waste to a minimum.

After it was established that, from an environmental point of view, an acceptable rehabilitation does not require waste relocation, it has been proposed that the rehabilitation include the construction of a retaining structure at the bottom of the deposited waste slope that would secure its stability. Calculations have been carried out that have shown that such rehabilitation will provide satisfactory stability factors. Thus, safety factors ranging from 1.32 to 1.70 for reduced waste and bottom liner shear strength parameters (parameters that, during back analyses of slide causes, yielded safety factors approx. equal to 1.0) are obtained for the final rehabilitation stage. Stability analyses for all rehabilitation stages and earthquake loads have also been carried out, and it has been established that the risk form slope sliding is low enough. Cross-section through the central slide zone is shown in Figure 14.

A retaining structure made of reinforced soil consisting of well-graded gravel material and geonet will be constructed at the toe of the berm. The retaining structure width is 3.0 m, its maximum height 2.0 m, with the front surface sloped at 2V:1H.
