EARTH PRESSURE REDUCTION BY GEOTEXTILE-REINFORCED LIGHTWEIGHT FILL

V. Herle

SG GEOTECHNIKA, a.s. Praha, Czech Republic

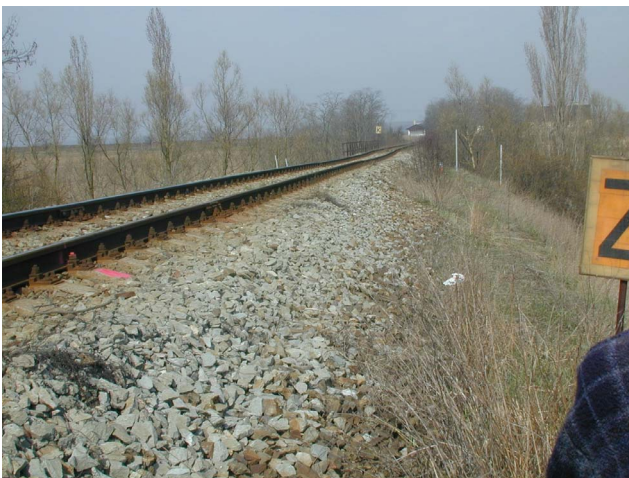
The second-class railway line at the Kněžice village near Žatec (W Bohemia) suffered in the past several years continuous settlement of 12 m high embankment near the bridge over the local stream. The deformation of rails ranged about 100 mm and more every year and required frequent filling up and tamping of the ballast to keep the railway line trafficable. Deformations of embankment influenced also deformations of the bridge abutment and wing walls. The rising costs for the track maintenance and apprehension from the continuous degradation of the stone wing walls forced the Czech Railways to call a tender for design and execution of the most suitable and economic solution. Deformed track is evident at Figure 1, deformed wing wall on Figure 2.

Figure 1 Deformed rail track near the bridge

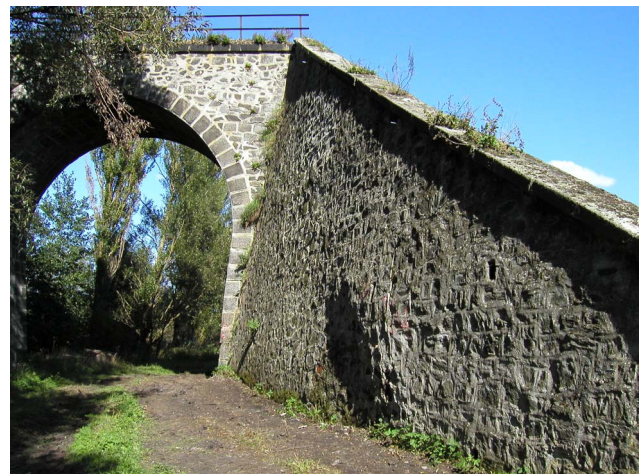
Figure 2 Deformed wing wall

The movement of the wing walls by earth pressure was caused mainly by insufficient design (over 100 years ago) of the wall. Less than 2 m thick gravity wing walls could not resist the earth pressure of 12 m high fill of mostly clay soil. However, the stone wing wall was shifted in one piece with some local distortions.

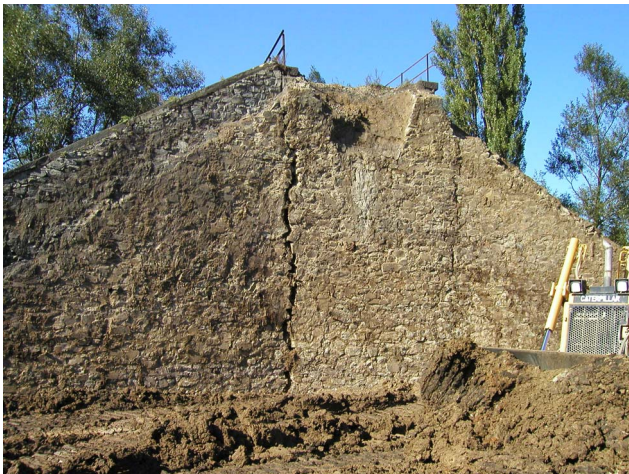
The geotechnical study had shown that the embankment was constructed from highly plastic clay (CH) that was poorly compacted. The upper 3 m of embankment were built from burnt coal slag (ash) with important quantity of unburned coal. Thickness of the ballast layer reached 2 m some places due to continuous tamping of the deformed track. In this way the weight of the track had gradually increased. The numerical analyses, supported by the field observation prove that the mechanism of the embankment deformations was combination of sliding and spreading. This movement was due to low shear strength and ductile behaviour of the poorly compacted clay soil and ash fill. Bringing more ballast to the top of embankment for filling depressions in the track was increasing weight that resulted in increase of driving forces. Weight increase at the top of the embankment and higher water table at the toe generated sliding (spreading) of the fill over the terrain surface. In addition to that the wing walls of the bridge were gradually shifted (rotated) by the earth pressure for almost 0,5 m along the vertical joint with the bridge abutment. This movement caused separation of the left wing walls from the abutment by 0,3 m wide vertical crack (see Figure 3). The right wing wall was also separated from the abutment but the width of the crack was substantially less. It was quite surprising that the highly damaged walls were still standing.

Figure 3 Vertical cracks separating wing walls and bridge abutment (inner side)

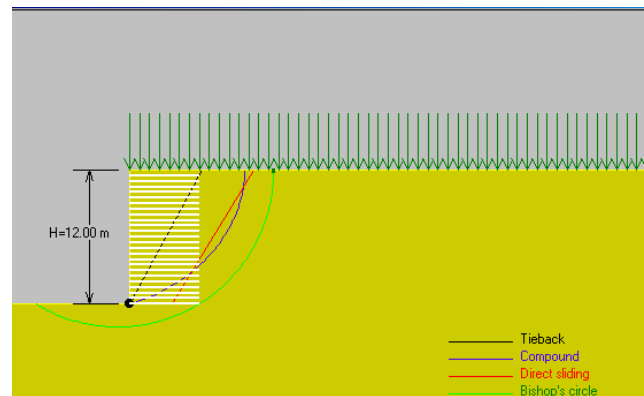
Figure 4 Calculation scheme of the wall reinforcement

For the design of the wall reinforcement we used “ReSlope (3.0)” software (ADAMA Engineering, Inc. USA). The calculation scheme is in Figure 4. Maximum design tensile force that was necessary to retain was 15 kN/m. The tensile strength of the recommended geosynthetic reinforcement was 60 kN/m. The calculated vertical separation of the reinforcement was 0,5 m, length of reinforcement 6 m from the inner face of the wall. The wrap-around system was proposed in order to prevent fall out of the aggregate during demolition of the stonewall. The design respected the Czech technical code for use of geotextiles and geotextile-related products in the fills of highway constructions TP 97 where the design of reinforced soil structures is described.

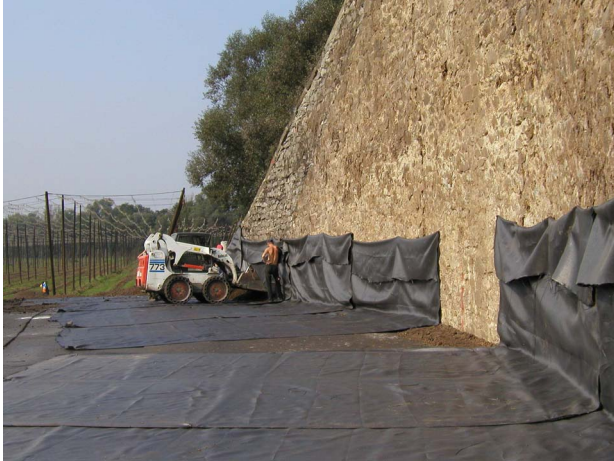
Figure 5 Laying geotextile reinforcement on the compacted soil

affected by high pH value of the surrounding environment. The geotextile used for soil wall reinforcement had tensile strength 60 kN/m. This low value of the tensile strength was possible due to the use of lightweight ceramic aggregates at the contact with bridge abutment and wing wall. The density of compacted lightweight fill was 3 kN/m³ only, i.e. more than 6 times less than density of the compacted soil fill. Laying the geotextile reinforcement and its temporary fixing on the wing wall is on Figure 4.

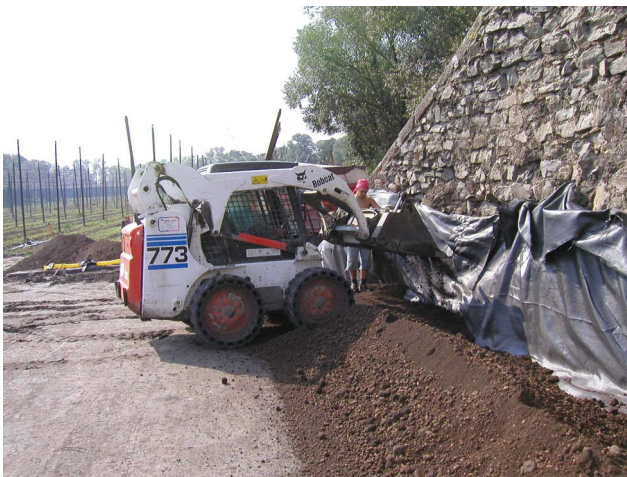
Figure 6 Placing lightweight ceramic aggregate on the geotextile near the abutment

The lightweight ceramic aggregate was spread on the geotextile by using a small loader that could ride on the geotextile without damaging it. The installation damage factor was considered $F_{dam}=1,15$, however in reality the measured value was $F_{dam}=1,04$. The placing of the lightweight ceramic aggregate on the geotextile near the damaged stone wing wall is at Figure 6.

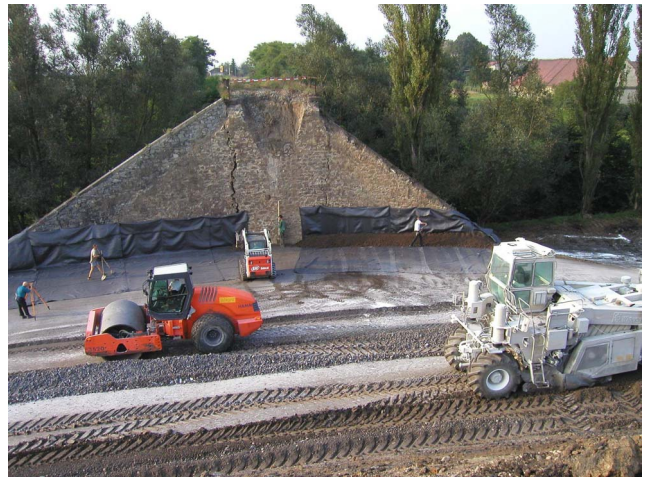
Figure 7 General view of the site during the stabilisation and soil reinforcing works

General view of the limited space at the construction site during lime improvement of the soil by mixer, soil compaction and geotextile reinforcement of the lightweight ceramic aggregate is on Figure 7.

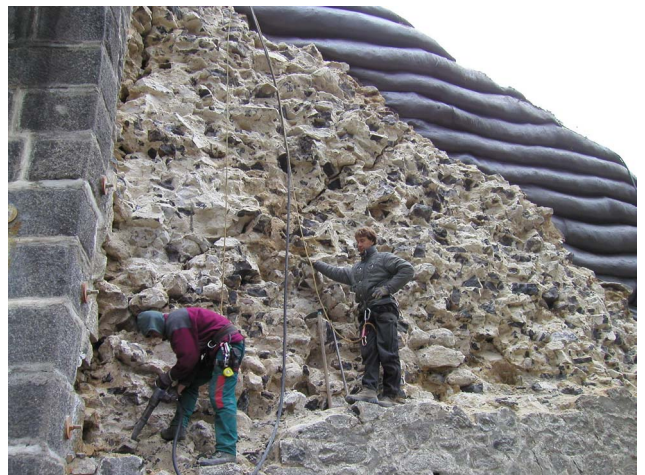
Figure 8 Demolishing of the upper part of the stone wing wall

The following year the damaged wing wall was carefully dismantled. Due to its very bad condition the work in the upper part of the wall had to be done by special team of mountaineers. Lower part was demolished by use of hydraulic and mechanical breakers mounted on the crane (see Figure 8).

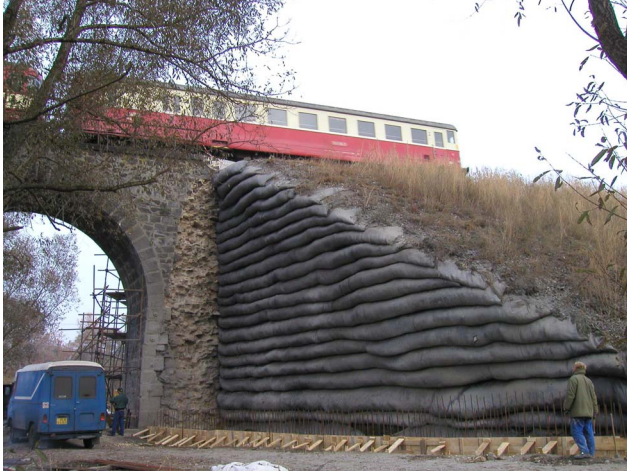
Figure 9 Reinforced soil wall after the stonewall removal

graphical observation of the deformation of the reinforced soil wall. This measure was needed because the wall removal was done during full railway operation as can be seen on the Figure 9. During the demolishing work and the new wall construction as well as after the completion no deformation has been recorded. The reinforced soil wall has behaved well and even the Contractor caused no damage to the geotextile reinforcement during the stonewall removal.

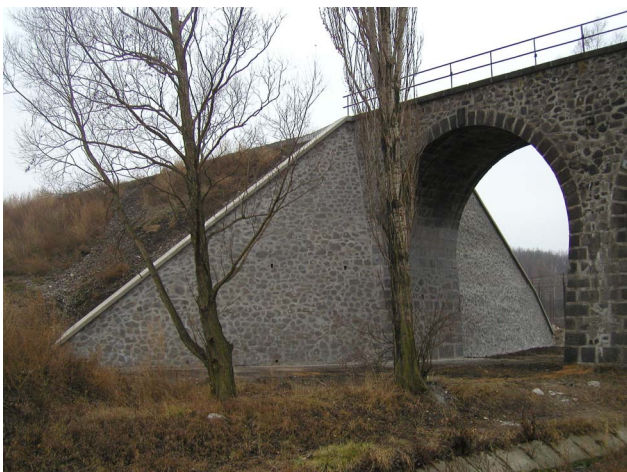
Figure 10 Reconstructed bridge and the embankment

Highly deformed railway embankment was stabilised by replacement of the old fill with the same soil that was improved with lime and reinforced with 60 kN/m strength geotextile. In order to completely eliminate the earth pressure on the damaged bridge abutment and wing walls, lightweight ceramic aggregates were used in 2 m thick contact zone between the damaged walls and lime-improved soil embankment. The damaged stonewall was removed the next year and a new concrete wall with stone cladding was built (see Figure 10). No deformation of the track, embankment or the new wall has been observed.
