An investigation of the durability of the soil nailing method

S.Tayama, Y.Kawai & H.Maeno

Research Institute, Japan Highway Public Corporation, Tokyo, Japan

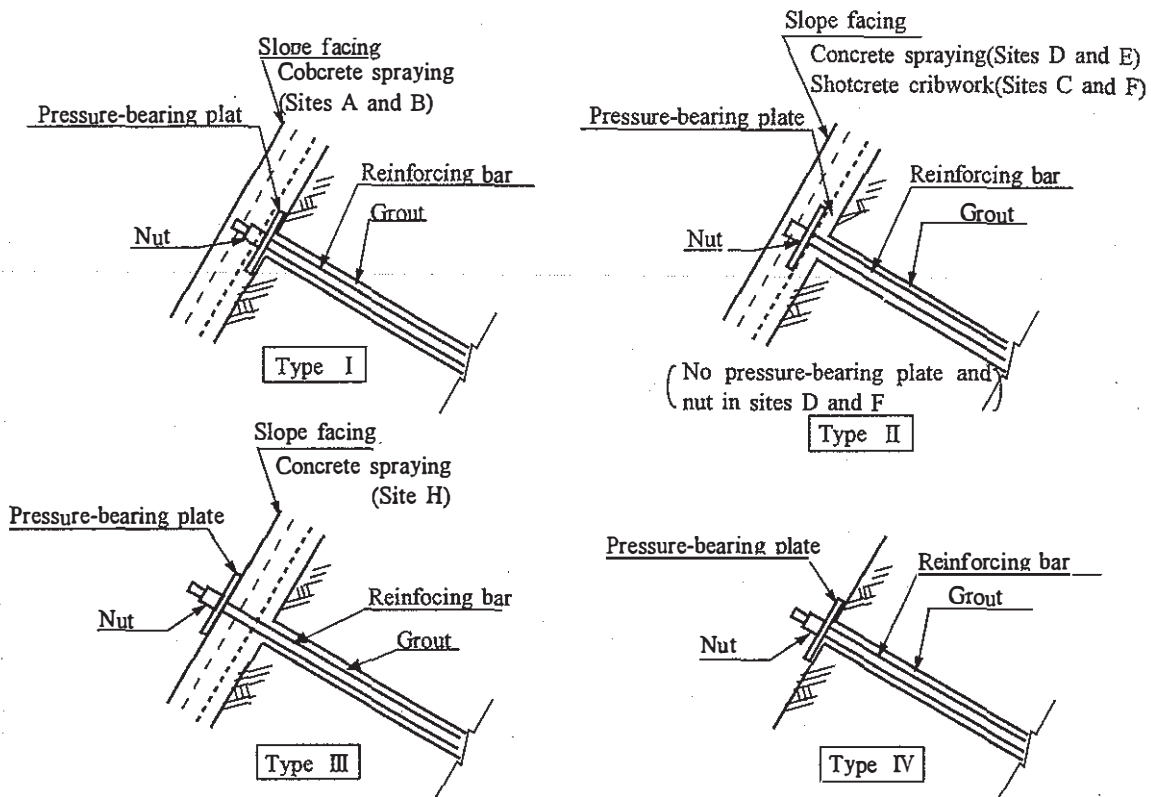
Now let us see the relation between the slope facing types and corrosion of the bar heads. Such corrosion was observed in the sites A and B where adopted was the type I facing under which the pressure-bearing plates contacted directly with the natural ground and in the site I where adopted were the type III and IV

Fig. 1 Type of slop facings.

facings which exposed the pressure-bearing plates to the open air. The bars in the sites G and H had galvanized heads and corrosion was slightly observed in their threaded areas in the site H only. No bar-head corrosion was observed in the sites of the type II, except the site D where the bars bent in advance contacted the natural ground in part where corrosion was observed.

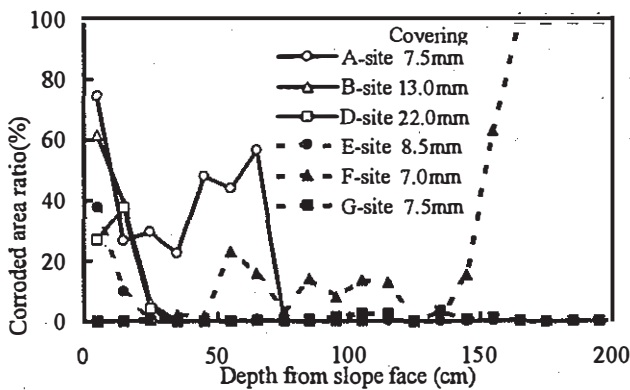
Fig. 2 Distribution of corroded area ratio.

Fig. 2 shows the distribution of the corroded area ratios of the representative bar of every site. In case of the site C, no corrosion was observed at all. Fig. 3 is a typical illustration of corrosion factors, of which the

discussion follows. About a half of the reinforcing bars in the sites A, B, D, and E presented corrosion in the depth of up to 30 cm from the ground surfaces, and some of them pitting corrosion, too. It appears to be the cause of this corrosion that some of the grout permeated into the soil after injection, creating a shortage in the upper space of the bore.

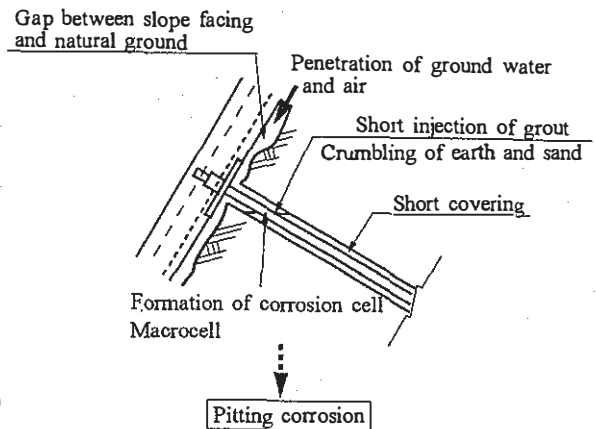
Fig. 3 Corrosion factors presumed.

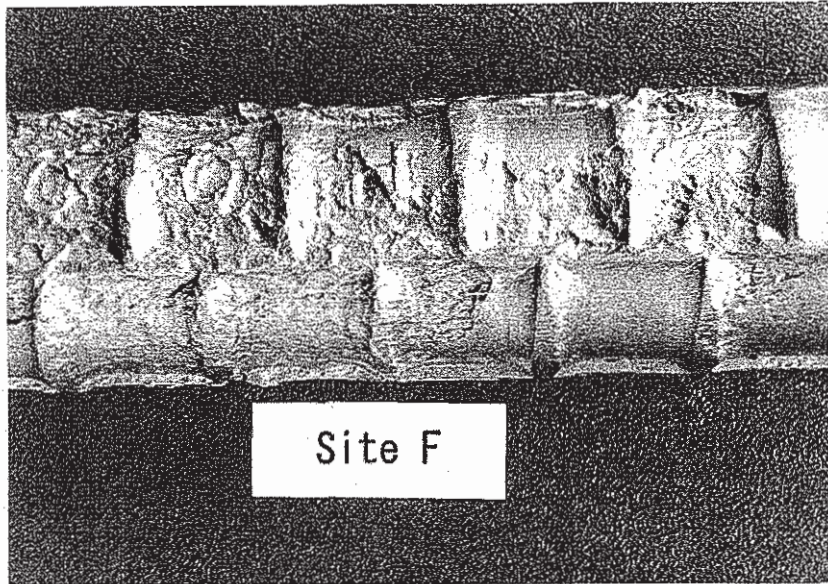
The reinforcing bars in the sites A, F, and G (just slightly, here) presented corrosion in deep areas. Photo 1 shows the condition of a sample which was collected from the depth and the corrosion products were removed from. On the other hand, no corrosion in the

Photo 1 Corrosion of reinforcing bar (Site F).

depth was observed in the sites B, C, and D where the coverings were over 10 mm. These observation results suggest that short coverings and inadequate injection of grout caused the corrosion in the depth. Besides, the site F was located in a corrosive environment, which should have furthered the corrosion.

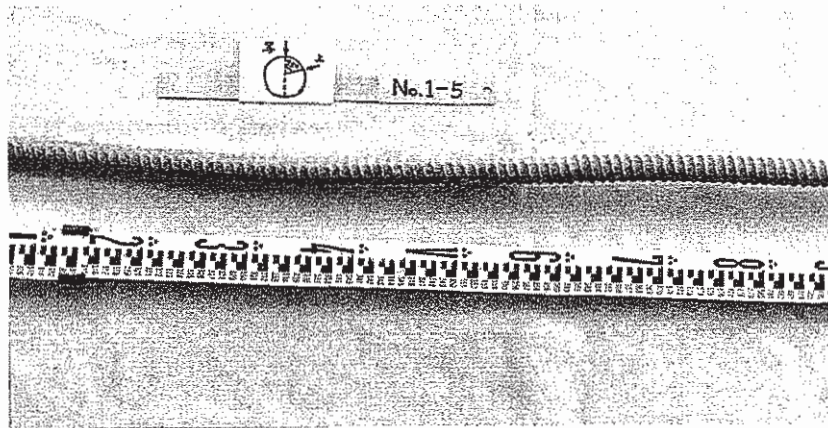
Photo 2 Bend of reinforcing bar (Site G).

Some of the reinforcing bars sampled in the sites A, B, C, E, and G were bent. Photo 2 shows the bending condition of a bar of the site G, which seems to have been taking a bending resistance. A reinforcing bar in the site A had a bend near the ground surface and, therefore, its preexistence could visually be confirmed during the first several tens of centimeters of the boring.

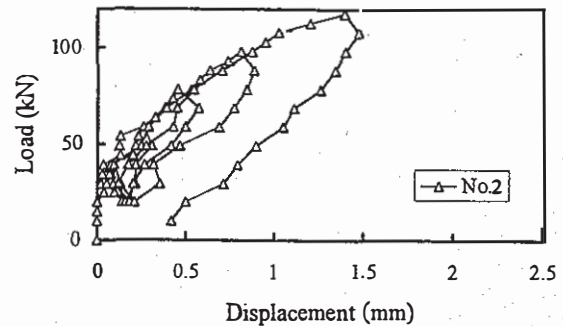
The pull-out tests were performed on three reinforcing bars in the site D, and the result of the representative case is shown in Fig. 4. No yielding or pulling out was observed in this load range. Besides, the displacement under the load of 100 kN was only of the order of a few millimeters and the residual displacement only about 0.5 mm. It appeared from these results that this reinforcing bar and the grout were still functioning well.

Fig. 4 Result of pull-out test.
