# Application of soil nailing method to protection measures against failures of massive cut-slopes

Y.Naka, T.Kunioka & T.Iwasa  
*Hiroshima Prefectural Government, Japan*

M.Inoue, H.Sasaki & S.Mori  
*Fukken Co., Ltd, Hiroshima, Japan*

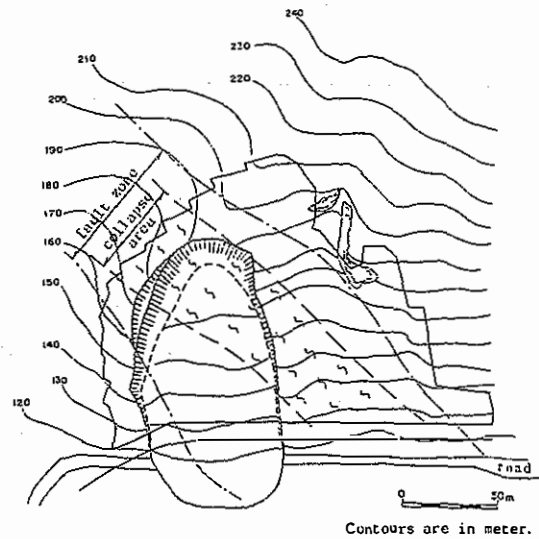
Fig.1 Plan showing slope-collapse area

**Collapse :** During the temporary road construction required for the excavation of a slope from above, a part of the road rehabilitation project, the slope collapse takes place at the middle of the fault zone with the dimension; height 80m, approximate width 70m and maximum depth 20m. Refer to Fig.1. The collapse of slope proceeds apace and the falling debris spreads up to the bed of the river Gonogawa destroying the protection fence of the temporary works. The slope collapse occurs in the rainy season. The rainfall recorded for the month before the collapse is 342mm which is comparatively high for the area in question.

The highly fractured rock of the fault zone and the steep slope of low strength that results from the prolonged erosion of soil by the rapid flow of the river Gonogawa are considered to be the causes of slope collapse. The secondary causes of the collapse are the rise of ground

water table due to continuous heavy rain and the excavation of lower portion of the slope.

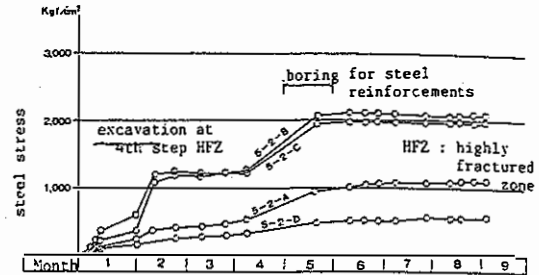
Fig.4 Changes in steel stresses with time

According to the results from measurement of steel stress by stress meters attached to the steel bars (refer to Fig.3) an abnormal increase in the steel stresses of the 5th step is confirmed. The increase in the stresses occurs in stages as shown in the graph of changes in steel stresses with time (Fig.4). The time of stress increase just coincides with the time of insertion of the steel bars after the excavation of highly fractured slope of 4th step. And the increase in stresses of the stress meters laid in the slope of 3rd and 4th step is small and it is less than 500

kgf/cm<sup>2</sup> at each point. Thus the abnormal increase in steel stresses of 5th step's slope is due to the fact that the steel reinforcement at the 5th step's slope is in a state of carrying a concentrated load as the original sliding soil mass moves its position under the pressure of slope cutting and bore-hole drilling. It is presumed that the measurement is not so much reliably trustworthy as the recorded steel stress at 5th step's slope exceeds 3000 kgf/cm<sup>2</sup>. Hence the intensity of steel reinforcement is increased to two times the original designed reinforcement by installing additional reinforcing bars. The additional reinforcement has an increase in stress less than 200 kgf/cm<sup>2</sup> and this means that the stress increase is negligible.

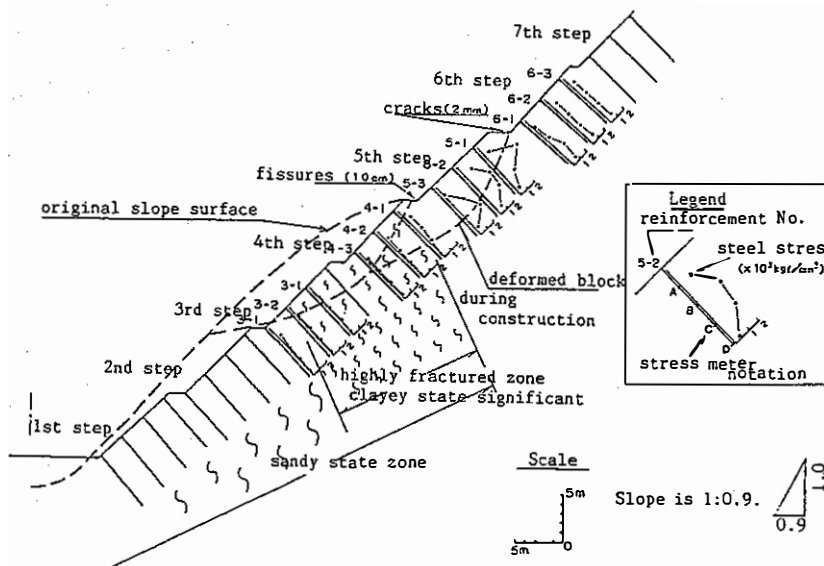
Fig.3 Cross-section showing steel-stress measuring points

When the reinforcement is completed up to the 7th step with the progress of the slope cutting on the 5th step, the slope on a part of the 5th to 6th step and the slope below it (not yet cut) are found fractured. Refer to Fig.3. The fracture is quite intense at around the toe of the 5th step's slope and the tensional fracture has a maximum width of 10cm whereas the 6th step's slope has only a few number of mm-thick fractures. As a result of measuring the deformation with the implacement of stress meters in the fracture the deformation is found to take place at the rate of 1mm per day for five consecutive days after the occurrence of fracture. This coincides with the time

After the slope's deformation stops the steel bars are inserted into the slope of 5th to 6th step and the construction works on the lower slope are carried out.
