Case study of Geotextile Method on extremely soft ground

ABSTRACT: The New Kitakyushu Airport is an off-shore airport constructed on the ground filled up by dredged soils from various port projects. Those dredged soils are classified as very soft clayed soil with over 300% water content immediately after discharged. For airport construction, the settlement acceleration work was necessary to be conducted with a view to secure trafficability and soil stabilization, and also to improve bearing strength of the ground. The Geotextile Method has been adopted for this purpose. As a large-scale rupture of geotextile occurred during construction, some countermeasures have been proposed to achieve safe construction based on those work experiences. Test soil stabilization works were carried out together with laboratory analyses to confirm the trafficability of the ground after sand spreading as a cover. The analyses confirmed that the geotextile rupture occurred due to differential strength distribution of ground, and non-uniform thickness of soil spreading accompanied by load concentration on geotextile.

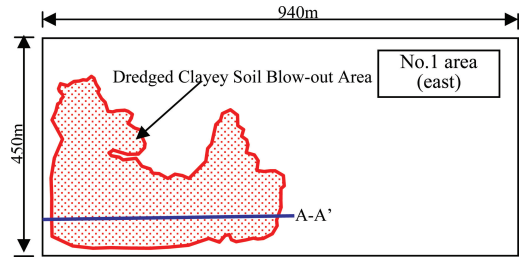
Figure 6. The scope of dredged clayey soil blow-out.

While around 50% of on-land conveying work that made use of granulated slag was in progress after the end of sand spreading by hydraulic conveyor technique, geotextile rupture suddenly occurred with the blow-out of dredged clayey soil extending to a wider area. First geotextile rupture occurred one point and got enlarged along revetment and inner separation embankment. In Figure 6, the scope of dredged soil blow-out and in Figure 7 the cross-sectional view is shown. From this it is found that the final dredged soil blow-out area is $440 \text{ m} \times 330 \text{ m}$; it is around $100,000 \text{ m}^2$ and the ground surface just before blow-out settled down more than 7 m with the pile-up of dredged soil on the upper layer.

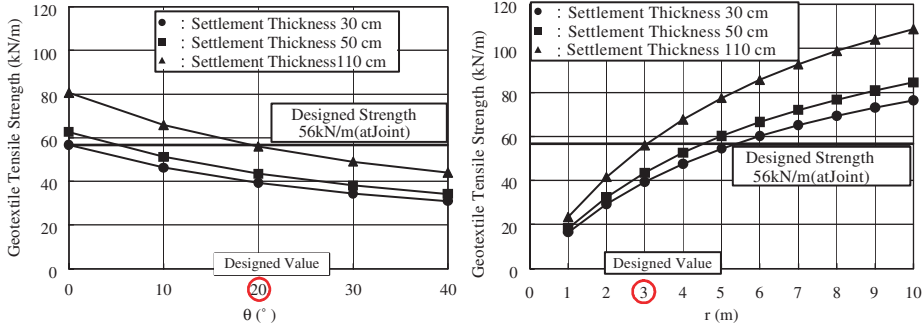
Figure 8. The relationship between r , θ and geotextile strength.

By equation 1, the required tensile strength of geotextile was determined assuming r and θ from ground's estimated bearing strengths.

Figure 8 shows the changes of geotextile's required strengths with the changes of r and θ . From this, when r is greater than the designed value, it is possibly estimated that a great tensile stress higher than the designed value was exerting on the geotextile.

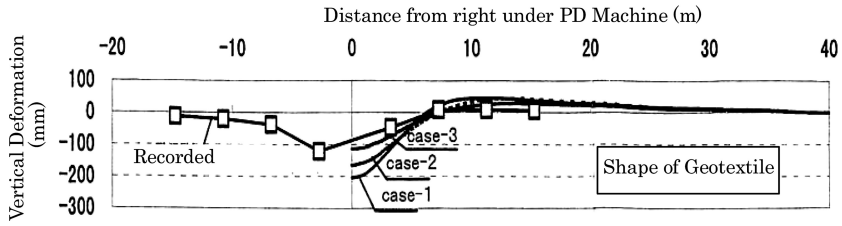
Figure 9. Results from FEM analysis.

Furthermore, the results from FEM analyses were shown in Figure 9. From this it is judged that CASE 3 reproduced the results obtained from loading tests.

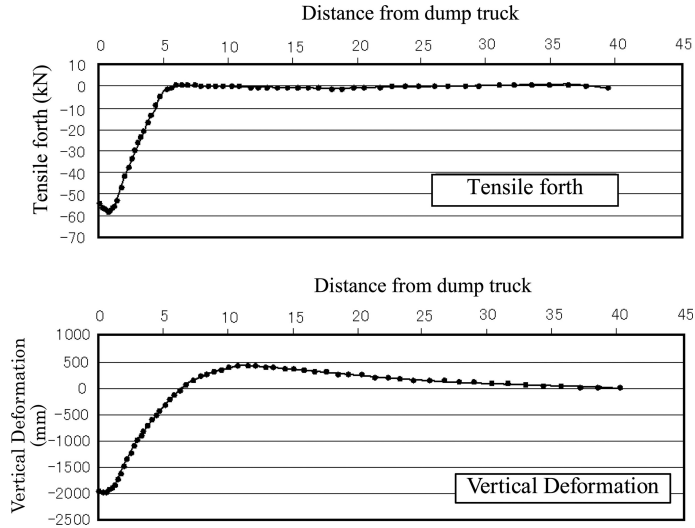
Figure 10. Results from FEM analysis.

The results from the analysis were shown in Figure 10. From this, the maximum tensile stress exerting on geotextile was 58 kN/m and geotextile settlement was 1.95 m.

Thus the maximum exerting tensile stress was far below the allowable tensile strength (80 kN/m) of the geotextile used in the project. Hence it was judged that the dump truck could safely be employed for the loading embankment construction.
