Trial construction of the reinforced river dike and its performance

K. Sawada, A. Yashima, Y. Sato & Y. Fujita
Gifu University, Gifu, Japan

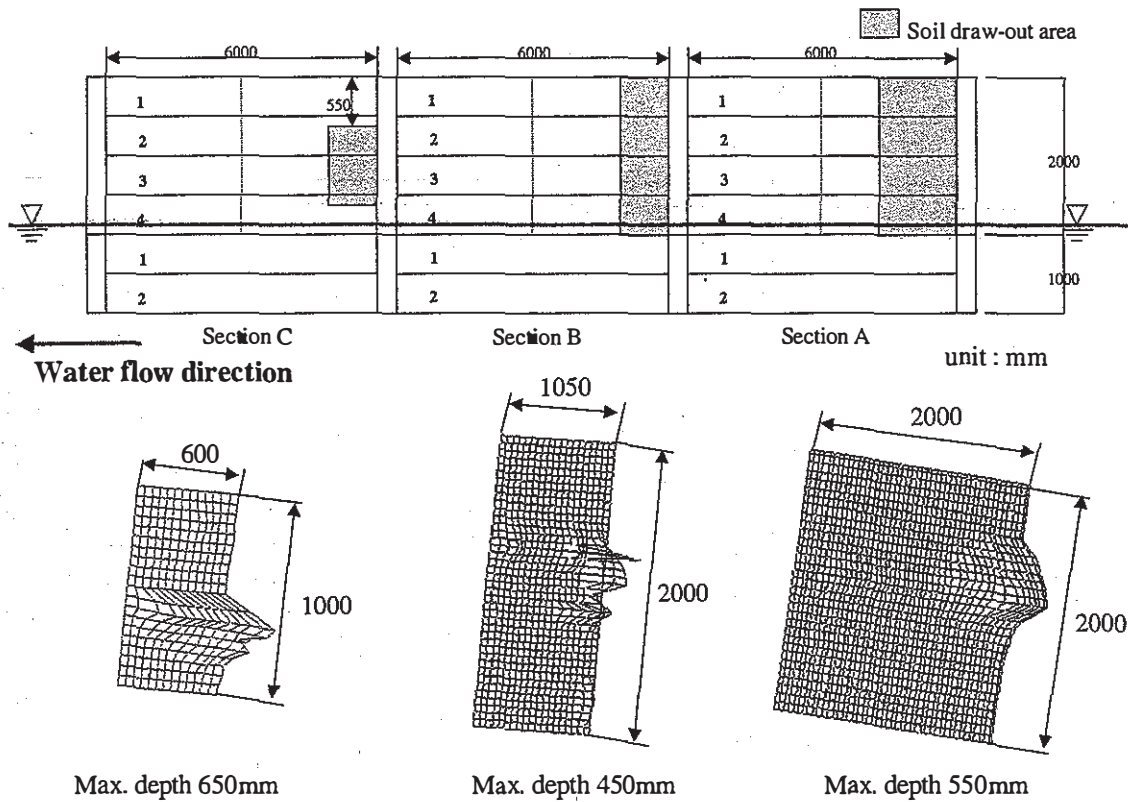
draw-out of filling materials from the slope surface of the dike. In order to investigate the situation of the draw-out, a frame with 10×10 cm grid was laid on the dike surface and the depth of the draw-out at every cross was measured by inserting a bar perpendicularly to the frame. It is found that serious draw-out occurred at the downstream side of concrete retaining sheets. The maximum values of the draw-out at Sections A, B and C are 55 cm, 45 cm and 65 cm, respectively. Figure 6 shows the distribution of the draw-out in each section. The reason why such a phenomenon occurred is that the resistances of the concrete retaining sheets and the dike surface are

quite different and consequently a turbulent flow happened at the downstream side of the sheet, resulting in the draw-out. Especially in Section A where a larger draw-out occurred as compared to the other two sections, the pipe was installed for setting up the measuring instrument at the concrete retaining sheet, which results in a large turbulent flow. In other words, if any extruded part of a structure exists, a turbulent flow will happen behind the extruded part, resulting in the draw-out of the materials.

Meanwhile, at the boundaries between different cover materials of the surface, a relatively larger draw-out was also observed. The reason is thought

Figure 6. Soil draw-out areas at each section and depth of cavity.

to be that the boundaries are easy to be eroded by the flowing water and become the origin of the draw-out.

During the observation, it is found that the draw-out at the second and third layers was most serious. The explanation of the phenomenon can be given clearly, that is, when the water level of the river increases due to flood, water flowed deeply into the reinforced soils through these two layers boundary. After the flood went away, the water within the soils flowed out and took away the soils.

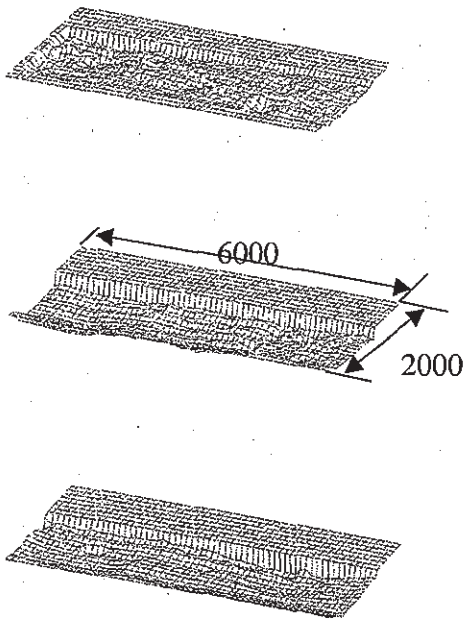
A serious flood due to a heavy rain happened from September 9 to 12, 2000. Because of the flood, the test site was also overflowed, the data logger flowed away and the top of the reinforced soil dike was eroded. Figure 7 shows the eroded top surface of the river dike at Sections A, B and C. The draw-out on the slope surface of the dike wall was also observed. The dike itself, however, was not destroyed and the retaining ability and endurance of the dike are remained in work. Figure 8 shows the situation of the dike one day after the flood. It is known from the figure that the water level was still very high, only 1 m below the top of the dike although the highest flood had passed one day before.

From the erosion of the top of the dike due to the flood, it is understood that in designing a reinforced soil dike, the erosion caused by flood should be considered. In present study, concrete retaining sheets are installed in the dike with each 6 m interval. Therefore, even if the retaining ability and endurance of the dike are confirmed during the flood caused by the heavy rain, it is still needed to confirm whether the retaining ability and endurance of a dike is still kept after a serious flood if the concrete retaining sheets are not installed.

Figure 7. Eroded top surface on each section.

Based on the damage of the first trial river dike, the construction of a geo-grid reinforced river dike is newly planned. In the planning of rebuilding, different checking items are proposed for each sections, for instance, the soil draw-out will be checked in Section A; the total safety of the embankment will be checked in Section B; the retaining effect of the surface coating will be checked in Section C. Of course, in the present case, suitable instruments will be installed on different sections according to their measuring items, based on which careful discussion will be done to find the weak points of the reinforced river dike which acts as a retaining structure of a river. Furthermore, as aforementioned, concrete

retaining sheets will not be installed at the boundaries between different sections this time because it will enhance the strength of a dike. It will be installed only at the beginning and ending sides of the test area.

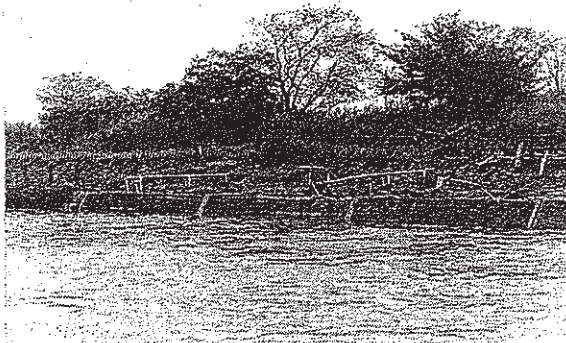
Figure 8. Situation of the dike one day after the flood.
