RECONSTRUCTION AND IMPROVEMENT OF DYKES BY USING LOCAL SOIL AND GEOSYNTHETICS

G. Heerten

Naue Fasertechnik GmbH & Co. KG, Lübbecke, Germany

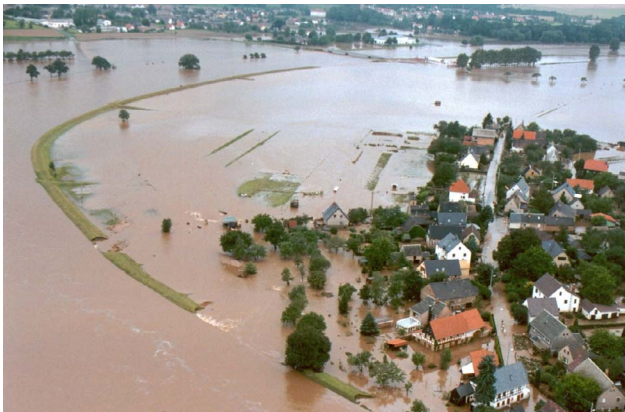
Dyke failures of comparatively "aged" old dykes characterize the damages caused by the floods at the German river basins of Donau, Oder and in 2002 at the Elbe River and its tributaries (see also Figures 1 and 2, more than 100 dyke failures along the Mulde River!).

Figure 1 More than 100 dyke failures and floodings in 2002

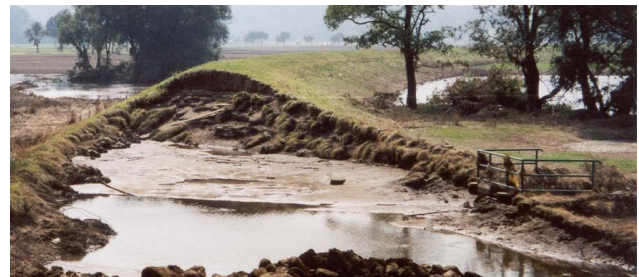
Figure 2 Mulde River dyke failure in August 2002

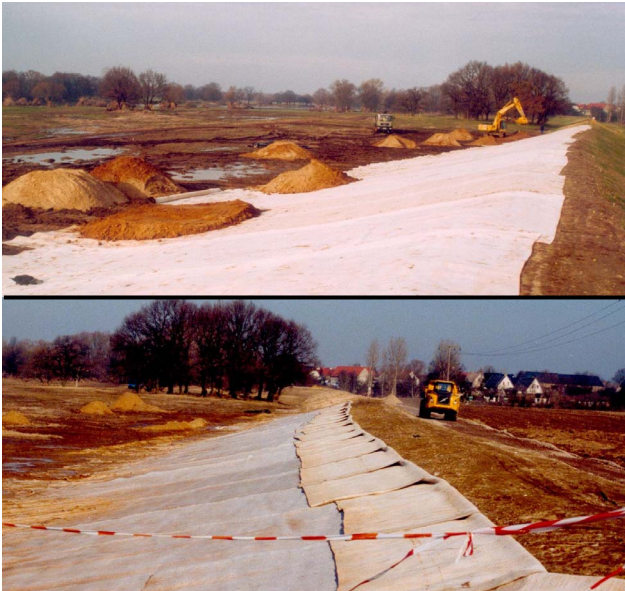
Figure 8 Mulde River dyke already protected during the construction phase: Installation of GCL on the slope at the water exposed side 2002 (top); already swollen but intact GCL which has been folded back to be able to drive on the dyke crown after the flood in winter 2003 (below).

The summer flood in the year 2002 caused more than 100 dyke failures at the Mulde River. In November 2002 sections of the Mulde River dykes to the north of Leipzig have been reconstructed within the framework of rehabilitation measures by means of a geosynthetic clay liner as dyke sealing system on the water exposed side. An installation of these layers during a frost period is no problem; however, the constructional accompanying measures, thus the covering of the GCL, could not be carried out in time because of the onset of winter. In February 2003 this region was again afflicted by a flood. At this time the rehabilitation works have not yet been finished and although the works at this dyke sealing project were still in progress the dyke where the already swollen GCLs have been installed without any soil coverage withstood this winter flood without any damages (Fig. 8). Thus, a sufficient protection against flood could be guaranteed even during the construction phase. After the winter flood has receded this project has been finished.

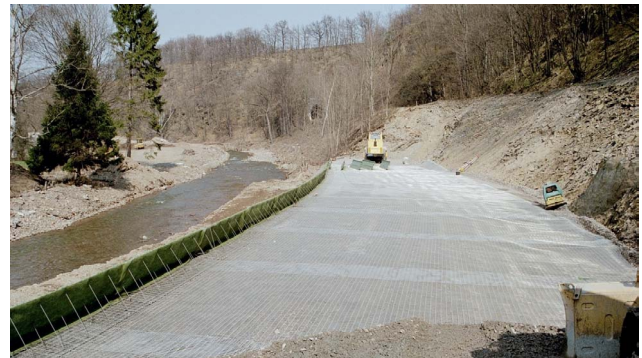
In consequence of the devastating floods in 2002 approximately 80% of the available infrastructure of the Müglitz-Valley near Dresden has been destroyed. Also the Weesenstein section of the Müglitz-Valley-Railway has been affected. Near Weesenstein the existing railway embankment and complete slope in direction to the Müglitz River flood have been eroded and destroyed by the flood water table and strong currents.

tensile strength. A crushed grain material (0/45 mm) has been used as fill material (Fig. 11).

Figure 11 Installation of geogrids as reinforcing as part of flood railway rehabilitation in Weesenstein (2002)

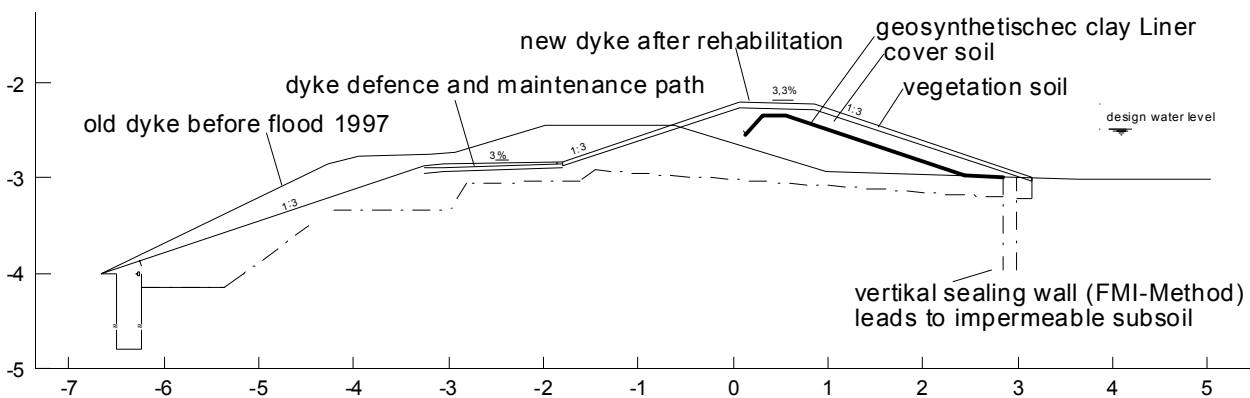
The summer flood in 1997 was an extraordinary event at the Oder River with a flood peak which remained on the same level for 14 days and where the highest recorded flood peaks have exceeded. The flood caused considerable dyke failures which have been repaired within the framework of an immediate programme for the rehabilitation of dykes and the general plan "flood protection Oder River" which have been brought into being by the regional authority for environment in Brandenburg (LUA). In 1997 leachates occurred at the land exposed side of the dyke in the area of Bad Freienwalde (northern area of the Oderbruch) as well as slippings of the slopes. All actions which have been taken included among others the elevation and widening of the dyke crown, a levelling of the water and land exposed sides of the dyke slopes as well as the installation of mineral load filters. The detailed rehabilitation programme is presented in a paper published by TÖNNIS, GRIOD & PAPKE (2002). The existing dyke has been removed - starting from the dyke maintenance road up to the slope toe at the water exposed side of the bench - and been displaced and reinstalled at the water exposed side (Fig. 10).

The slopes have been built up again in inclinations of V:H = 1:3 and a geosynthetic clay liner has been installed as dyke sealing. This GCL has been covered with gravel sand and top soil. Due to the special geological situation of the dyke subsoil a vertical sealing wall where the GCL is connected was installed in a vertical FMI-wall at the water exposed side of the dyke toe area.

Figure 10 Cross-section of Oder River dyke in Bad Freienwalde (TÖNNIS et al. (2002))
