Impacts of construction practices and reservoir filling on geomembrane uplift

ABSTRACT: This paper addresses a case history, illustrating a common phenomenon experienced during the first filling of liquids reservoirs lined with an exposed geomembrane. During the first filling of the considered reservoir, uplift of the geomembrane occurred. The analysis of the phenomenon shows that the uplifting was caused by air entrapped beneath the geomembrane. This paper discusses the causes of geomembrane uplifting and presents the method that was used to mitigate the problem. The paper shows that the designer's job is not finished upon completion of design, or even after all construction activities are complete. Provisions for the first filling of liquid reservoirs lined with exposed geomembranes are essential.

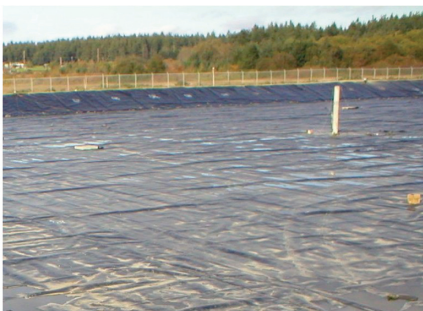
The installed geomembrane exhibited wrinkles (Figure 1). However, the height of these wrinkles (approximately 0.15 m) was considered normal for an HDPE geomembrane.

Figure 1. Wrinkles in the HDPE geomembrane at the end of installation.

Based on Figure 1 and the size of the lagoon bottom (178 m × 105 m), one may consider that there were of the order of 500 wrinkles distributed throughout the lagoon bottom. These wrinkles had the following typical dimensions: 3 to 10 m long, 0.15 m high and 0.3 m wide. As a result, it can be estimated that a volume of air between 50 and 100 m³ was entrapped in the wrinkles. During the first filling, a fraction of this air was pushed toward the vents by the water pressure, and a fraction accumulated in wrinkles located in the north half of the lagoon to form 15 to 20 bubbles of approximately 3 m³ each.

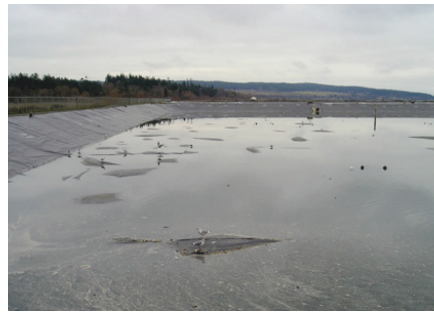
Shortly after completion and certification of the liner system, the owner began filling the lagoon with water from the wastewater treatment plant. When the depth of water reached approximately 0.2 m at the lagoon north end (and approximately 1 m at the south end), it was noted, at 15 to 20 locations, in the north half of the lagoon, areas of the geomembrane were emerging slightly above the water level. These “bubbles” are shown on Figure 2. With continuous filling, and after several days, there was no diminution of the geomembrane-emerging areas. Observers concluded that these geomembrane areas were “floating” on water. In fact, the geomembrane was not really floating, as discussed hereafter.

Figure 2. Emerging areas of geomembrane upon initial filling of the lagoon.

Filling of the lagoon started on the south side (i.e. the lowest side). As water submerged the wrinkles in the south half of the lagoon, the cooling effect of the water caused thermal contraction of the geomembrane and reduced all wrinkles. As a result, some air was expelled toward the drainage geocomposite. Also, the water applied pressure on the wrinkles. Some wrinkles flattened out, others did not. The air expelled from the wrinkles that flattened out was subjected to significant pressure, and traveled in the geocomposite toward the vents. It is possible that the lower part of the drainage system was filled with water (i.e. water from the fluctuating groundwater table or water entrapped in the drainage system during construction). Therefore, air may have been prevented from flowing southward. Also, it was easier for the air to flow toward the north for two reasons: (1) the length of the lagoon bottom is shorter in the north-south direction than in the east-west direction; and (2) water depth, hence normal stress on the geomembrane and the drainage layer, was less in the north part than in the south part of the lagoon. On its way toward the north end of the lagoon, the flowing air was trapped into certain wrinkles where the air pressure was still low in spite of the rising water level in the lagoon. As a result, air accumulated in some wrinkles located in the north half of the lagoon. At those locations, the geomembrane buoyed by the underlying air pockets was uplifted as the water level was rising in the lagoon. Thus, the bubble formation started.

HDPE geomembranes are prone to the uplift phenomenon described in this paper because they exhibit large wrinkles due to their high stiffness and thermal expansion coefficient, the two main parameters of wrinkle development according to Giroud and Morel (1992). Also, their stiffness makes HDPE geomembranes resistant to re-conformation to a flat substrate. However, it should be noted that PVC geomembranes also are uplifted during first filling by air entrapped during construction, even though they do not exhibit large wrinkles due to their flexibility. This indicates that a significant volume of air can be entrapped beneath PVC geomembranes. Due to their flexibility, PVC geomembranes can deform to form dome-shaped bubbles, whereas HDPE geomembranes, which are stiff, tend to form relatively flat bubbles (Figure 2).

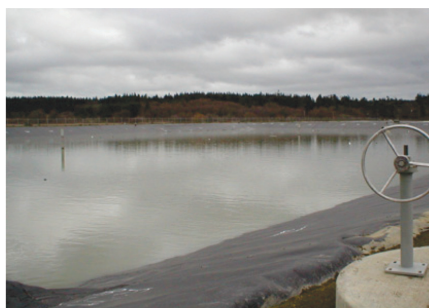
Figure 3. Removal of the “bubbles” has completed the installation and start-up process for the lagoon.

Removal of the entrapped air is necessary for relief of the problem. A simple solution was adopted to mitigate the phenomenon. In December 2004, a team of up to five owner and contractor personnel equipped with hip waders walked on the geomembrane, pushing the bubbles ahead of them. As they walked, they felt under their feet some wrinkles, which they pushed toward bubbles, thereby feeding the bubbles with air from the wrinkles. Then, they walked the bubbles to the toe of the nearest side slope, generally the north side slope. Then, the air naturally flowed in the geocomposite up to the vents. The geomembrane, thus relieved of the upward forces caused by the entrapped air, was submerged and held below the water level. This was easily accomplished and only a

few isolated areas had to be “re-walked” to rectify the situation. Some also worked from boats, using oars or paddles to push the geomembrane down. The operation lasted two days and was followed by one day of inspection by boat.

Figure 3 shows the lagoon shortly after the removal of the bubbles, and as it operates to this time, over a year later. This is a simple solution to a simple problem, but one which appeared severe and seemingly catastrophic to the owner at the time.
