On-going performance of a double LLDPE liner in a concrete lined reservoir with 200 column penetrations

Finlay, P.J.

Sadler, M.A.

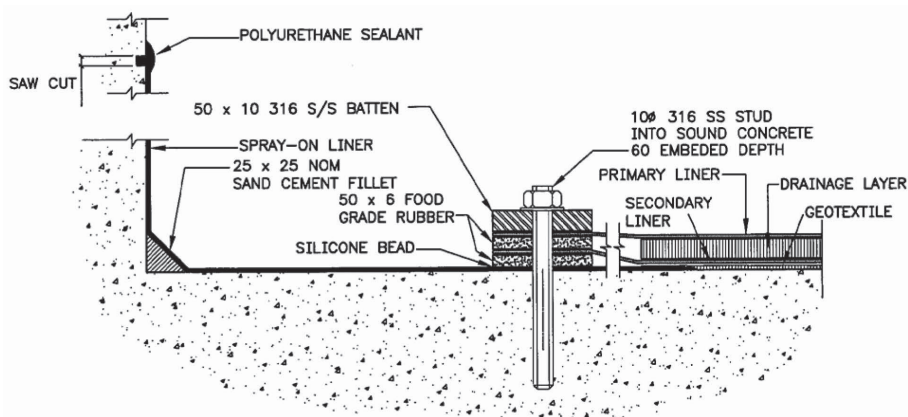
The adopted penetration sealing system was a mechanical batten and compressible rubber gasket to seal around the large number of column and a few pipe penetrations. In addition, concern over the potential for leakage through the concrete between the batten and the column bases lead to the use of a spray applied polyurea membrane that also provided

Figure 2. Typical batten and spray polyurea system at columns.

there was some disappointment at the inability to effectively test the batten systems for their effectiveness especially as the large numbers of identical columns presented an opportunity for development of suitable systems.

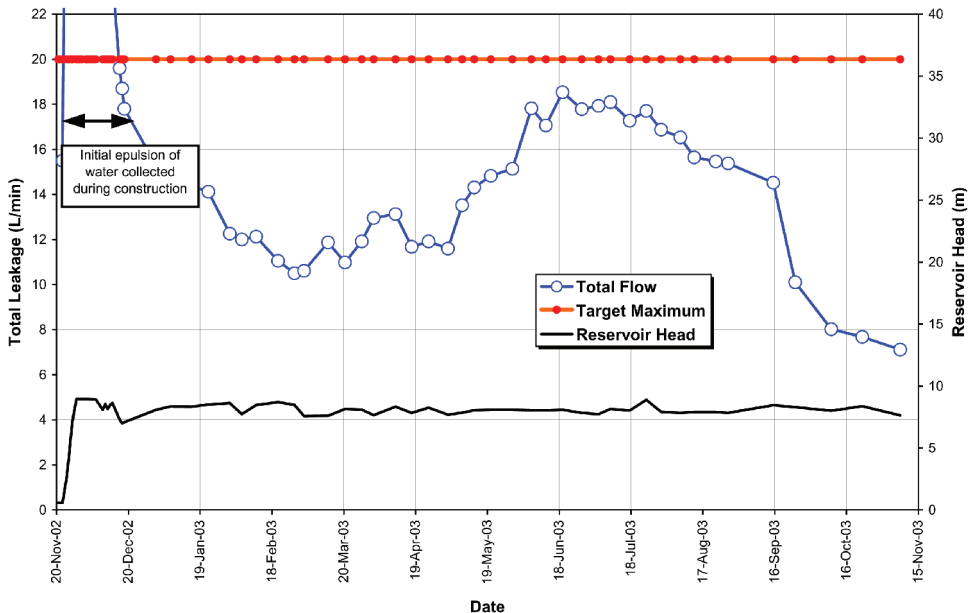
The liner system was subjected to a seven day hydrostatic leak test under full reservoir head at the end of November 2002. Figure 3 shows the results of the leakage monitoring (total leakage rate) from late November 2002 to the end of October 2003. The initial water expulsion rate exceeded the allowable rate as accumulated water was released and then reduced to acceptable levels.

After the initially high leakage rate due to the expulsion of construction water the leakage has so far remained below the target value set. The fact that the actual leakage rate is of the same order and not much lower than the target value indicates that significantly more leakage is occurring than the lower leakage rate that would be expected for an equivalent liner system with no column penetrations.

Figure 3. Typical leakage results from commissioning in December 2002 to October 2003 – Total flow.

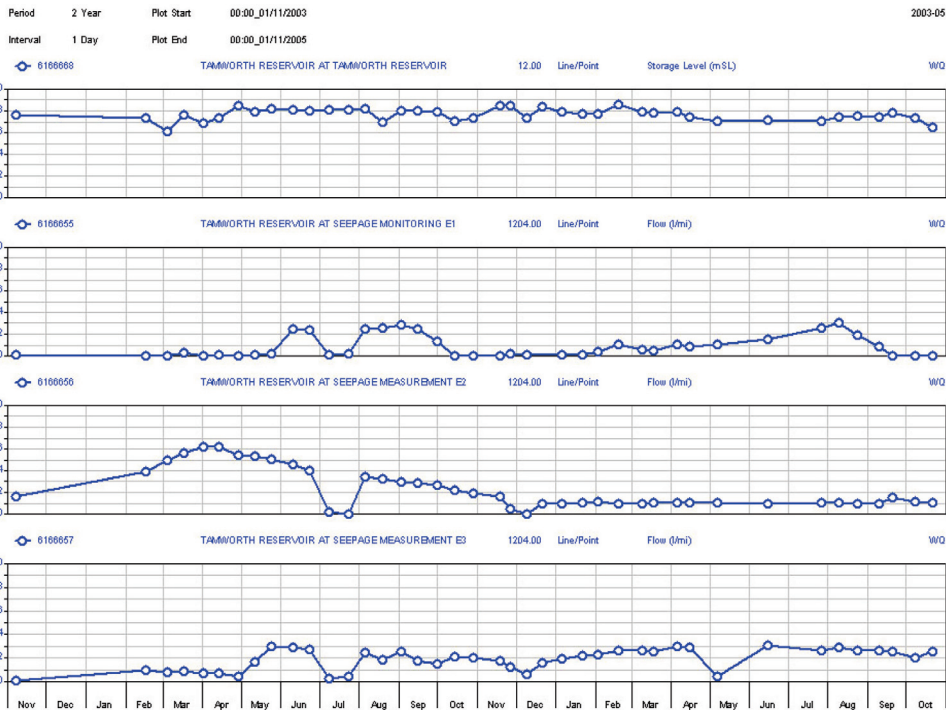
Figures 4 and 5 show the typical results of monitoring from individual leak zones, in L/min, over the period from November 2003 to November 2005. Space does not permit inclusion of more results and the results presented are representative of the others.

Overall the leakage rates continue within acceptable bounds although there are occasional increases in leakage rate which then drop back to quite low rates.

There is some speculation that this might be due to the lower flow capacity of the geotextile drainage layer and its supplementation by pipes at intervals. It is hypothesised that leakage water may accumulate in the drainage layer until the head in the drainage layer builds up enough to push the water through to the drainage pipes.

Figure 4. Typical leakage results from November 2003 to November 2005 east side.

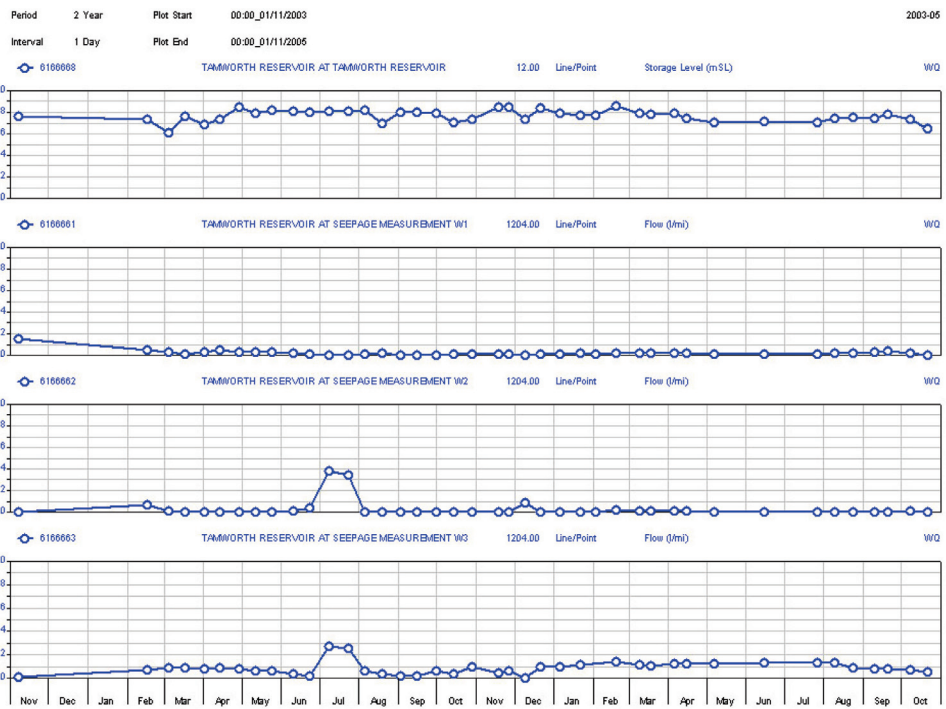
Figure 5. Typical leakage results from November 2003 to November 2005 west side.
