Ballistic soil nailing

T.S. Ingold
Birmingham University, UK

B. Myles
Soil Nailing Limited, Cardiff, UK

ABSTRACT: Ballistic soil nails are fired directly into the ground using a compressed air launcher which can propel 38 mm diameter steel nails 6 m or more into the soil to be reinforced. Elements of design and construction of ballistically nailed works are considered and the versatility of the technique illustrated through four examples. The first relates to a steep cut to be retained by a reinforced soil modular block slope where temporary works construction gave rise to instability and the modular block slope was replaced by a ballistic nailed slope. The second details slope stabilisation works combining the use of bored piles, conventional reinforced soil walls and ballistic soil nailing. The third involves remedial works to a secondary road, supported by fill on sidelong ground, where the natural slope had been undercut by a stream at its toe. The final example recounts remedial work to a deep shaft, lined with concrete segments, which suffered a serviceability failure during construction.

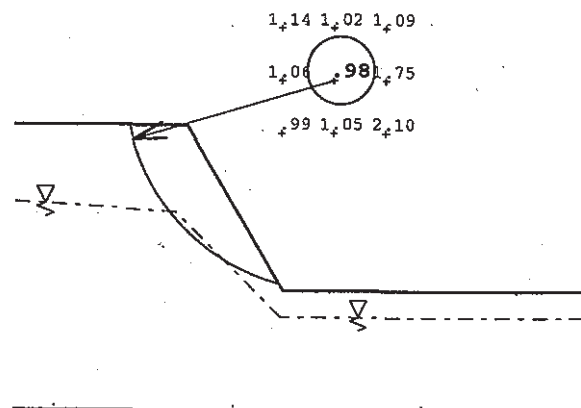
Figure 2 Stability of temporary works

Reinforcement to the modular block facing extended up to 3 m back from the rear of the facing and to install the reinforcement required the formation of a temporary works slope a corresponding distance back from the final line of the face. Short term analysis indicates a minimum factor of safety in excess of 4 decreasing to less than unity in the long term, Figure 2. Intermediate term stability is difficult to predict in cohesive soils but, with the presence of frequent sand partings, it was probable that the long term condition would be attained in much a shorter time span than for a homogeneous clay. Shortly into construction, signs of failure were manifested and it seemed that the clay, over stressed by the temporary works, was reducing in shear strength from a peak to a residual value. Consequently a cantilever sheet pile wall was installed in the cut slope, to the rear of the reinforcement line, with a view to regaining stability in the area affected. In light of the instability associated with the temporary works it was decided, by others, that a permanent continuous sheet pile wall should be installed along the length of the modular block slope prior to slope construction.

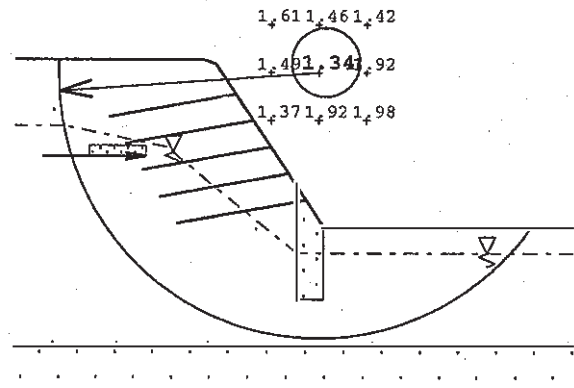
Figure 3. Stability of final nailed slope

The nailed slopes were designed at a batter of 1½:1, (56°), and at the design stage the 6.3 m high slope was assessed assuming use of 38 mm diameter steel nails with 5 nails, spaced evenly up the slope, at 1 m lateral spacings. Without the ground beam and bored pile foundation, as proposed for the modular block faced slope, the nailed slope returned only a minimum factor of safety of 1.18 under abnormal pylon loading.

However, rather than reverting to a piled foundation, it was decided to use mass concrete counterfort buttresses installed at the toe of the slope and extending downwards sufficiently into the clay foundation soil to raise factors of safety to the target values. A 1 m thick counterfort buttresses, installed to 2.7 m below the cut invert level, was calculated to raise the factors of safety to 1.51 for the normal pylon loading and 1.34 for the abnormal loading so attaining the target values, Figure 3.

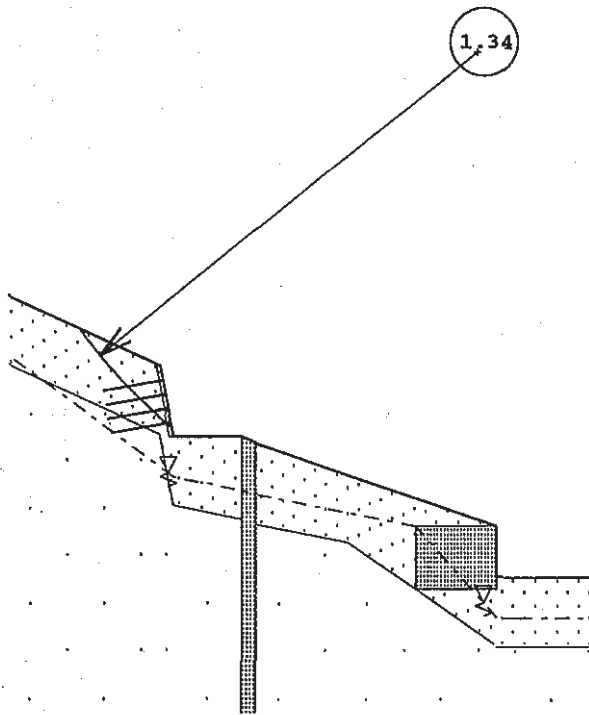
Figure 5 Typical slope cross section

In 1994 a football stadium was constructed with part of the structure being built into a natural mudstone slope. This section of the structure was supported by contiguous bored piles and the temporary works associated with the piling required a high level bench to be cut into the slope to allow access for the piling rig. The bench, with a side slope inclined at 85° to the horizontal, was subsequently abandoned on the assumption it would remain stable. To create access to the stadium the toe of the natural slope was cut back to a nearly vertical slope, Figure 5. Both cut slopes, and the natural slope, were stable in the short term but had begun to weather and so required stabilisation to ensure long term stability.

The root cause of the stability problem was that the mudstone slope had weathered, to a depth of around 3.5 m, and was subject to a high ground water table issuing at the slope toe. Based on $c' = 0$, $\phi' = 33^\circ$ and $c' = 20 \text{ kN/m}^2$, $\phi' = 33^\circ$ for the weathered and unweathered mudstone respectively, slope stability analyses were carried out using the Talren programme to determine the necessary distribution of soil reinforcement. The minimum required factor of safety was 1.3 and this was assessed for the upper slope, the lower slope and the slope overall. Based on 38 mm diameter steel nails,

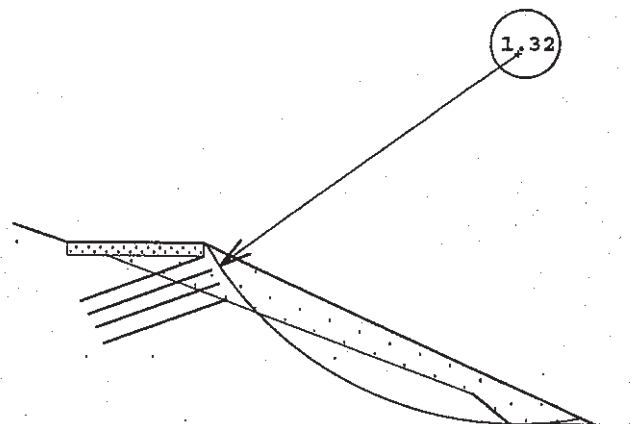
Figure 7 Cross section of remedial works

Following heavy rainfall a secondary highway, constructed in sidelong ground, suffered a slope failure which extended back to the very edge of the road pavement construction. A survey of the site revealed that the road had been constructed on clay fill placed on a natural clay slope with a stream running along the toe of the slope. As a result of heavy rainfall the stream had become swollen and rapidly eroded the toe of the slope so causing slope instability. Both the footpath and crash barrier had been carried away by the slip leaving a rear scarp, approximately 1.5 m deep, immediately adjacent to the pavement construction. Cracks were appearing in the remaining pavement and it was feared that further slope movement might well remove the entire pavement construction.

This particular failure required the solution of two problems. The first was to urgently stabilise the edge of the pavement and the second was to stabilise the failed slope. Consequently it was decided to nail the upper section of the slope, to stabilise the edge of the pavement, but to take account of the effect of the nails in designing the final remedial works. The site survey indicated that the initial slip had removed practically all of the original clay fill and analyses showed that by replacing this with a granular fill, and regrading the slope, the combined effect, including the nails, was to return the required factor of safety, Figure 7.

Construction involved the installation of four rows of 5 m long nails into the rear scarp of the slip to initially underpin the pavement, Figure 7. As shown in Figure 8, installation was achieved by mounting the launcher on a tracked excavator working from pavement level.

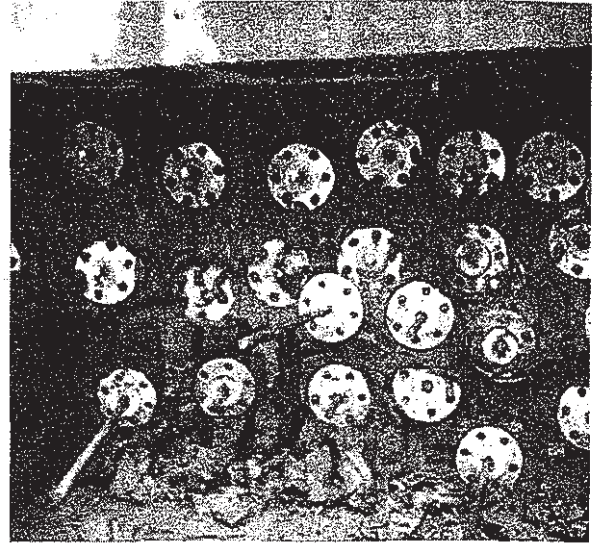
Figure 9 Nails installed in failed shaft face

Early in 1996 the construction of a very large concrete lined underground storage shaft was in progress when a serviceability failure occurred. The shaft, 26 m in diameter and with a final depth of 18.5 m, was lined with precast concrete segments 2 m long, 1 m high and 0.5 m thick. Ground conditions were generally good and comprised stiff to very stiff clay with occasional pockets of sand and gravel. The ground water table was low, typically 9 m below ground level, which meant that approximately half the depth of the shaft would be below the ground water table. Construction involved excavating the shaft in 1 m increments without supporting the clay face. Following excavation, the precast concrete segments were placed with the void between the clay face and segments then being grouted. This process continued uneventfully until the shaft was excavated to a depth of some 12.5 m with the lowest one metre of the shaft unsupported in readiness to receive the liner segments. At this stage clay was observed to be extruding into the excavation over 20 % of the perimeter.

As a result of the ongoing extrusion of the clay face into the excavation the liner segments above the extruded area began to move downwards, unevenly, and eventually deflected a maximum of 520 mm. Probing of the face revealed stiff clay beyond the soft clay causing the extrusion and so 6 m long soil nails were installed in the soft face at 300 mm centres, Figure 9. This controlled the extrusion and the shaft was then deepened, with further nailing, to allow a level ring of precast liner segments to be inserted below the upper sections of lining which had deformed. The resulting nonuniform gap, shown in Figure 10, was then filled with an insitu concrete liner.
