DURABILITY OF PVC-P GEOMEMBRANES IN HYDRAULIC STRUCTURES

Carreira, Tiago¹, Tanghe, Hans²

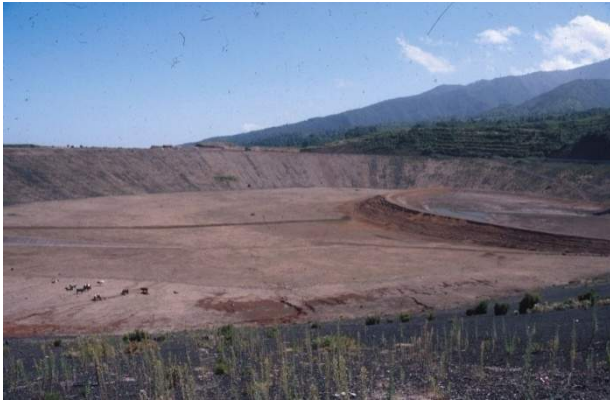
The reservoir is located on the island of La Palma (Canary Islands), close to the sea at an altitude of 700 metres. The initial waterproofing was carried out in 1976 with compacted volcanic clay, but it never worked. The initial solution with a 6 metre layer of clay rapidly became altered with the appearance of cracks due to the effect of shrinkage (Figure 1). All the attempts to restore the layer of clay failed. This case study was initially published by Fayoux and Potie (2006). The rehabilitation of the waterproofing was done in 1991 using a PVC-P geomembrane (Figure 2).

Figure 1. Barlovento, initial waterproofing carried out in 1976 with compacted volcanic clay

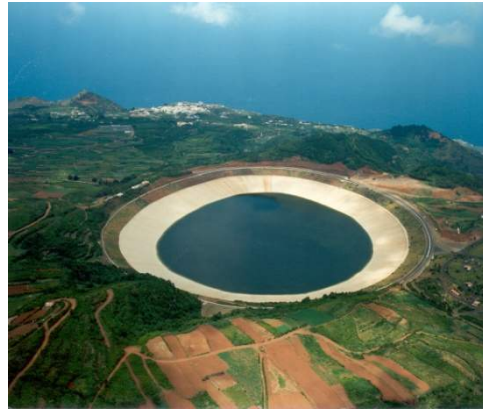
Figure 2. Barlovento, waterproofing with PVC-P geomembrane

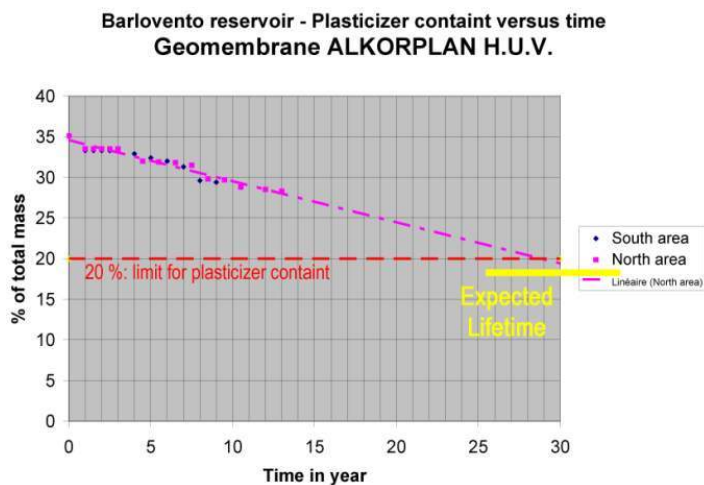
After 13 years of exposure to a tropical climate, the geomembrane continues flexible presenting limited plasticizer loss, thus guaranteeing high life durability. The geomembrane is monitored in a regular manner by the Spanish administration. CEDEX has regularly issued several reports. The latest report shows the evolution of the 13 year old geomembrane (Figure 3).

Figure 3. Barlovento, plasticizer content over time

Plasticizer loss in relation to the original samples does not exceed 26% (corresponding to a plasticizer content of approximately 26%) in any of the samples considered, with the reduction being similar in all the samples independently of their orientation. The flexibility test at low temperatures carried out at -20°C, was surpassed in all samples. The mechanical characteristics remain very stable: Strength at failure remained practically constant over time

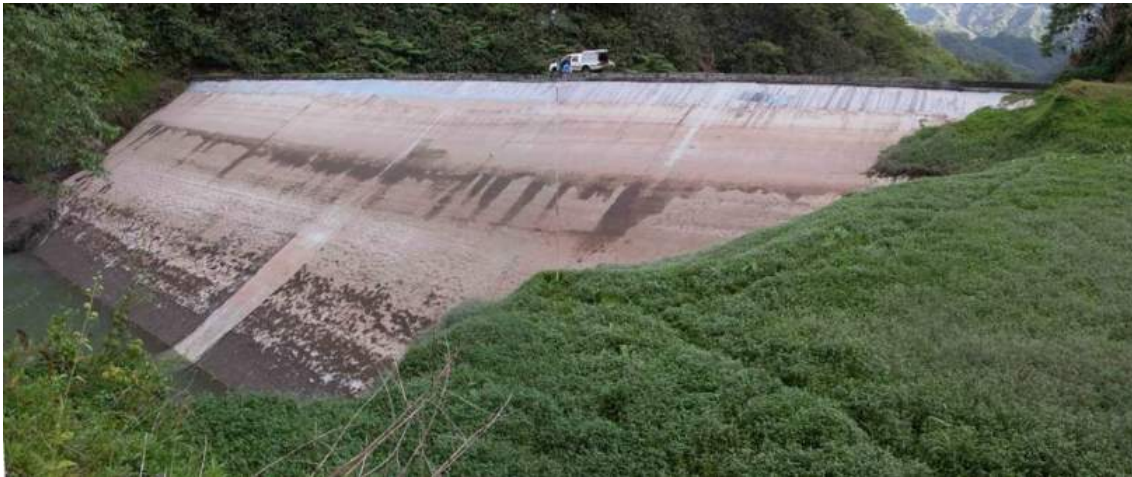
Figure 4. Typical dam in Tahiti; 1.0 mm PVC-P Geomembrane

All the products, except Papenoo H, present a normal evolution, taking into account the thickness of the geomembranes and climate. Based on the laboratory results (independently of all the extrapolation considerations which may lead to other priorities), the evaluation in terms of the state of the geomembrane is as follows:

1. Papenoo H (far from the normal durability values): the geomembrane formulation is not adapted to tropical climates, but to countries in central Europe. This may have been due to a mistake on the part of the client, since the client was French.

2. C2 (exceeded the usual plasticizer loss limits).
3. VAITE 2 and AB are theoretically at the same level, with a plasticizer content corresponding more or less to the limit to which the waterproofing begins to be difficult to be maintained. Geomembrane AB has a reinforced. The reinforced may limit the propagation of tearing. VAITE 2, despite have slightly lower plasticizer content than AB, appears, in the field, to be in better condition (less repairs and specific points are in a good state). This situation may be explained by the design system used, which enables VAITE 2 to present better durability, despite in practice present a lower plasticizer content. This fact demonstrates the importance of design in a waterproofing system.

4. Tahinu and Vainavenave also have a good reserve of life in terms of their plasticizer content. However, these 2 structures present some problems, stress on the geomembrane, due to insufficient drainage.

5. The Vainavenave geomembrane should be monitored to check if the problem of micro-cracks is stabilising or continues to evolve.

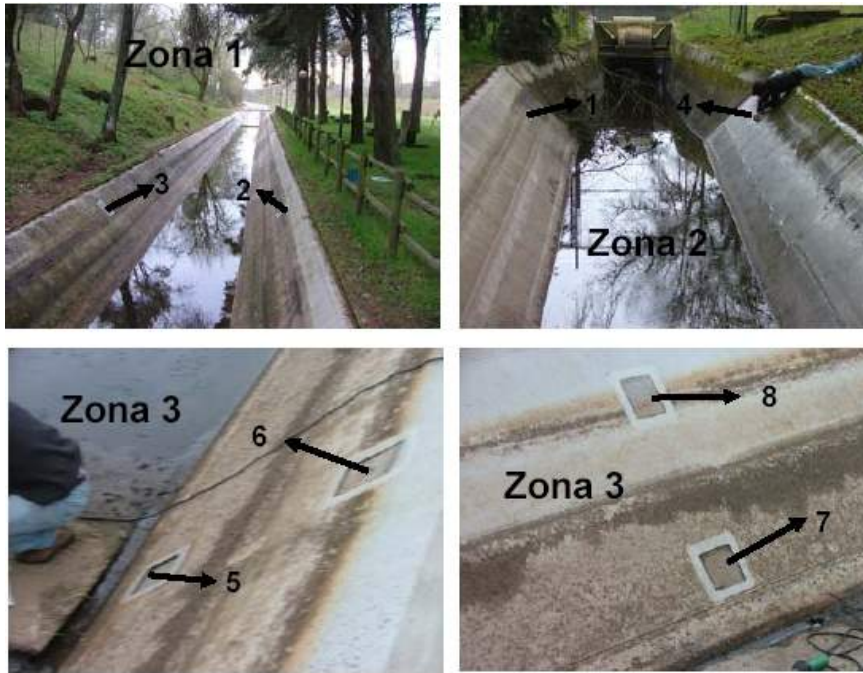
In April 2007, 12 and a half years after the installation date, geomembrane samples were taken from Chaves Canal, to analyse their behaviour. Samples were collected from 3 different zones (Figure 5). As shown in Figure 5, Zone 1 and Zone 2 are situated in a part of the canal which is always in shade; in Zone 1 the velocity of the water is higher (start-up zone) and Zone 3 is completely exposed to the sun. Samples 3, 4, 7 and 8 face East and samples 2, 1, 5 and 6 face West.

Figure 5. Chaves Canal, location of the samples (*Zone 1, Zone 2 and Zone 3*)

All the samples analysed present a good reserve in terms of plasticizer content. The mechanical characteristics present reasonable values taking into account the age of the project. The canal Zone, above the waterline, facing East, appears to be where the geomembrane is in its best state of conservation (sample 3 with 29% of plasticizer and sample 8 with 27% of plasticizer). The samples below the waterline, in Zone 1 and Zone 3, and the samples above the waterline facing West, in Zone 1 and Zone 3, present very similar values (between 22 and 23% of plasticizer, for samples 2, 5, 6 and 7). The samples from Zone 1 are difficult to interpret. Firstly, they do not permit us to conclude, in this case, the existence of a direct relationship between plasticizer loss and velocity of water flow (comparison between Zone 1 and Zone 2). On the other hand, sample 4, above the waterline, facing East presents a low value, 23% of plasticizer, in comparison with the other samples also facing East and above the waterline. This difference may however be explained by the existence of water, coming from outside the canal, at sample 4 creating the ideal environment for the development of vegetation and consequently microorganisms. Another conclusion may be the fact that the samples in best condition (plasticizer content), present the same mechanical characteristics as the samples which are in worst condition. This situation is explained by the fact that the samples in best condition are situated above the waterline, exposed to UV action, presenting phenomena of superficial micro-cracks. This phenomenon considerably reduces the mechanical resistance of the PVC-P geomembranes.

As strange as this may seem, UV action is not the main action responsible for the aging of the geomembrane of Chave Canal. There are other phenomena, in the samples below the waterline, which are revealed as or more important than UV action. These phenomena were studied in-depth in laboratories and nowadays the PVC-P geomembranes of this company are reinforced for improved resistance to these phenomena.

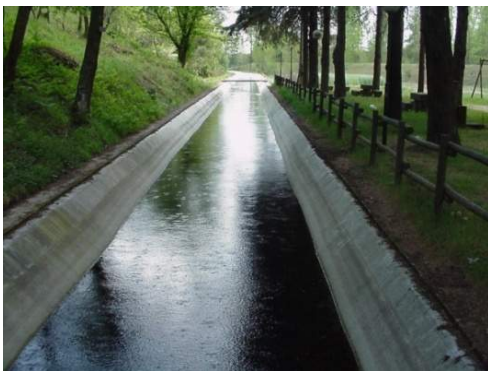
Over the years Chaves Canal has demonstrated being one of the best examples of a waterproofing project and design using PVC-P geomembranes, found in Portugal. Based on laboratory analysis of the samples taken, in the climatic situation and above all based on in-depth knowledge of the method of design of the waterproofing system, we can state that the geomembrane installed in Chaves Canal has a predicted durability greater than 20 years (Figure 6).

**Figure 6.** Chaves Canal, 12 and a half years later

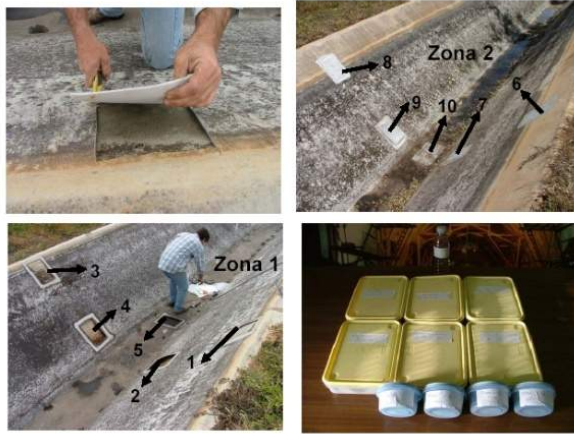
In 2006 samples were taken from PVC-P geomembrane installed in Campilhas Canal (Alentejo, not very distant from the sea). This canal presented serious problems, given that the geomembrane had apparently reached the end of its life at only 7 years old. 10 samples were taken from 2 different Zones (Figure 7). In Zone 1, which has a lower development, samples were taken from the bottom, bottom of the slopes (from both sides of the canal) and above the waterline (from both sides of the canal). In Zone 2, which has a higher development, samples were also taken from the bottom, bottom of the slopes (from both sides of the canal) and above the waterline (from both sides of the canal). The geomembrane has the same formulation as that in Chaves, solar orientation is completely the same as that in Chaves and average temperatures only vary slightly in the winter. Differences in terms of UV action are not significant either. The ideal conditions were created for us to be able to understand what had happened at Campilhas.

Figure 7. Campilhas Canal, location of the samples (*Zone 1, Zone 2*)

The result of the laboratory analysis of the samples was, surprising perhaps for some, given the visible state of deterioration of the canal. The minimum value found of the plasticizer content was 28%, compared with 22% at Chaves Canal. The Campilhas geomembrane was practically as new, especially above the waterline. Similarly to Chaves Canal, here the geomembrane was also in a better condition above the waterline, exposed to UV action, than below the waterline. Therefore there are no significant differences between the behaviour of the samples from Campilhas and Chaves.

The geomembranes at Campilhas and Chaves are so similar that it can be said that both have lost on average 1% of plasticizer per year, to a more serious situation. Hence, Campilhas has lost 7% (from 35% to 28% of plasticizer) and Chaves has lost 13% (from 35% to 22% of plasticizer). So, how to explain what occurred in Campilhas? The only significant difference between Chaves Canal and Campilhas Canals was the design of the waterproofing system. The design of Campilhas Canal did not take into account the typical particularities of this type of material when subject to mechanical action, physical and chemical action, and the aging. This is a typical example of how the design of a waterproofing system may negatively influence the durability. This influence is such that the durability of Campilhas Canal was approximately 3 times lower than that predicted for Chaves Canal.
