Damage to dike revetments strengthened with geotextiles

van den Hoek, K.A.

Berendsen, E.

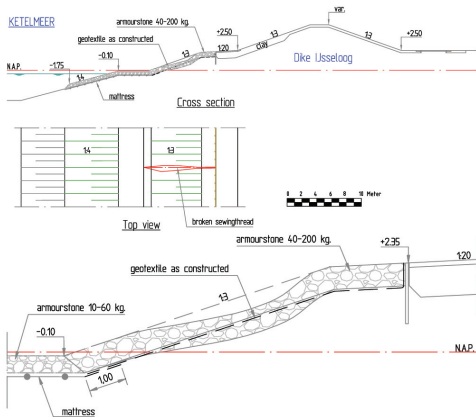
Figure 2. Cross-section dike IJsseloo.

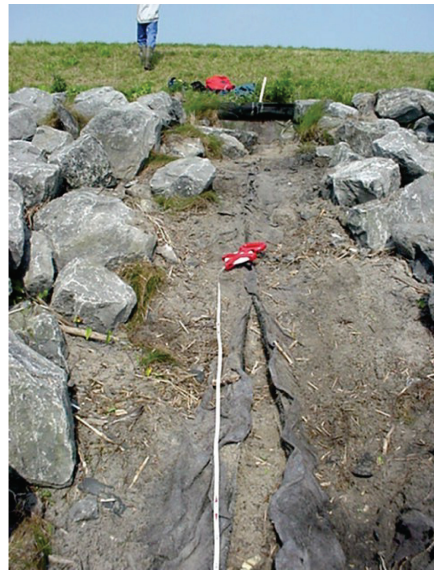
After a storm in February 2002, when the water reached a level of NAP + 0.6 m, deformation of the upper slope of the dike revetment was observed over a length of 600 metres. This deformation was locally

concentrated at the sewn seams in the geocomposite. At least 20 to 30% of the sewn seams showed damage. At one location the armourstone sagged over a length of 15 m. The photograph of Figure 3 shows the sandfill being partly exposed. It appears that the effect is washing out of sand rather than radial shear of the sand. The thread of the sewing joint was broken. At several locations stones had perforated through the geocomposite. However, the effect of the damage was limited: sand had washed away, but the stone had sank into the perforation and partly closed it. The damage near the sewn seams was more serious: much more sand had washed away.

Figure 3. Photograph of broken sewn seams (stones removed).

- (i) Overlap of the geotextile of the upper slope and the fascine mattress under the berm under was not correct. With wave attack, the geocomposite of the upper slope revetment should have been under and not above the geotextile of the fascine mattress, as there is an apparent leak for the sand to be washed out.
- (ii) Heavy armourstone 40-200 kg had been applied directly on the geocomposite. Due to the space between the stones the sand of the subsoil could wash away as a result of the pore pressure in the sandmatrix (micro instability). This phenomenon caused tensile forces in the geocomposite and in the sewn seams and the latter failed, because the sewn seams are the weakest parts of the geocomposite.

- (iii) The flow capacity of the geocomposite could be less than the porosity of the subsoil. This could have exceeded the pore-water pressure in the subsoil and could have caused liquefaction.

- (iv) Locally heavy stones perforated the geocomposite, which lead to washing out of subsoil. Most probably direct damage started by dropping the coarse armourstone on the geocomposite. As a result of this work method tensile forces in the geotextile and the sewn seams increased. At the same time the revetment shape developed to a "S-profile" (see Figure 2). This further increased tensile. This progressive mechanism went on until the sewn seams broke. As a consequence, the sand (subsoil) washed away through the toe of the upper slope and through holes in the geocomposite. Probably, the storm of February 2002 has washed away a lot of subsoil, which lead to the deformation of the structure. However, washing out of subsoil sand could have started prior to this storm.

As a consequence of this damage, repairs have been carried out; initially to a limited extent (one trial section), but it is expected that far more repair works will be needed, implying that high costs are involved.

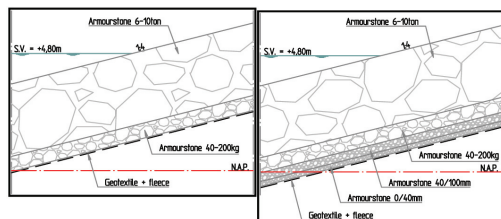
Figure 5. Initial (left) and adjusted (right) plan Maasvlakte.

Damage to the geocomposite has been detected during construction of the revetment. The detected gaps, tears and teared sewn seams were caused by the impacts of the heavy toplayer armourstone combined with the effects of the sharp edges of the filter layer rock 40-200 kg, its relatively small layer thickness (0.6 m) and the application of a geocomposite with

insufficient mass or strength. The placement of the stones of 40-200 kg using a crane, with its bucket scraping the stones over the geocomposite, caused tears in both the woven fabric and the non-woven. The chosen work method did result in additional damage to the geotextile because of the rather rough method of placing the heavy armourstone 6-10 tons.

Due to the damage occurred during execution, it was decided to adjust the design. Several alternatives have been considered: the application of a heavier/stronger geocomposite, application of more geocomposites, a better distribution of the load on the geotextile by applying extra granular filter layers etc. The last alternative has been chosen: two extra layers of stone (0/40 mm and 40/100 mm) were added (see Figure 5 right part). The main function of these extra layers is to get a more even distribution of the load on the geotextile.
