## **OBSERVATIONS AND THOUGHTS ON THE PERFORMANCE OF POLYPROPYLENE GEOMEMBRANE LINERS AND FLOATING COVERS: TOWARDS IMPROVED SPECIFICATIONS**

**Ian Peggs<sup>1</sup>**

<sup>1</sup> *I-CORP INTERNATIONAL, Inc. (e-mail: icorp@geosynthetic.com)*

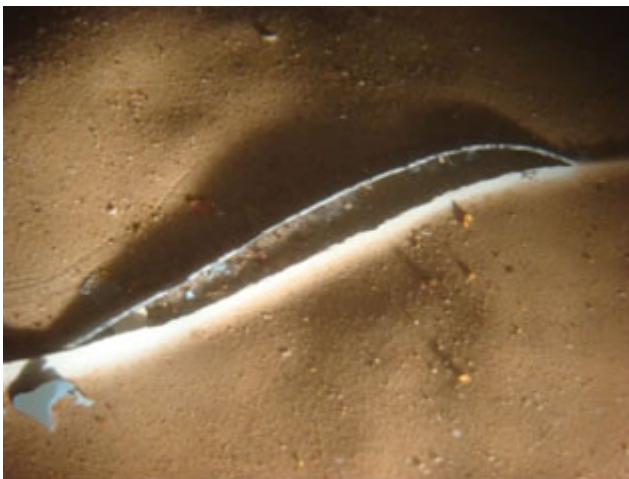
Bottom liner cracks typically occur on the tops of wrinkles at floor/wall corners of tanks (Figure 1) and on any wrinkles on the floors of open ponds. Black geomembrane is often whitened along the wrinkles. The severity of cracking increases with hydrostatic head. In exposed pond liners at the tops of slopes cracks occur, as they did in HDPE liners, along the edges of extrusion welds (in the lower sheet) and then diverging into the panel (Figure 2).

**Figure 1.** Crack on whitened wrinkle in fPP at floor/wall corner

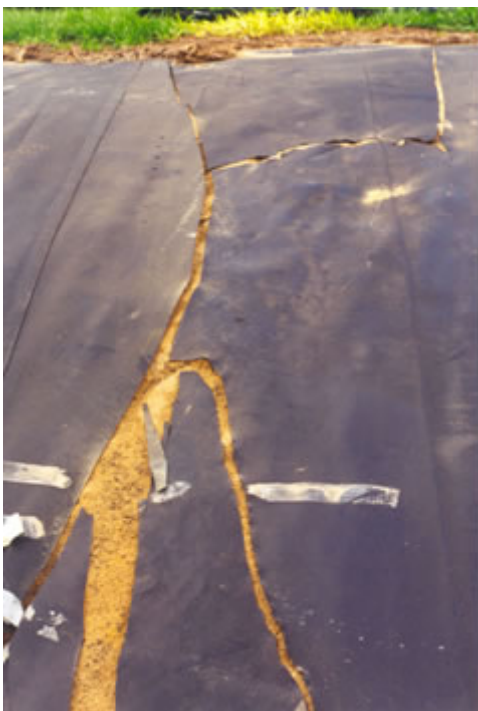
**Figure 2.** Crack along edge of weld moving into panel of fPP

The stabilizer package in several samples taken from an fPP geomembrane which underwent the limited RCP failure shown in Figure 2 was investigated with the results shown in Table 1 (Peggs 2005).

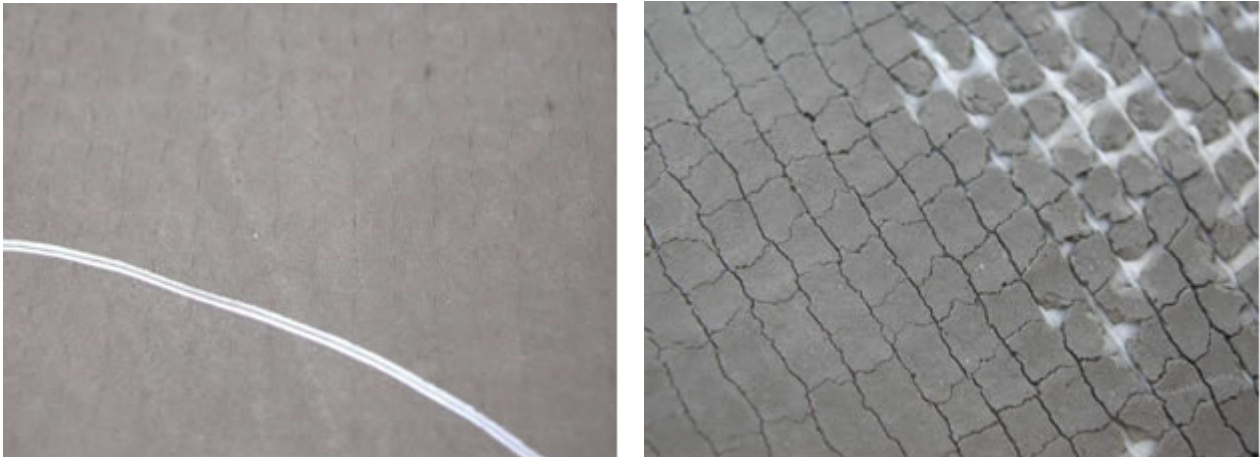
In fPP-R cracking usually starts along the warp reinforcing yarns as shown in Figure 3. Individual cracks above the weft yarns link up to form long cracks along the warp yarns. These cracks may form independently of the direction of the apparent primary stress. Thus, cracks at the tops of drainage troughs in floating covers do not necessarily initiate along the bend from flat surface to wall of trough (i.e. parallel to the axis of the trough) but may occur around the bend normal to the direction of the trough. Similarly, initial cracks on the reservoir side slopes may be oriented up and down the slope not across the slope. This occurs because the warp (roll direction) yarns are typically more spherical in cross section than the more oval weft (cross direction) yarns, thereby resulting in thinner and more highly stressed PP polymer above them. Cracking then starts along the weft yarns (Figure 3) until discrete squares of polymer are left above the reinforcement openings. Ultimately these squares spall away (Figure 4) leaving the reinforcing yarns exposed. The yarns then rapidly degrade leaving a fibrous tangle on the surface (Figure 5).

**Figure 3.** Initial cracking above reinforcing warp yarns (left). Subsequent cracking along weft yarns (right).

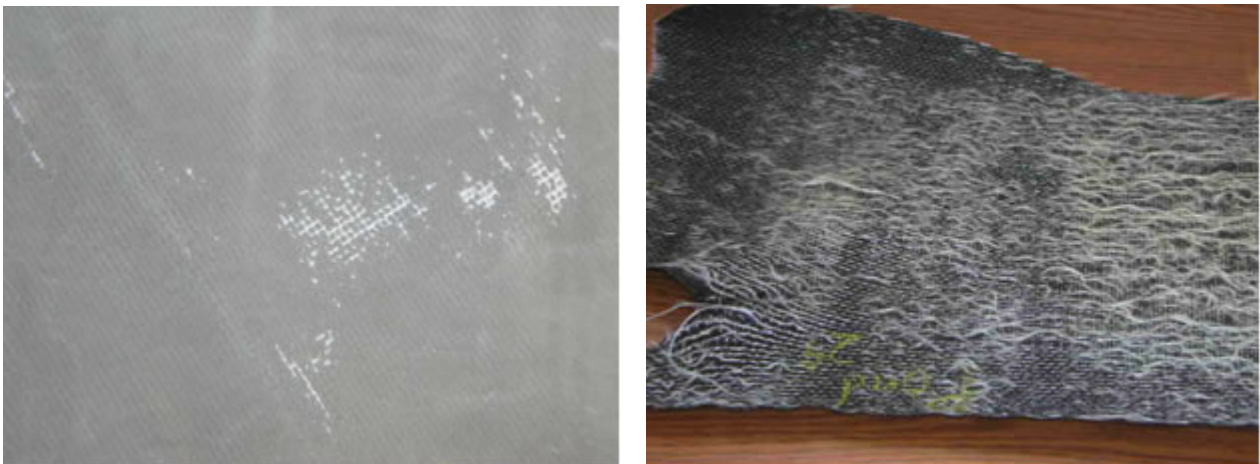
**Figure 4.** Squares of polymer spall away

**Figure 5.** Exposed reinforcement degrades

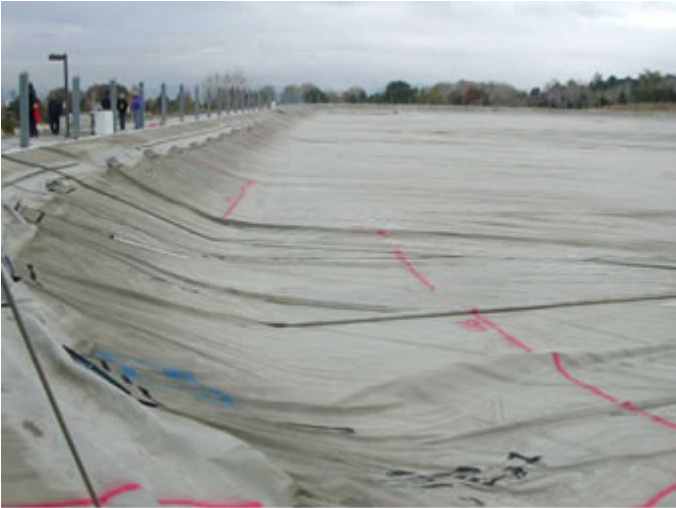
The exposed side slope liner failure in Figure 6 occurred after 9 years in a hot sunny environment. The side slope floating cover failure in Figures 3, 4, 5 and 6 occurred after 6 years in a cold winter and hot summer environment. Much of the stress in this case was caused by constant wind uplift and flapping of the excess side slope material.

**Figure 6.** Cracking (dark areas) in tensioned fpp-R floating cover

Peggs (2006) also reported the effects of stress on thermal and UV degradation rates. Archive samples of the reservoir fPP-R floating cover shown in Figure 6 were subjected to GRI GM 18 oven aging and UV resistance tests, both under a constant tensile load and without loading. Strip specimens were cut on the bias (at 45° to the reinforcing yarns) so all the stress would be taken by the polymer. HP-OITs were measured before testing and after break and are shown in Table 2. Initial breaks occurred over the warp reinforcing yarns as they did in the field. Times to break were approximately 500 h.

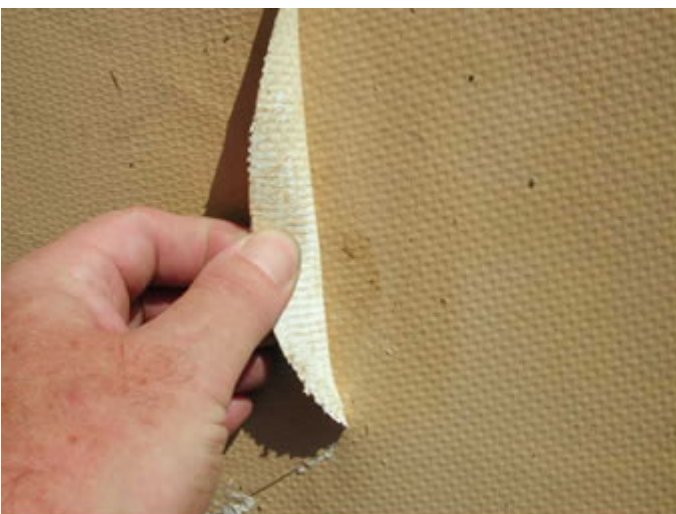
**Figure 8.** Poorly bonded repair patch

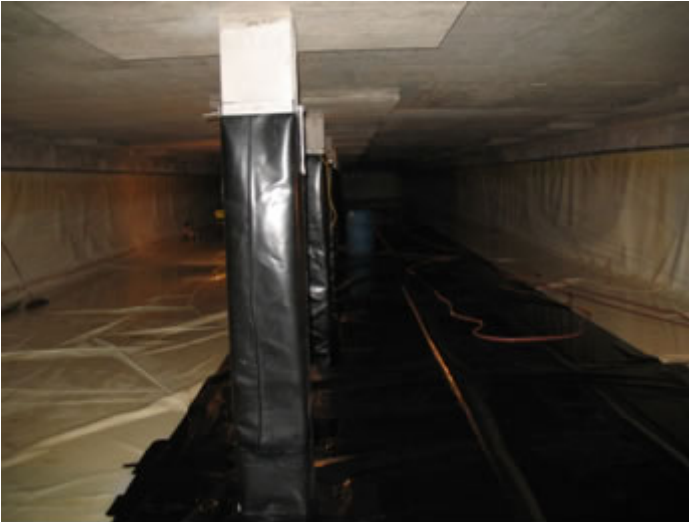
Figure 9 shows a white fPP-R liner installed in a concrete basin potable water reservoir. Since installation the liner had been leaking. After only one year repairs were initiated but were very difficult to make. It can be noted that liner above the water line is yellowing, probably the result of oxidation. Swimming pool covers have been oxidized between where they lift off the water and the peripheral fastening.

**Figure 9.** Potable water reservoir liner
