# Geosynthetic reinforcement in distressed canal embankment in Gujarat, India : a case study

Vivek P. Kapadia

Water Resources Department, Government of Gujarat, India

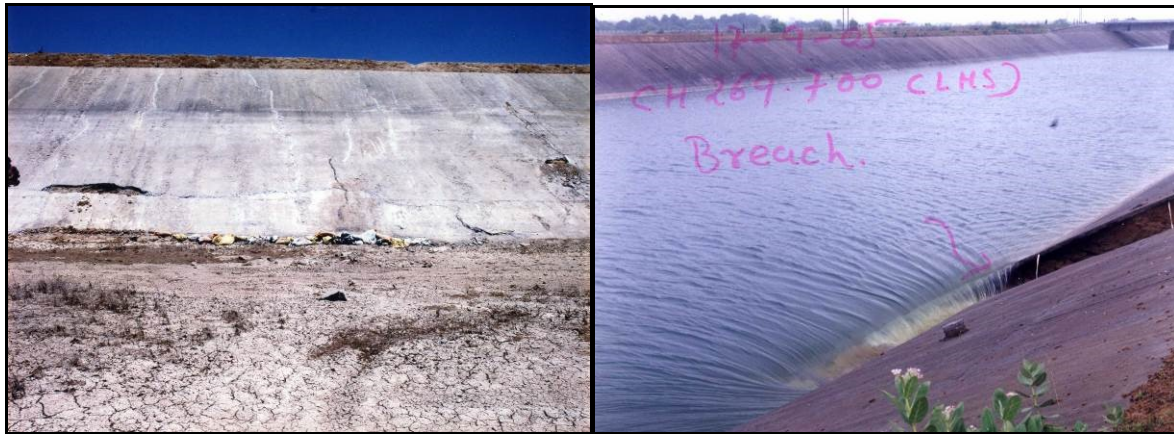
Failure of concrete lining of the canal at a particular height for a noticeable length was also observed as shown in Photograph 1. Snapshot of the very instance of occurrence of the breach in the embankment in September, 2005 is shown in Photograph 2. It clearly shows how piping enlarged to result in to a breach. Devastation in vicinity of the canal is shown in Photograph 3 and Photograph 4. The breach of 11<sup>th</sup> June, 2008 was about 65 meter in width and the embankment was found cut in a chiselled fashion as shown in Photograph 5 and Photograph 6.

Photograph 1 and Photograph 2. Defects in lining and breach in initial stage

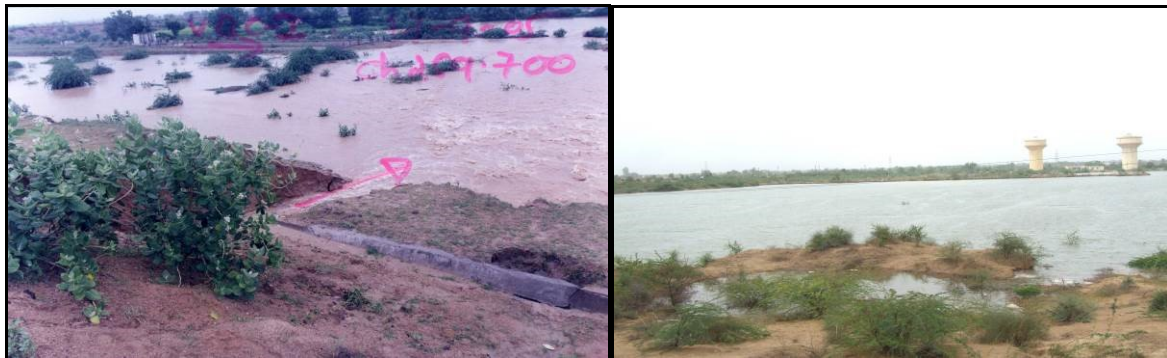
Photograph 3 and Photograph 4. Devastation in vicinity of the canal

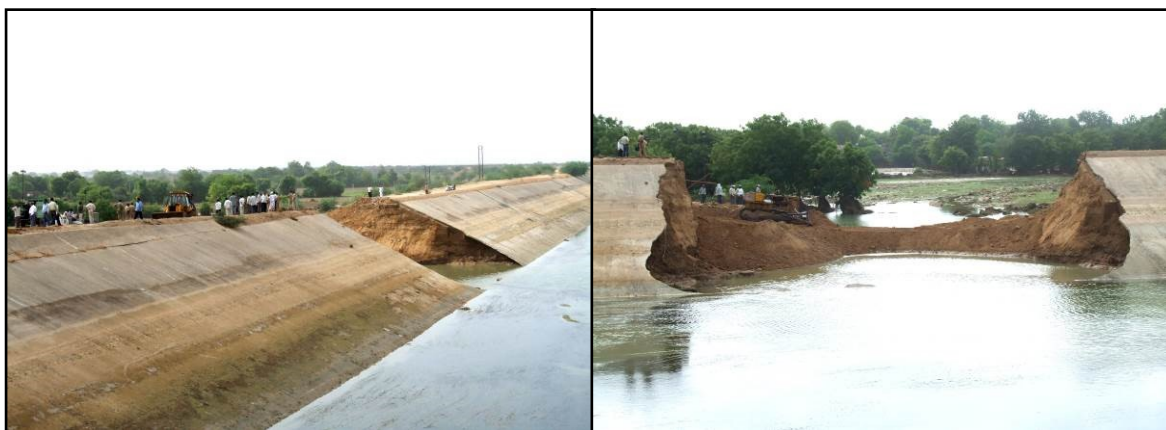
Photo – 5 and 6 Chiselled embankment

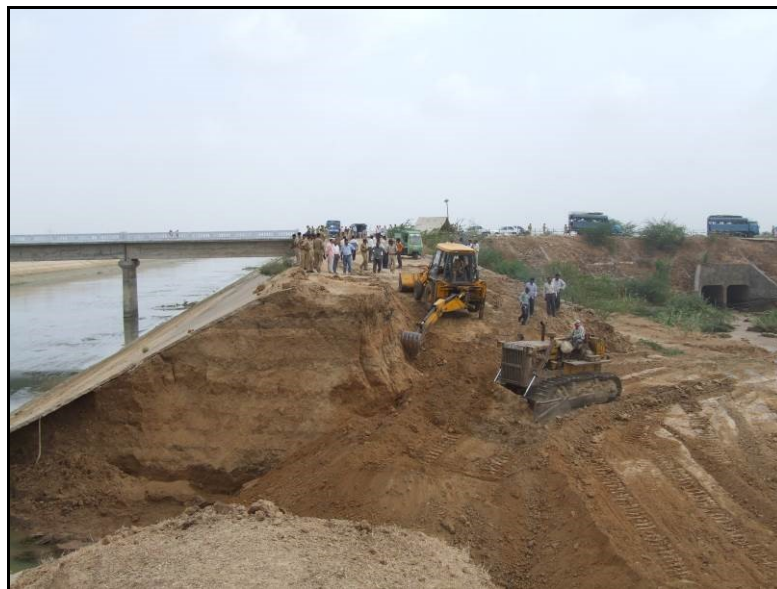
- I. No zones with specific soil properties as per design were actually provided in the embankments.
- II. Obligatory technical specifications for laying and compacting the soils in accordance with their types and properties as well as locations were totally neglected with the result that there were numerous locations and bands of loose or inadequately compacted soil zones.

- III. No chimney filter or horizontal filter blankets were provided to protect the soil and prevent migration of particles outside.
- IV. Due to very loose soil bands, particularly in the lower portion of the embankment, there was substantial subsidence of the earthwork causing loss of support for the plain cement concrete lining. The lining, as a result, cracked irregularly at several places creating even big hollows at some locations. The cracks and openings provided direct entry points for the canal water.

- V. The canal water entering the embankment with relatively high pressure caused dislodgment of particles in the inadequately compacted soil due to high seepage forces resulting into piping and progressive failure ultimately.

Many defects narrated above in construction of canal embankment are clearly viewed in Photograph 7.

Photograph 7. Stratified strata of soil with no zoning or filters
