# Rapid restoration for a seriously damaged railway embankment during violent earthquakes

Kitamoto, Y. & Abe, H.

Keywords: geosynthetic, construction, railway, earthfill, reinforced soil

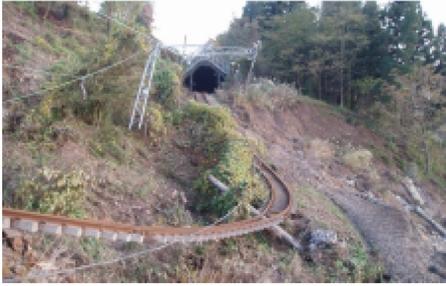
As is shown in Photo 1, the earthquake caused railway embankment failure near the tunnel portal, especially the embankment for a Niigata track (down line) on the undercut slope, which was built on the valley side formed by erosion from the Shinano River. A national highway runs on the alluvial terrace over the tunnel of a Takasaki track (up line) adjacent to the down line. The ground bearing the embankment of the down line in the region is characterized as dipping planes, so to speak, sloping heavily toward the river and then easily gathering water during rainfall.

Photo 1. Overview of failure of the embankment.

The surface of the embankment had failed in the past, namely in 1981 and 1999, and slope protection measures were adopted, such as restraining rail piles, earth retaining walls and free-frame work. However, the embankment slope has shown repeated small-scale sliding because the bedrock itself dips to the river and because it is difficult to fully embed the foundations into the ground due to the steep slope and narrow space. The total soil quantity that failed during this earthquake last fall was estimated to be  $9,900 \text{ m}^3$ .

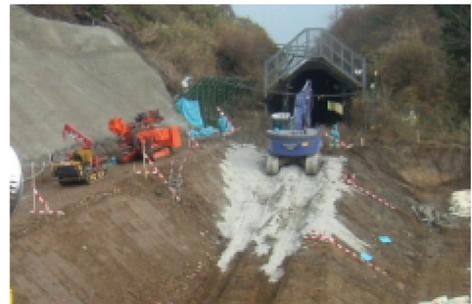
Photo 2. Soil stabilization by cement.

To reinforce the bearing stratum of reinforced embankment and to secure the operation yard for heavy equipment, the soil was stabilized for a depth of 1m by applying cement-type solidifiers with a blending proportion of 150 kg/m<sup>3</sup>. The quantity of solidifiers was so determined that a coefficient of subgrade reaction  $K_{30}$  of 70 MN/m<sup>3</sup> could be achieved according to plate loading tests. A one-ton pack of additive was supplied over an area of 6.5 m<sup>2</sup> because the depth of soil reinforcement was one meter. The soil was mixed with solidifiers in the area using a backhoe (Photo 2).

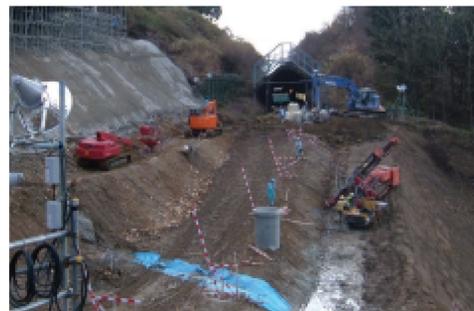
Photo 3. Installation of ground anchor.

After the soil was stabilized with cement, a soil platform for anchor work was built for installing fourteen 15-m-long ground anchors with pretension of 600 kN per rod at intervals of 4 m. Drilling angle was 15° upward to the normal slope line (Photo 3). After the drilling boreholes were washed out with fresh water to remove slime and other materials, grouting was carried out while carefully removing water and air from the casing pipe until the grout material filled the boreholes and was discharged.

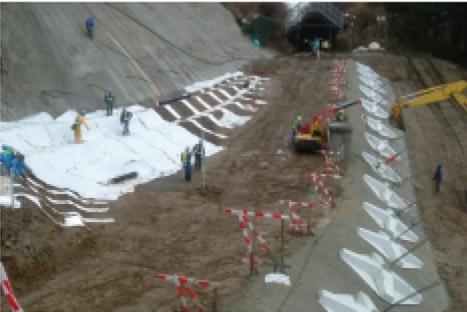
Photo 4. Drainage work.

To remove the seepage discharging from the ground and the water infiltrating into the embankment, perforated underdrain pipes with a diameter of 65 mm were installed on bench-cut ground berms, which were lined with crushed stone (C-40) and connected to the drainage pipe in front of the reinforced embankment. Filter drainage layers 0.5 m wide and 4 mm thick were laid at the boundary between the ground and the embankment at intervals of 2 m. Material against sand outflow was attached throughout the ground to prevent fine soil particles from entering the crushed-stone embankment from the ground (Photo 4).

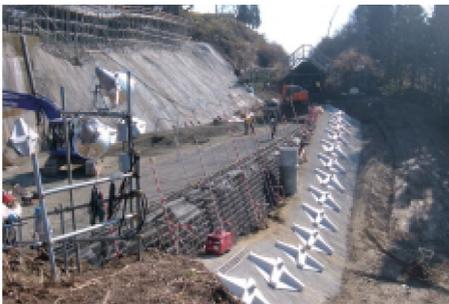
Photo 5. Geosynthetics reinforced embankment.

As planar reinforcement material, high-strength vinylon geogrids were placed on each layer in the embankment at vertical intervals of 30 cm with no loosening. The reinforcement material was laid with an overlap of 10 cm at joints in the longitudinal direction on the embankment. To ensure slope stability during construction of the embankment, L-shaped wire cages were introduced for temporary restraining. Sheets with a thickness of 10 mm were attached in the cages to prevent the embankment material from spilling out (Photo 5).

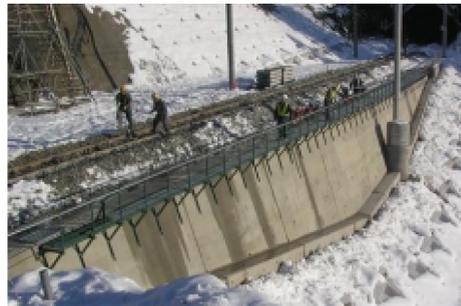
Photo 6. View of the completed structure in snow.

Restoration from damage is conventionally temporary because of its emergency nature, and full-scale measures satisfying permanent requirements are taken later. At the project site under study, the adopted RRR method satisfies the requirements even on the bearing stratum composed of colluvium on a steep slope. A permanent structure with an approximate length of 60 m and maximum height of 6.9 m was completed in approximately one month by a method that could shorten the construction period through the reduction of resource quantities and due to favorable weather conditions (Photo 6).
