# The effects of large scale earthquakes on EPS structures

Masuo, T. & Hara, K.

Civil Engineering Products Division Taiyokogyo corporation (SUN)

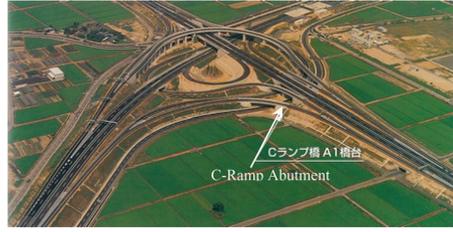
EPS embankment on backside of C-Ramp Abutment was the first EPS embankment built in Japan for a highway road. At its design, Expressway Technology Center (EXTEC) established a committee to study experimentally and analytically on the reduction of earth pressure by EPS embankment. Also for its seismic stability, a shaking table test and 3-D FEM analysis were made to study that the embankment is stable for the Mid-Niigata class earthquake. At the construction, various measurement devices were set to confirm the analysis. JMA Seismic Intensity Scale was 5 lower at the site, no displacement was found on road surface and wall surface.

Photo 1. Niigata interchange.

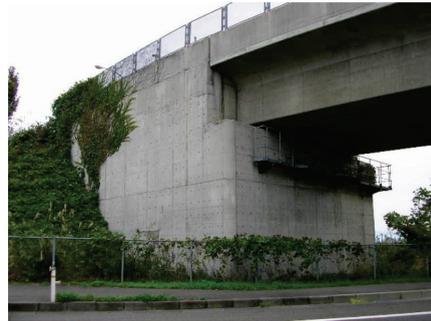
Photo 2. Abutment at Niigata interchange.

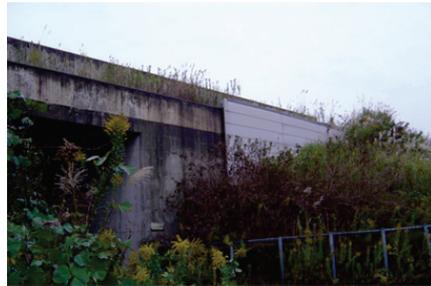
Photo 3. EPS embankment backside of the abutment.

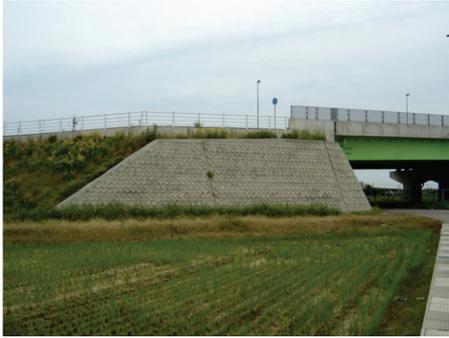
Photo 5. EPS embankment backside of abutment for overbridge.

embankment was built with vertical wall for both sides. At its design, EXTEC established a committee to study the construction method to replace earth embankment in service to new EPS embankment. Seismic stability was also studied to verify the stability of the embankment for Mid-Niigata class earthquake. At the construction, various measurement devices were set to confirm the analysis. JMA Seismic Intensity Scale was 5 lower at the site, no displacement was found on road surface and wall surface.

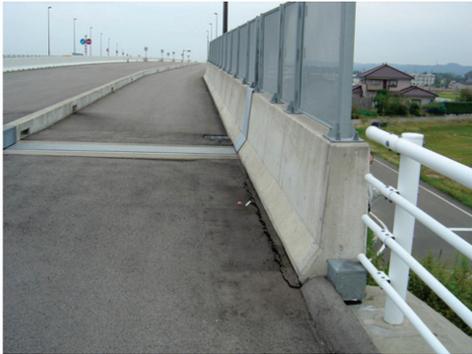
Photo 6. Road surface of backside of abutment.

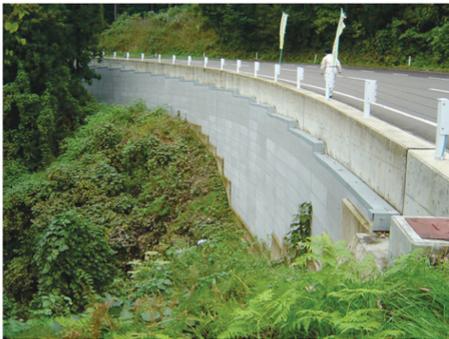
Photo 7. EPS embankment for road widening project.

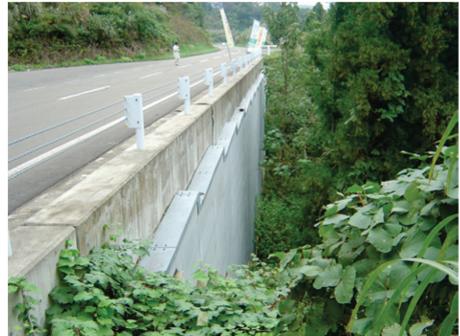
EPS embankment was built on precut road No. 61 Anegasakimaki line as an urgent maintenance service project. Since landslide were happen often in the area, Yasuzuka Civil Engineering Office of Niigata prefecture examined various sorts of construction methods and decided to construct an EPS embankment. It was built for a part of road widening project. The height of embankment is 7 m. JMA Seismic Intensity Scale was 5 lower at the site, no displacement was found on road surface and wall surface.

Photo 8. EPS embankment for road widening project.

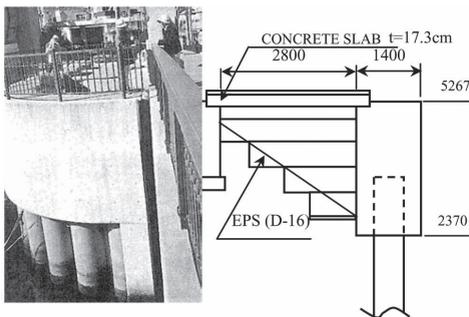
Since the damage caused were wide spread, survey was made for 10 locations as shown in Fig. 5. The results show no direct damage on any EPS embankments by the earthquake. Only slight EPS displacement caused by the settlement of foundation itself was found for one location. Port structure and

Figure 6. Slight damage on EPS embankment.
