# Damage performance of steel-reinforced earth structures in the 1995 Hyogoken-Nambu Earthquake

Yoshinori Otani & Makoto Mega  
Hirose & Co., Ltd, Tokyo, Japan

Tamotsu Matsui  
Osaka University, Japan

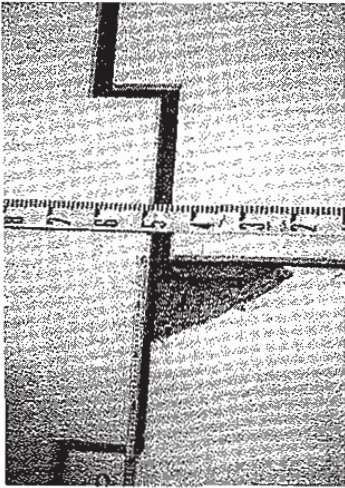
Between the upper and lower concrete wall elements, plates of cork or hard rubber are used as horizontal joint bond, while between the right and left elements, a gap of approximately 15mm exists. Therefore, each wall elements can move flexibly, following seismic performance of backfills. A few types of damage as (1) (see Photo 1) and (4) above-mentioned might be caused as a result of wave-form deformation of the entire wall during earthquake. Especially, damage to corners of wall elements might be caused as a result of direct contact of keyed joints around wall elements, owing to the relatively large displacement between adjacent wall elements as compared to movement of an entire wall. In all reinforced earth walls investigated which suffer damage only at the corners of wall elements, no large cracks were observed, followed by judging them as slight damage that do not need any repair.

Photo 1 Example of separation of a concrete fragment at a corner of wall element

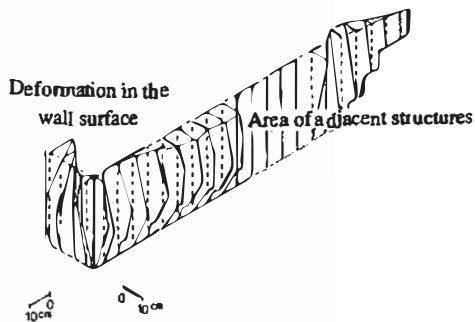
Figure 4 Example of deformation of wall surface in reinforced earth wall

Figure 4 shows an example of three-dimensional deformation in the wall surface of a reinforced earth wall of 3.75m high significantly damaged. The displacement is represented choosing the bottom of wall as the reference point, because of no record before earthquake. The wall

surface inclines forward as a whole, but the top of wall tends to incline toward backfill. Although the long-term stability of the wall should be discussed based on a long-term observation of wall deformation and an investigation for confirming sufficient friction acting on reinforcements, the measured deformation which corresponds to about 3% of wall height at most might not be caused a significant problem. This is because 3% of wall height is a reference for vertical accuracy of wall in execution management when construction. In this case history, however there was some observed damage to the structure, including cracks and separation of concrete fragments at the corners of wall elements, or settlement of ground surface at the top of wall. Therefore, this reinforced earth wall was ranked as needed reinforcement or repair.

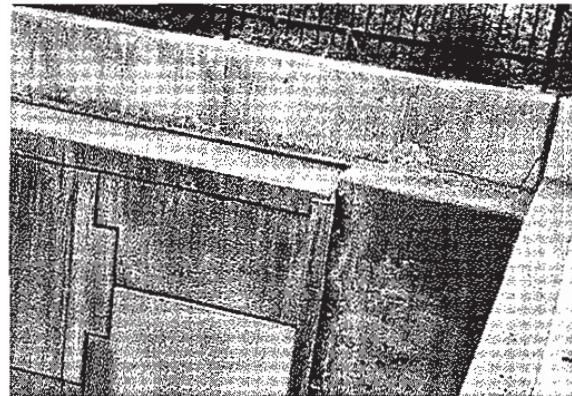
In reinforced earth structures located at near abutments or concrete retaining walls, steel angles are fixed with anchor bolts to adjacent abutment or retaining wall to restrict forward inclination of wall during compaction work of backfills. The concrete separation surrounding the anchor bolts was observed in two reinforced earth walls (Photo 2), in which settlement of ground surface at the top of wall was observed, but no deformation of reinforced earth wall, and no cracks of wall elements. These structures were judged to be in need of repair in order to prevent the steel angles detaching from their anchors in future, although the reinforced earth walls and the adjacent structures were sound.

Photo 2 Damage example of joints of reinforced earth structure

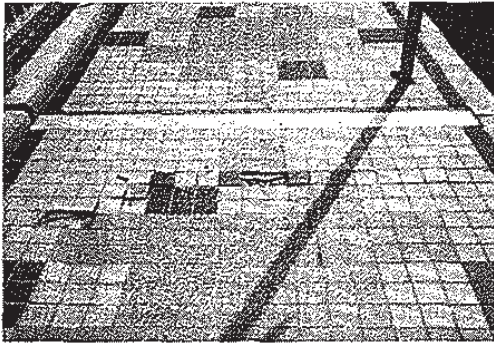
In some reinforced earth walls investigated relative settlement of 1~2cm of the ground surface was observed at the top or in front of walls as well as cracking on pavement surface (Photo 3). In the reinforced earth wall, sandy material are used as backfills to ensure adequate drainage of rain water. Therefore, this type of damage was little significant among investigated structures, followed by judging as no need to repair.

Photo 3 Example of relative settlement of ground surface at the top of wall

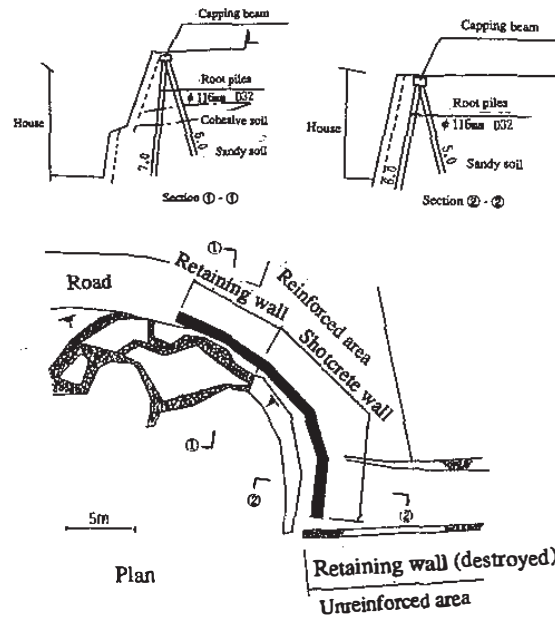
Figure 5 Location of Case history 1

As shown in Figure 5, two types of facing were used in the construction of the reinforced natural ground structures (6m to 7m in height). One consists of a retaining wall of piled stones and the other a shotcrete wall. Adjacent to the shotcrete wall, an unreinforced retaining wall (3m or less in height) was constructed by piled stones. Cracks were observed in the ground surface at the top of shotcrete wall and hair cracks were also detected on the face of the shotcrete wall. An opening of 5cm was observed at the facing boundary of reinforced earth structures (Photo 4). The adjacent unreinforced retaining wall was destroyed after falling forward, in spite of lower wall height. Houses located in front of reinforced structures suffered some significant damage. Significant damage was observed in the facing of shotcrete, which has less rigidity than in piled stone retaining walls. Comparing the performance of the unreinforced and reinforced structures above-mentioned, it can be confirmed that the advantage of seismic integrity of reinforced earth structures.

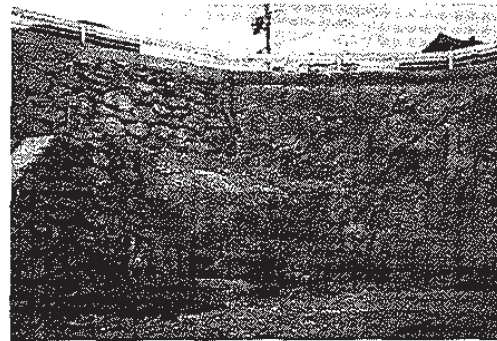
Photo 4 Damage example at facing boundary of reinforced earth structure

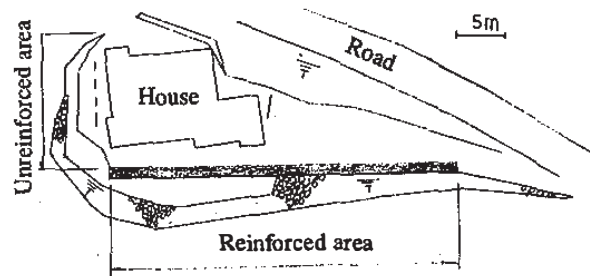
Figure 6 Location of Case history 2

As shown in Figure 6, an investigation of the post-earthquake condition of the site involved two locations, namely the reinforced retaining wall (H=7.5m) of Type B in Fig. 1 and an unreinforced retaining wall which is located orthogonal to the reinforced wall.

The unreinforced retaining wall deformed forward with an opening of 20cm at most between wall top and backfills, together with cracks on ground surface along the wall. The ground caved-in parallel to cracks by 7cm difference in areas of 20m off the top of retaining wall. This suggests that the natural ground might slightly slide in the unreinforced area.

In the reinforced area, several cracks on ground surface were detected and the ground mass deformed forward in the front of the reinforced retaining wall, although no cracks or deformations were found at the backfills. In this site, the direction of ground motion is approximately orthogonal to the reinforced retaining structure, suggesting that more severe seismic force acted on the reinforced retaining wall. Consequently, it is suggested that the reinforced earth structure has a strong seismic resistance.
