A debris flow induced by the collapse of a reinforced earth wall

ABSTRACT: A reinforced earth wall (MSEW) was constructed at the edge of a tableland to establish a site for dumping abandoned soil. The site was also located on the top of a valley that has a mean slope of 18° and a length of approximate 400 m. The wall was 14.5 m high, 50 m long, and with a slope face of 70° . In the fall of 1998, a heavy storm caused the wall collapsed suddenly. Then the water blended with soil mass rushed down along the valley and formed into a debris flow that ruined a two-story house downstream and buried two people in the house. To investigate the cause of this disaster and the mechanism of the failure, a series of tests and stability analysis were conducted. The results of the analysis show that there are three factors that possibly triggered or resulted in the failure of the wall: poor compaction during construction, the heavy storm dropped more than 590 mm of rainfall in 48 hours, and the adverse effect of dumped soil piled up on the top of the wall. Hence, even the wall could maintain its stability from the design point of view, the failure still occurred because adverse conditions were not

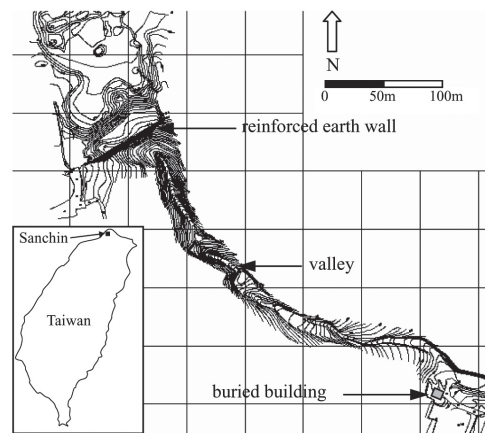
Figure 1. The topography map of the site.

The site is located at a hill on the northwest side of Tatun volcanic mountains in northern Taiwan. The area usually has plentiful rainfall from October to March when the northeast monsoon prevails. The reinforced earth wall situated at the edge of a tableland was constructed to establish a site for dumping soil from nearby excavations. From the topographic map, it shows that the thickness of the fill on the top of the wall was about 9 m when the wall failed. There was little vegetation on the fill, this would result in high quantity of runoff at the site. The site was also near the top of a narrow valley that has a mean slope of 18° and a length of approximately 400 m (Figure 1).

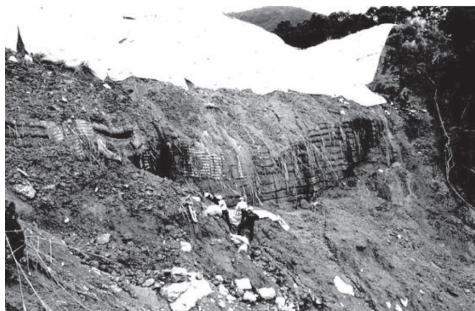
A 3-tier reinforced earth wall 14.5 m high, 50 m long, and with a slope face of 70° , located at the edge of a tableland at Sanchin Village in Taipei County in northern Taiwan (Figure 1), collapsed suddenly under the heavy storm carried by Typhoon Babs at about 8 P.M., Oct. 26, 1998 (Figure 2). The water mixed with the collapsed soil mass, rushed down along a narrow valley and formed into a debris flow

Figure 2. The failure of the reinforced earth wall.

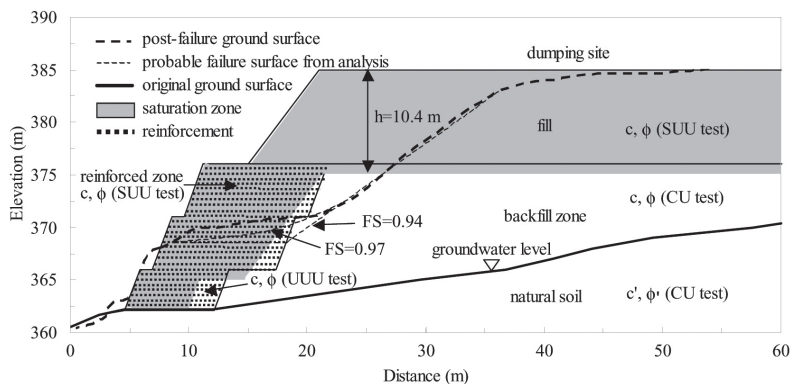
Field investigations, sampling, and testing were conducted to examine the field condition after failure and also to obtain soil and geogrids samples for laboratory tests. The profiles of the wall before and after failure, as well as the original ground surface are shown in Figure 3. It can be seen that the failure zone was within the upper half of the wall and the fill.

Figure 3. The cross section of the reinforced earth wall.

The shear strength parameters used in the zones are shown in Figure 3. In ordinary condition, the UUU test results are used in the reinforced zone due to partially saturated condition ($S = 73 \sim 82\%$). Whilst the dumped soil has a relatively high degree of saturation ($S = 88 \sim 96\%$), thus the shear strength parameters in this zone uses the CU test results. The total stress parameters (c, ϕ) are used for the soils above the ground water table, and the effective stress parameters (c', ϕ') are selected for the soils below the ground water table. The shear strength parameters of the soil-geogrid interface and the tensile strength of geogrids are from the geogrid test results. The values of the parameters are taken from Table 1.

the wall. The wall would fail (FS = 0.99) and sliding along the soil-geogrid interface when the distance between the edge of the fill and the crest of the wall was 6 m. If the distance is reduced to 4 m, the factor of safety of sliding along the interface between the middle and the lower tiers is 0.94. However, the factor of safety along the probable failure surface from the survey is 0.97. The two failure surfaces are very close as can be seen in Figure 3. Therefore, the wall was very likely to fail under this condition.
