Structures reinforced with geosynthetics – some illustrated causes of failure

Davies, P.L.

Kaytech Engineered Fabrics, Durban, South Africa

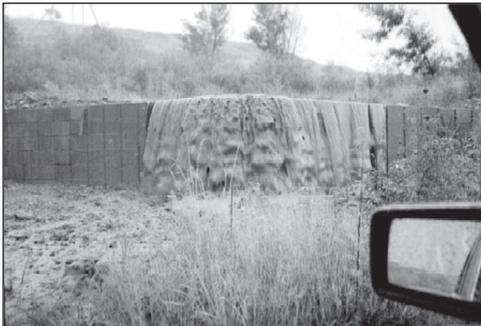
Picture 1 shows an extreme example of this, where a geosynthetic reinforced CRB wall is being overtopped by rainwater because of nonexistent surface water control. This wall failed further to the left of the location shown here and is the subject of discussion later in this paper.

Picture 1. No surface water control . . .

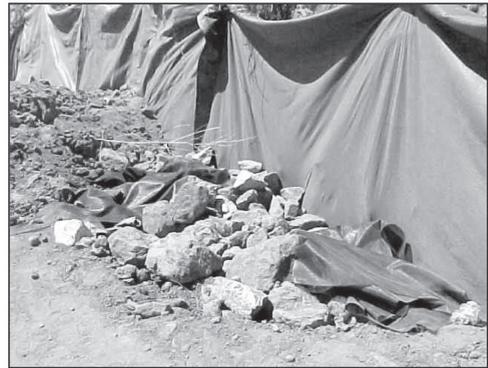
shows what this supervisor considered to be suitable "coarse" material as backfill to be used in constructing an eight metre high retaining wall. This project was one of those where the client did not want to pay for project supervision by the design engineer, so he never saw this abuse during construction.

Common sense dictates that material such as that shown in Picture 2 would be highly likely to damage the geosynthetic reinforcement when compaction was taking place, but it is a sad fact that an engineer should not rely on "common sense" always being shown on site.

Picture 2. "Coarse material" . . .

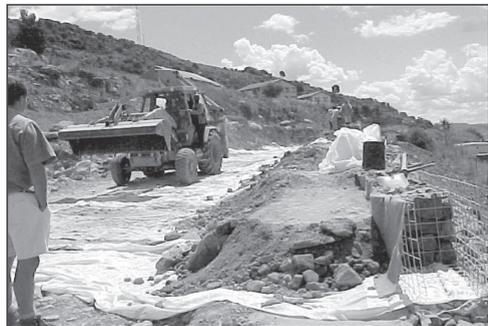
Picture 3. Gross negligence . . .

He is watching a woven multifilament geotextile reinforcement being placed over a coarse rocky substrate, (not even in the same plane as the top surface of the lift of the facing elements), and then covered with an extremely harsh fill, which was compacted to 95% mod AASHTO.

Once again, the project specification for the backfill material for the walls did not specify a maximum and minimum particle size. The project manager was allowing construction plant such as that seen in the background to ride over the geotextile that in turn was laid over a harsh rocky surface. When the author examined the fabric, it was riddled with holes, soaked in hydraulic fluid leaking from the plant shown in the background, and its reinforcing ability was completely compromised.

In the projects shown in Pictures 2, 3 and 4, hard extruded or bonded geogrids would have been far more appropriate than the woven multifilament geotextile specified (good as it may be), had the designer known what would happen on site.

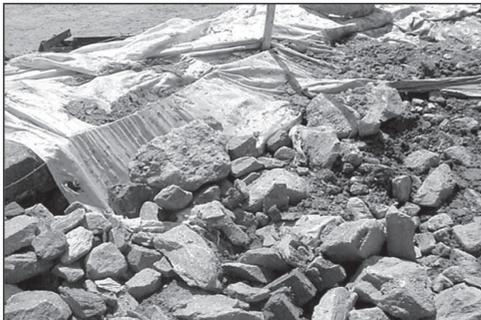
Picture 4. More "Coarse material" . . .

Not only is the backfill most unsuitable, but here too the reinforcement is not even installed in the same plane as the top of the lift of facing elements. This is the worst case the author has seen and it seems inconceivable that an installer could show such a careless approach. Once again, the specifier had trusted to common sense, and the backfill material was merely specified as "coarse".

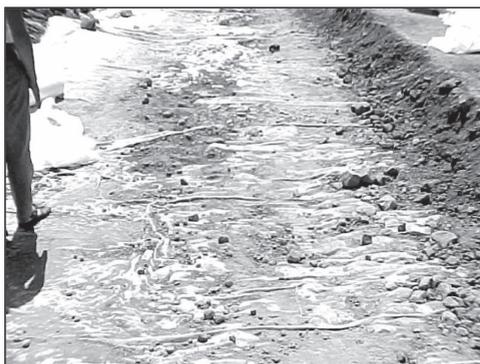
It would seem obvious that the reinforcing component of a reinforced soil wall cannot be laid as seen in Picture 5 on the following page, and be expected to work as intended, yet fabric or grids which have been laid slack or full of wrinkles are a common sight on many projects. The result can be walls with facings that bulge outwards even before they are complete, and which fail in due course.

Figure 5. Untensioned reinforcing elements.

The designer should specify in the contract documentation, at tender stage, that the reinforcing elements should be laid in tension as far as is practically possible.

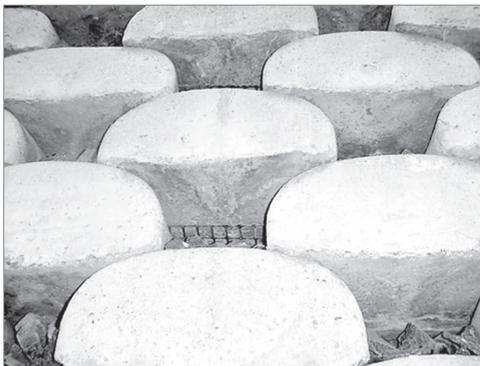
We have often come across instances where the reinforcement/block tie-in length has been inadequate as shown in Picture 6, or in some instances, reinforcement does not connect with the blocks at all.

Picture 6. Reinforcing not properly clamped in CRB.

The author recommends that the reinforcing elements should be designed and clearly specified to protrude a small distance beyond the face of the retaining blocks during construction, so that it can be seen to be in place on inspection and then properly clamped in position.

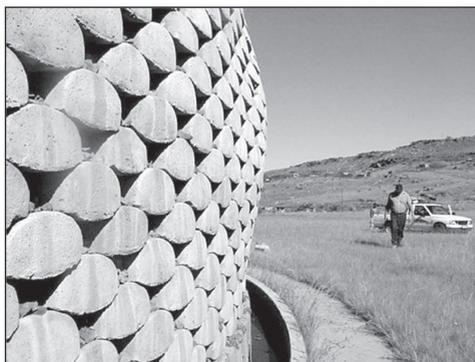
The expansion of the heated media can result in extra pressure on the CRB face, and if the reinforcing is not properly clamped in position, the blocks can pull free and the structure then collapses (see pictures 7 & 8 – all the same structure).

Picture 7. Unreinforced CRBs bulging.

When the structure has been completed, the protruding reinforcing can then be neatly trimmed up against the face of the CRBs. The result of not insisting on this can be seen in Pictures 7 & 8.

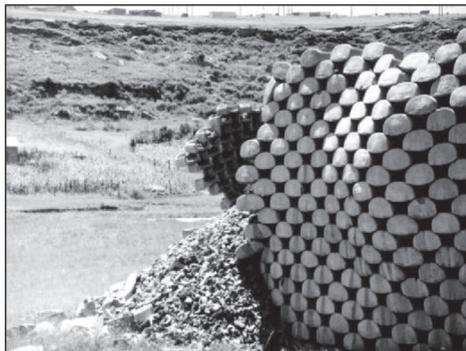
Picture 8. Failure.

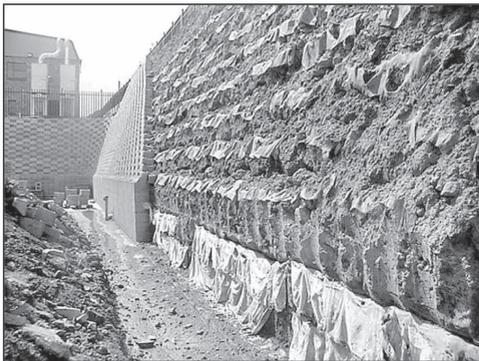
- Reinforcement installed at level of top of block 3, but only clamped between blocks 4 and 5 (see Pictures 9 & 10 and note how the reinforced soil is still intact – just the blocks have fallen off). Errors of this type were noted in several other locations on this site.
- The reinforcement sheets were not installed horizontally as specified. The sheet ends were clamped between the blocks at a level much higher than the sheet elevation, clearly shown in Picture 10. This resulted in a vertical reinforcing discontinuity against the wall, so that no tieback forces could be mobilised. The wall, with little or no horizontal resistance, experienced large outward movement under the action of imposed soil and water pressures.
- Once the top of this base wall had moved out, the retaining facing and the reinforced soil mass moved

Picture 9. Failure – note skewed fabric tie into block joint.

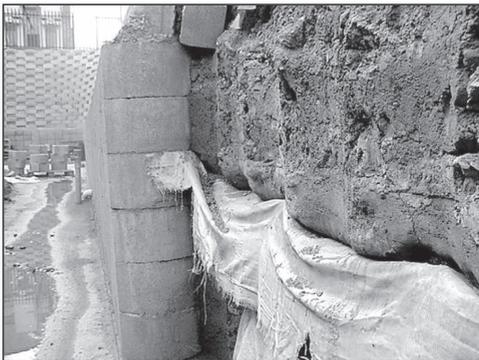
Picture 10. Failure – note minimal fabric tie into block

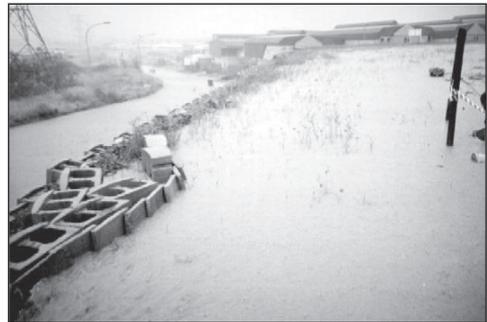
The stormwater referred to is a contentious issue. As early as June 1999, the designer of the geosynthetic-reinforced structures discussed here had warned the site developer that surface water control was needed – particularly in the areas shown in Pictures 11 and 12.

Picture 11. Inundation – no stormwater control . . .

Provision for designing such control was not included in the wall designer's brief and he had no control over site conditions not immediately connected with the structures he was commissioned to design. The measures requested were not attended to, and the result is seen in Picture 1 on page 2 of this paper, Picture 11 above, and Picture 12 on page 6.

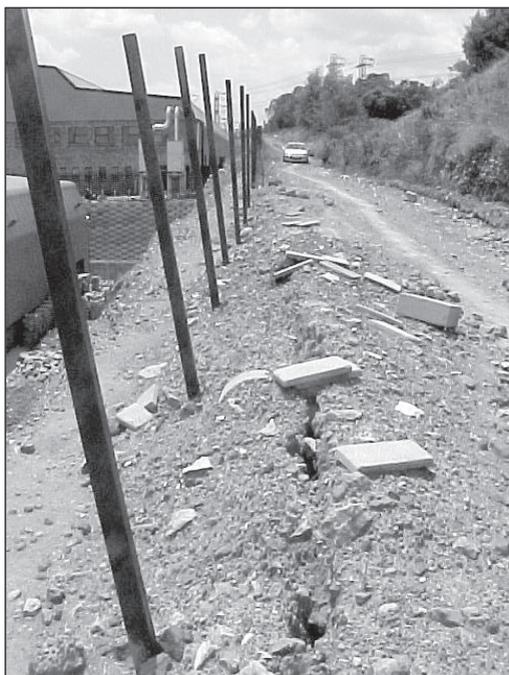
slightly out and downward, creating a void/tension crack at the top of the wall (see Picture 12 on page 6). Water not only entered this crack, causing further outward movement, but also entered the wall area between the blocks and the reinforced soil mass.

Picture 12. Failure – tension crack – note angle of poles
